Operations on board Istanbul University RV YUNUS – 29-30/01/18

Summary

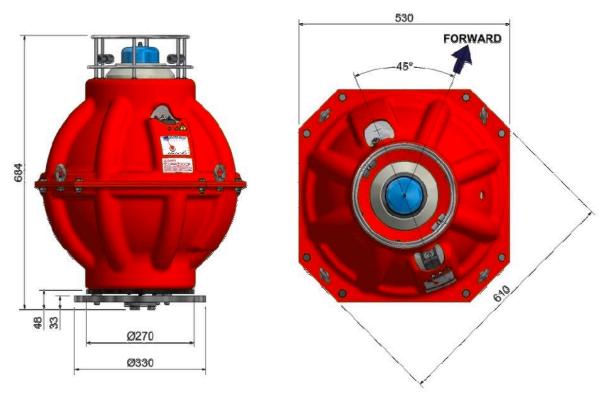
Figure 1: Sonardyne "Fetch" acoustic transponder releasable unit.

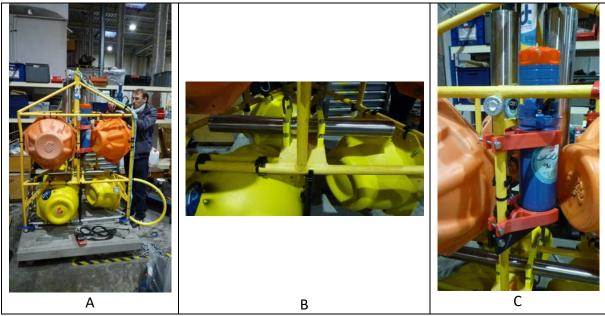
Figure2: mooring frame instrument set up. (A) general view. (B) RBR Bottom Pressure Recorder. (C) Seaguard Recording Current Meter

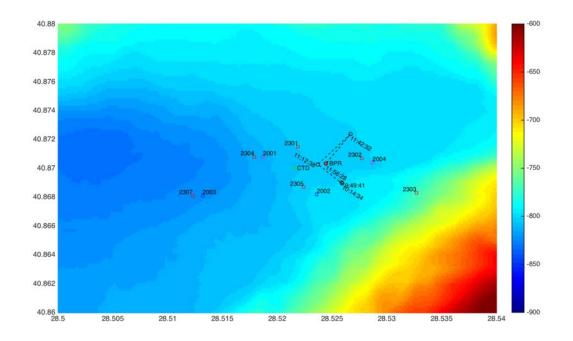
Figure 4: Bathymetric map of area (grid from Suroît 2000 EM300) with location of acoustic beacons, deployment point of CTD (with Poseidon in 2016) and of bottom pressure recorder (BPR, with R/V Yunus in January 2018). Ship positions logged during BPR deployment are indicated. Acoustic beacons still on the sea floor are indicated in red (Geomar beacons) and magenta (LGO beacons). Retrieved beacons (LGO beacons 2002/003FC4 and 2003/004011) are indicated in blue

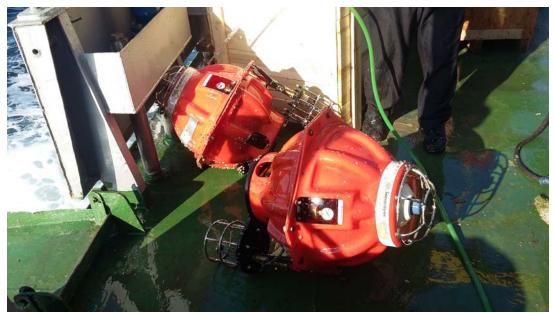
Beacons 2002 and 2003, located south of the fault were recovered (Figure 5). Beacon 2004 could not be released because of failed communication. More surprisingly, Beacon 2001 did not release although the FOPEN command was apparently received and executed (Figure 6a and 6b). For comparison, Beacon 2003 released successfully (Figure 6c). There is a possibility that Beacon 2001 acoustic release was actuated but that the sphere stuck to its base for mechanical (or biomechanical...) reasons. It thus remains possible that a delayed release occurs spontaneously, in which case there is a risk that the beacon will be lost.

Figure 5: Beacons 2002 and 2003 on deck. Attached organisms include bivalvs and cnidaria

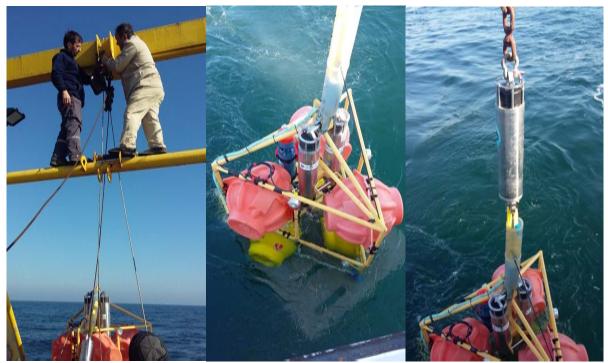
It appeared necessary to use the additional hoist rope and the SeaCatch quick release hook to lift the frame above the stern roller, and an additional pulley and cable was fit to the A-frame for this purpose (Figure 7a). And incident occurred as the SeaCatch cut the aramide rope that was holding the device. This could have been avoided by fitting a shackle between the SeaCatch and the aramide rope. No injury occurred when the frame fell back on deck. The shock was in part taken by the main cable (with the acoustic releaser) but 2 of the 4 short legs extending below the concrete ballast (those located on the aft side, which was also the side where the sensors are attached) were pushed up through the ballast when they hit the deck. The Colson collar restraining the top of the flotation sphere located below the oxygen sensor and its connector broke, and the sphere dropped by 10 cm. It could be clamped back in place and re-attached to the metal bar with a Colson collar. A nylon strap and a shackle provided by the crew were then used and the frame successfully lifted overboard and lowered in water.

Figure 7: Deployment of BPR mooring frame. Left: fitting additional pulley on A-Frame. Center: mooring in water. Right: View of acoustic releaser system used for deployment at the seafloor.
