Thermoplastic Composite Cylinders for Underwater Applications

Marine Technology Department, IFREMER Brest Centre, France

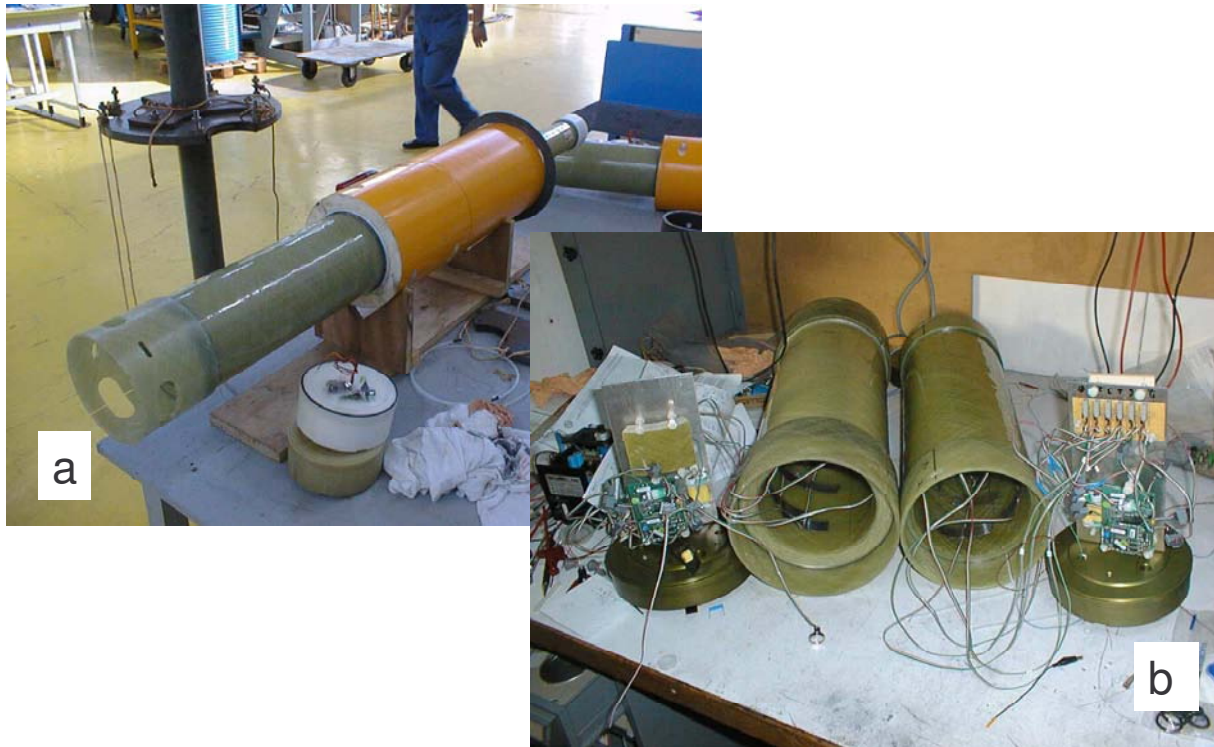
Figure 1. Deep sea instrumentation containers in glass/epoxy composite.
a) 55 mm inner diameter messenger tubes, b) 150 mm inner diameter instrumentation containers

The present work was initiated in order to establish whether thermoplastics offered significant advantages over the filament wound glass/epoxy materials currently employed for deep sea oceanographic containers. These are small cylinders used to protect instrumentation or electronic equipment deployed in the ocean to measure physical parameters of the deep sea environment. Figure 1 shows two examples. The reference material for evaluation of the thermoplastics is therefore an E-glass reinforced 125°C cure epoxy system.

Figure 1. Deep sea instrumentation containers

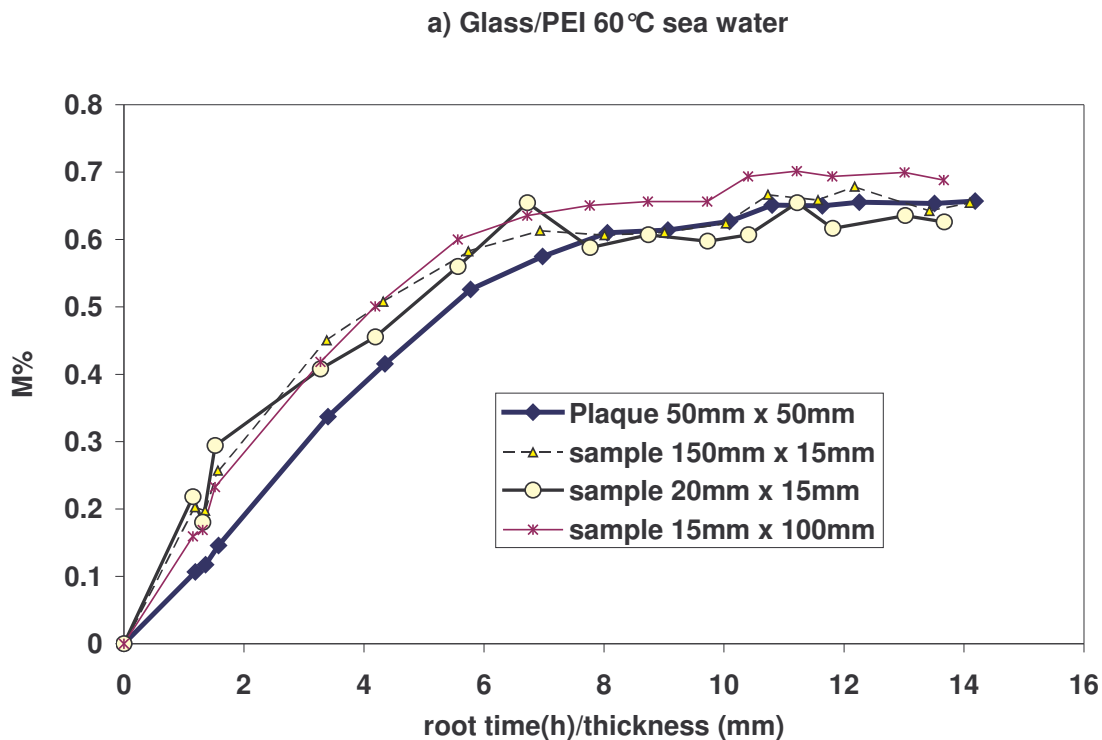
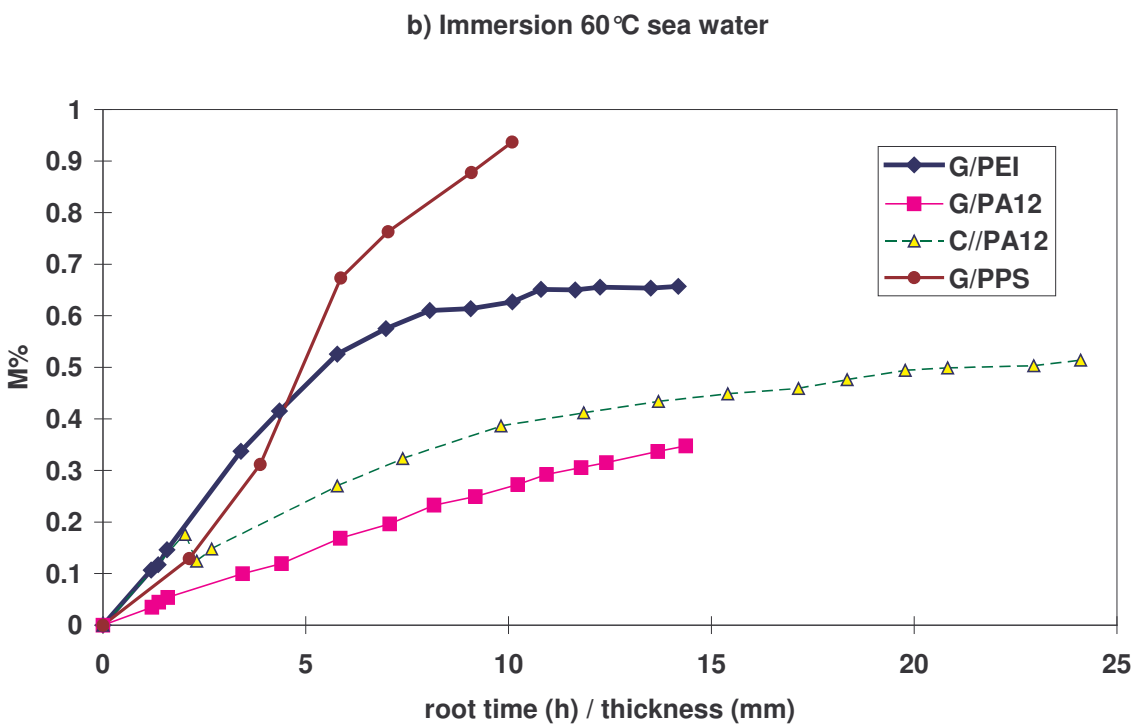
Figure 2 Weight gain plots in %, a) PEI, different sample sizes b) all composites 50 x 50 mm² plaques

The use of narrow specimens rather than large plates may influence the weight gains, but the comparison of weight gains for different specimen widths does not show a large effect here, Figure 2a. Figure 2b shows a comparison of the weight gains of the 50 x 50 mm² samples of all the glass reinforced composites and carbon/PA12 aged at 60°C. The PEI and the carbon/PA saturate at low weight gain values, while the glass/PA and PPS composite samples continue to increase in weight after 3 months' immersion.

Fig 2 Weight gain plots, a) glass/PEI, b) all composites

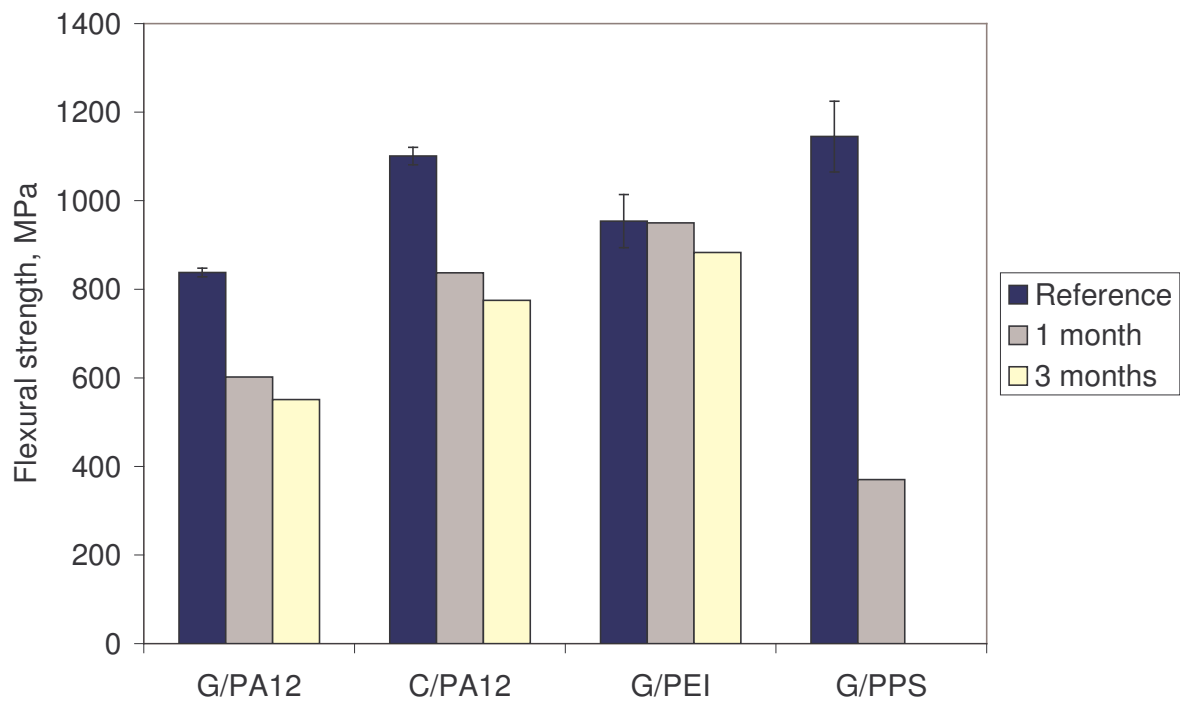
Figure 3. Influence of aging on mean flexural strength values, error bars show minimum and maximum values

Figure 3 shows the flexural strength results from these tests. All the strength values tend to decrease with aging. Significant drops are measured for the PA and PPS composites, while the PEI strength loss is less than 10% after 3 months' immersion.

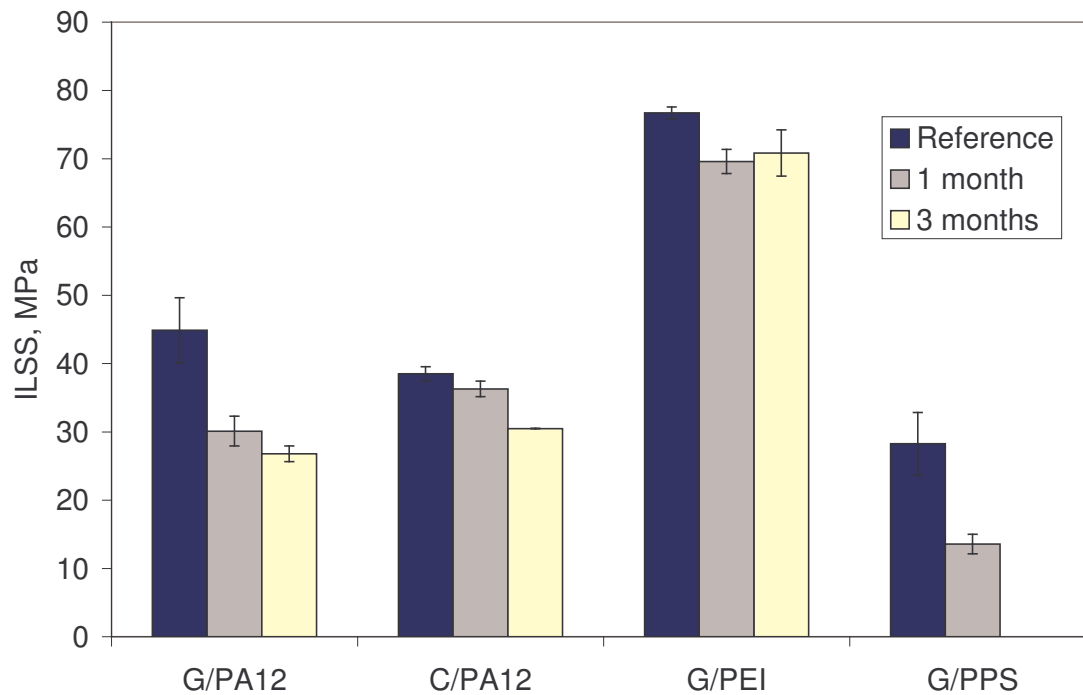
Figure 4. Influence of aging on mean ILSS values, error bars show \pm one standard deviation.

Figure 4 shows the interlaminar shear strengths obtained after aging. Again the PEI composites show less sensitivity to water immersion than the PA and PPS composites.

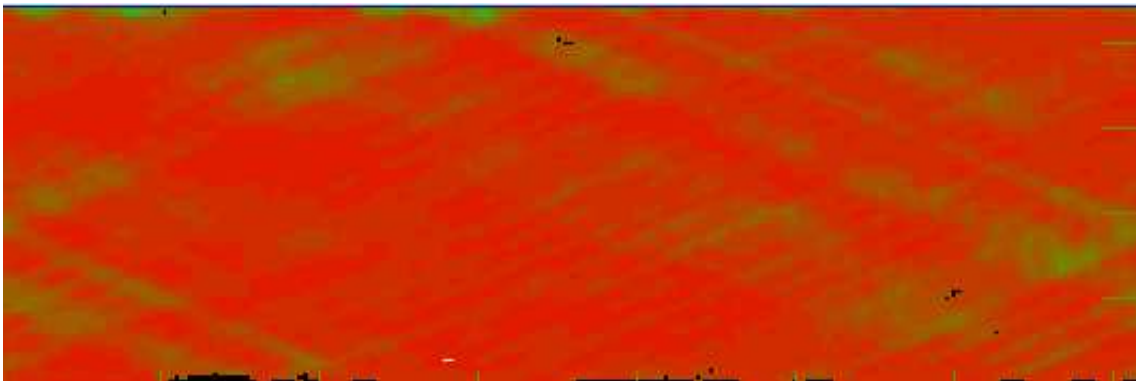
a) Carbon/epoxy

b) Carbon/PEEK

Figure 5. Examples of ultrasonic C-scan maps, 2 MHz focussed transducer, C/PEEK and C/Epoxy.

The attenuation level used for accepting the carbon reinforced cylinders was the same as that employed in previous studies for carbon/epoxy tubes, namely a 25 dB attenuation. The value of this criterion is based on experience and it cannot be used alone to define tube quality. Olson et al have shown that while high attenuation levels can be related to high porosity in thermoplastic composite cylinders there is not a simple relationship between dB loss and porosity level below 2% [16]. Examples of C-scans for carbon/PEEK and carbon/epoxy cylinders are shown in Figure 5. The attenuation levels were similar for both.

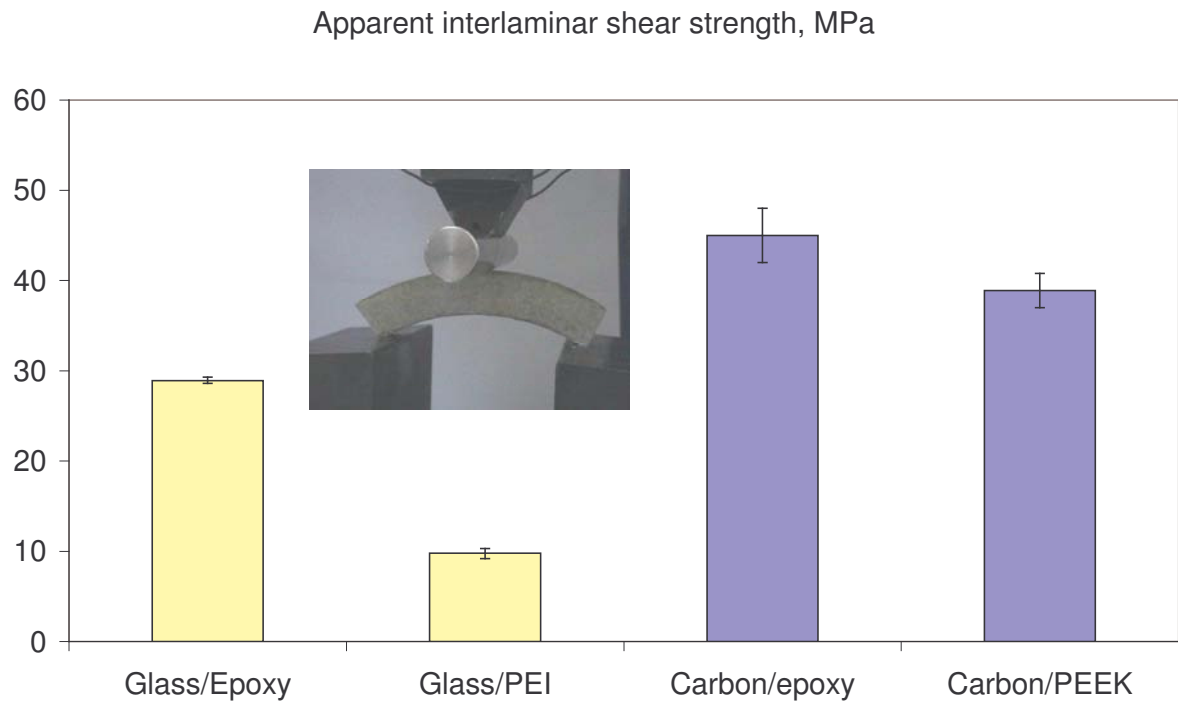
Figure 6. Apparent interlaminar shear strength tests, curved specimens, error bars show \pm one standard deviation insert photo shows specimen of glass/PEI during test

A simple mechanical test was then employed to evaluate the mechanical performance. This was intended to provide quality control information, so that future material systems may be evaluated rapidly before proceeding to costly implosion tests in pressure vessels. They are performed on ring segments, as shown in Figure 6, This test, described in ASTM 2344-1984, yields an apparent interlaminar shear strength. Figure 6 shows the results for both materials, together with results from tests on the glass and carbon reinforced epoxy samples from cylinders of similar diameters.

The results from these tests suggested that the fabrication of the glass/PEI tubes was not optimised. A large quantity of small defects throughout the wall thickness were noted, Figure 7.

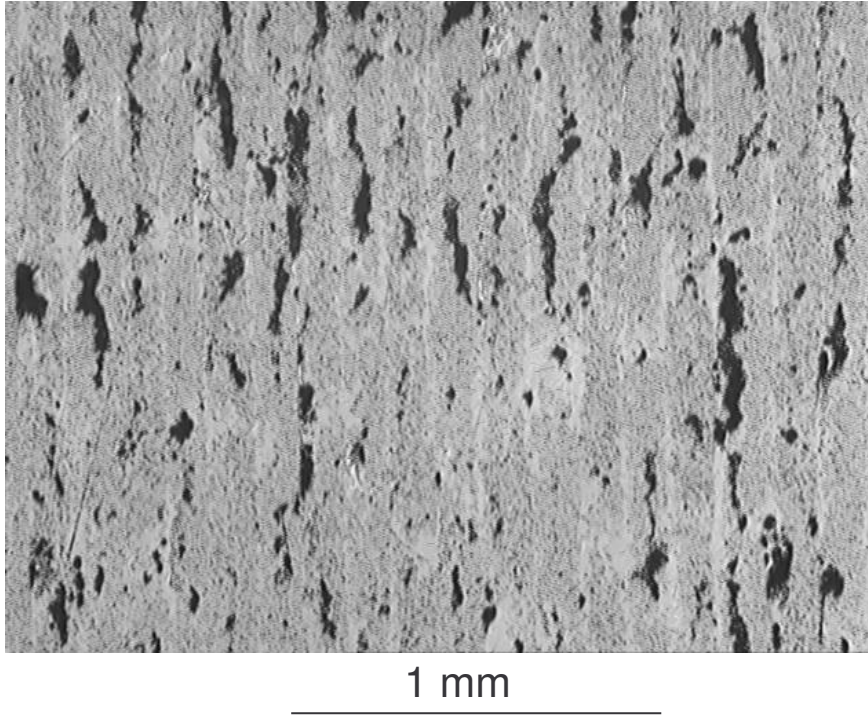
Figure 7. Defects in glass/PEI cylinder wall

The reason for the poor performance of this thermoplastic composite material appears to be the presence of the defects shown in Figure 7. Given the excellent performance of this material in screening tests further work is needed to optimise the manufacture of cylindrical structures, in order to realise its full potential. For the glass/epoxy no sign of buckling was detected by strain gages. The failure values obtained are slightly lower than those published by Hinton for a similar material [13] but the geometry is not identical as those authors tested

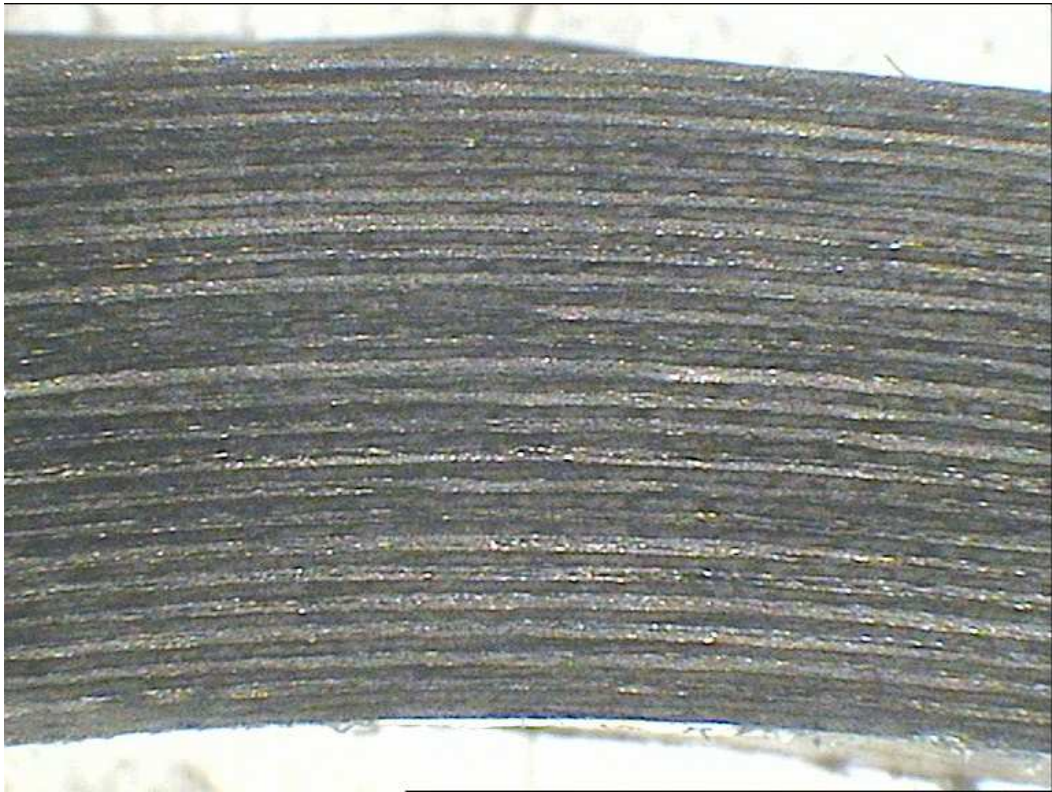
Figure 8. Section through carbon/PEEK cylinder wall cut at 55°.

The results for the carbon/PEEK specimen are similar to those of the carbon/epoxy system, suggesting a reasonable fabrication quality. Sections through the carbon/PEEK tube wall indicated low void content and little fibre waviness, Figure 8.

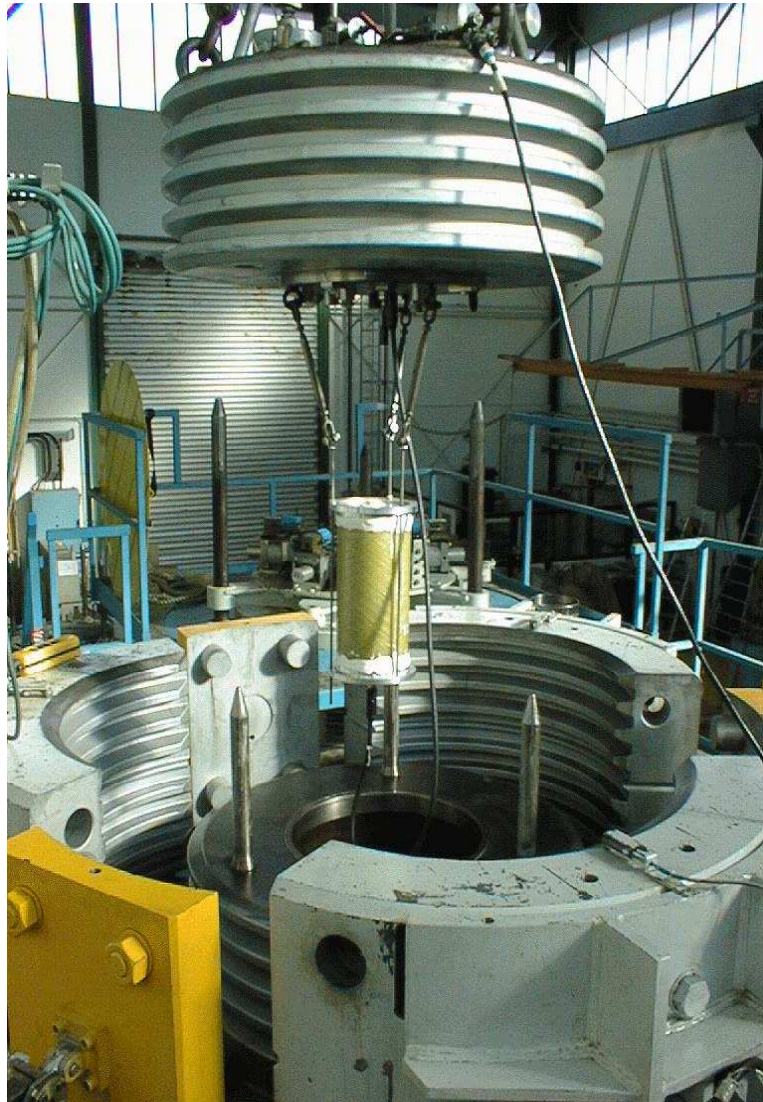
Figure 9. 2400 bar pressure vessel used for implosion tests, showing 175 mm diameter glass/epoxy cylinder before test.

Implosion tests were performed at the IFREMER pressure test facility in Brest in a 2400 bar pressure vessel, Figure 9.

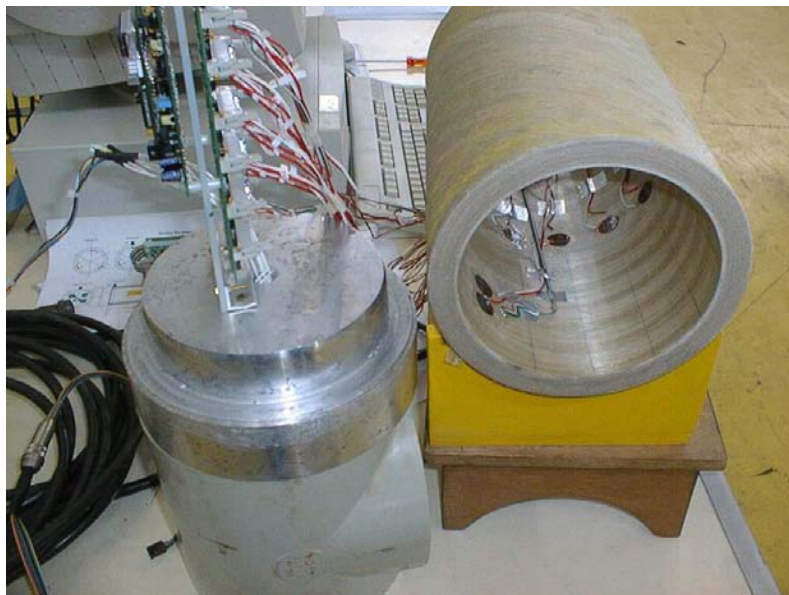
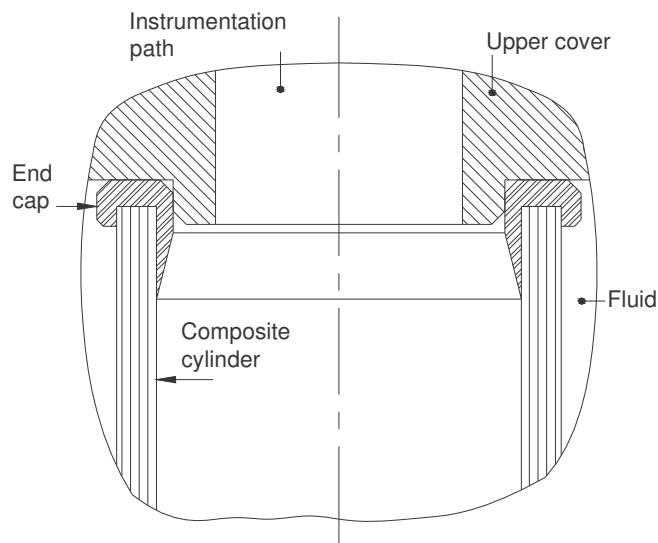
Figure 10. Experimental fixtures for implosion tests.

a). Glass/PEI cylinder before test, showing contoured end closure, data acquisition card and strain gauges.

b). Diagram showing aluminium end caps for small carbon reinforced cylinders (drawn to scale).

All specimen lengths were twice the inner diameters. The glass reinforced cylinders were 350 mm long, carbon fibre cylinders were 110 mm long. Cylinder ends were machined to ensure they were parallel. The end closures are critical in these tests on thick cylinders as stress concentrations can provoke premature collapse [29,30]. Aluminium end closures were used to close the large diameter cylinders [31]. These have contoured plugs to provide a progressive contact with the inner wall as pressure is increased. Figure 10a shows the glass/PEI specimen before implosion. Machined aluminium end caps were bonded to the small diameter cylinder ends, Figure 10b, these were designed to avoid fiber brooming, and these cylinders were placed between rigid end blocks. Previous tests on small and large diameter carbon/epoxy cylinders have yielded similar results using the two end closure systems [32].

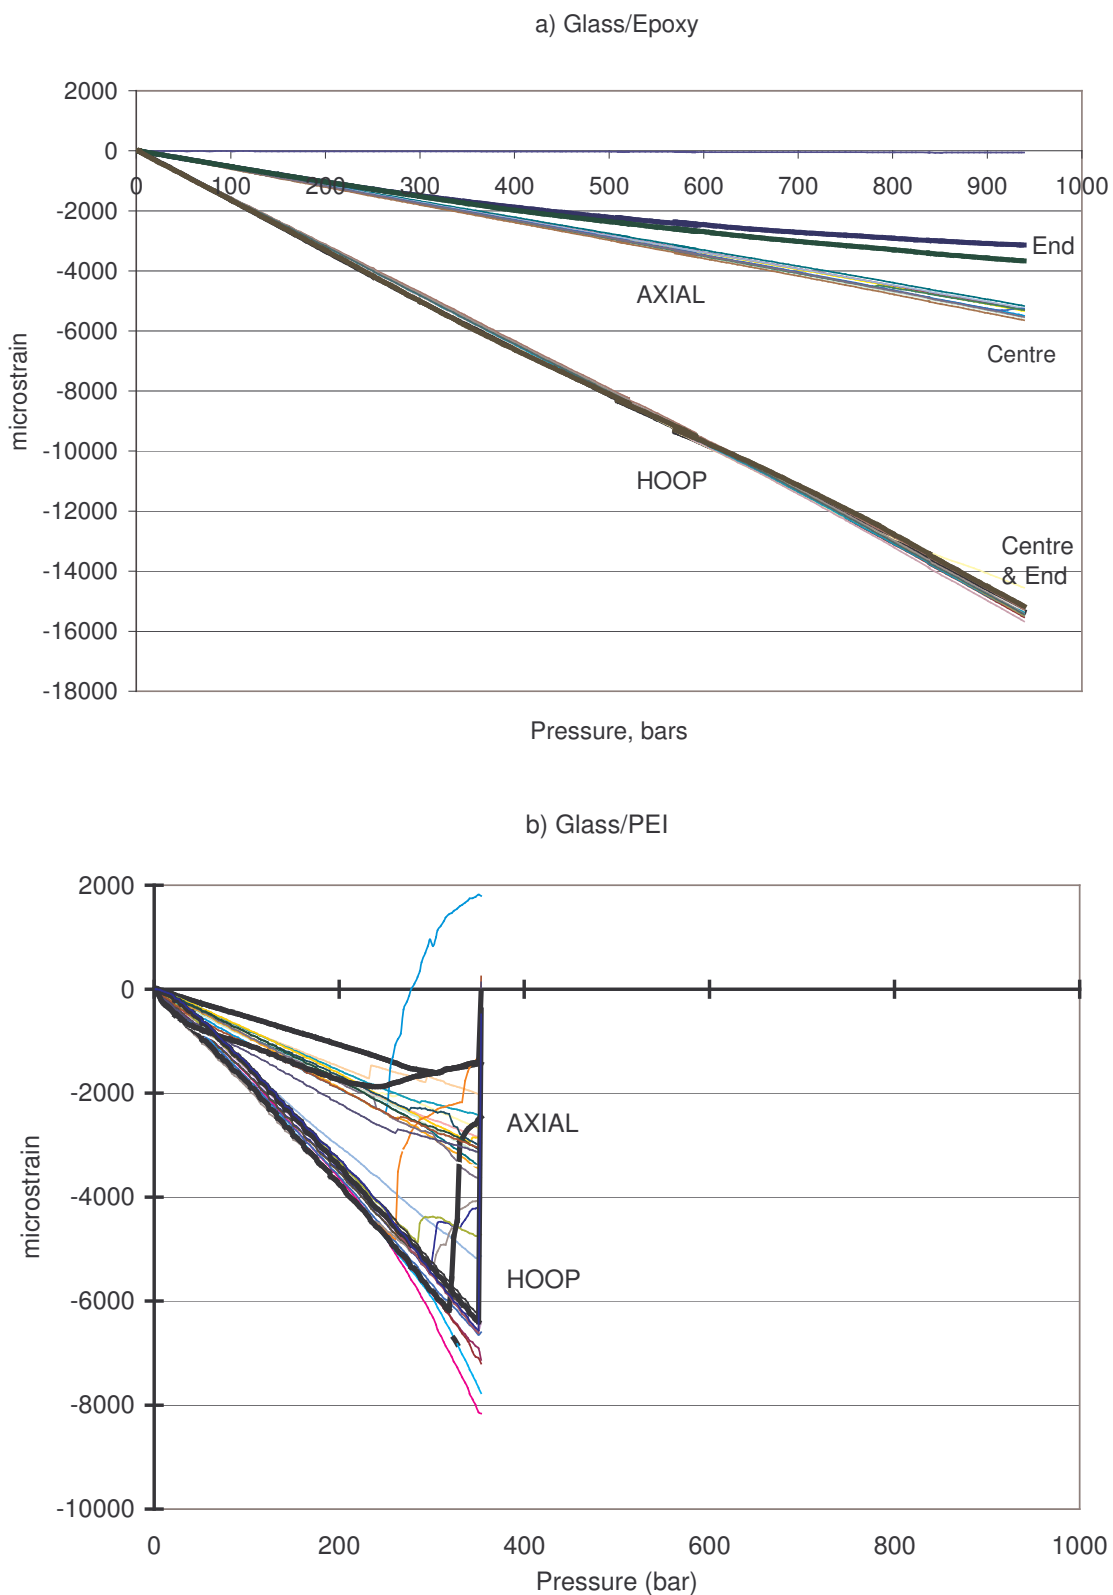
Figure 11. Examples of axial and hoop strain response from 28 strain gauges, 24 at centre and 2 at each end of cylinder a) glass/epoxy and b) glass/PEI.

Bold lines indicate end strain gauge response.

The reference glass/epoxy cylinders, 175mm diameter, imploded at pressures around 900 bars (90 MPa). The glass/PEI cylinder imploded at a much lower pressure, around 400 bars (40 MPa). Figure 11 shows examples of strain measurements at the inner wall during pressure loading for the two cylinders. The hoop strains at the tube end are very similar to those measured in the centre while axial strains tend to be lower near the end caps. Strains in the glass/epoxy cylinder reach 1.5% before failure whereas the glass/PEI fails at much lower mid-section strains. There is also considerable scatter in the strains measured on the latter.

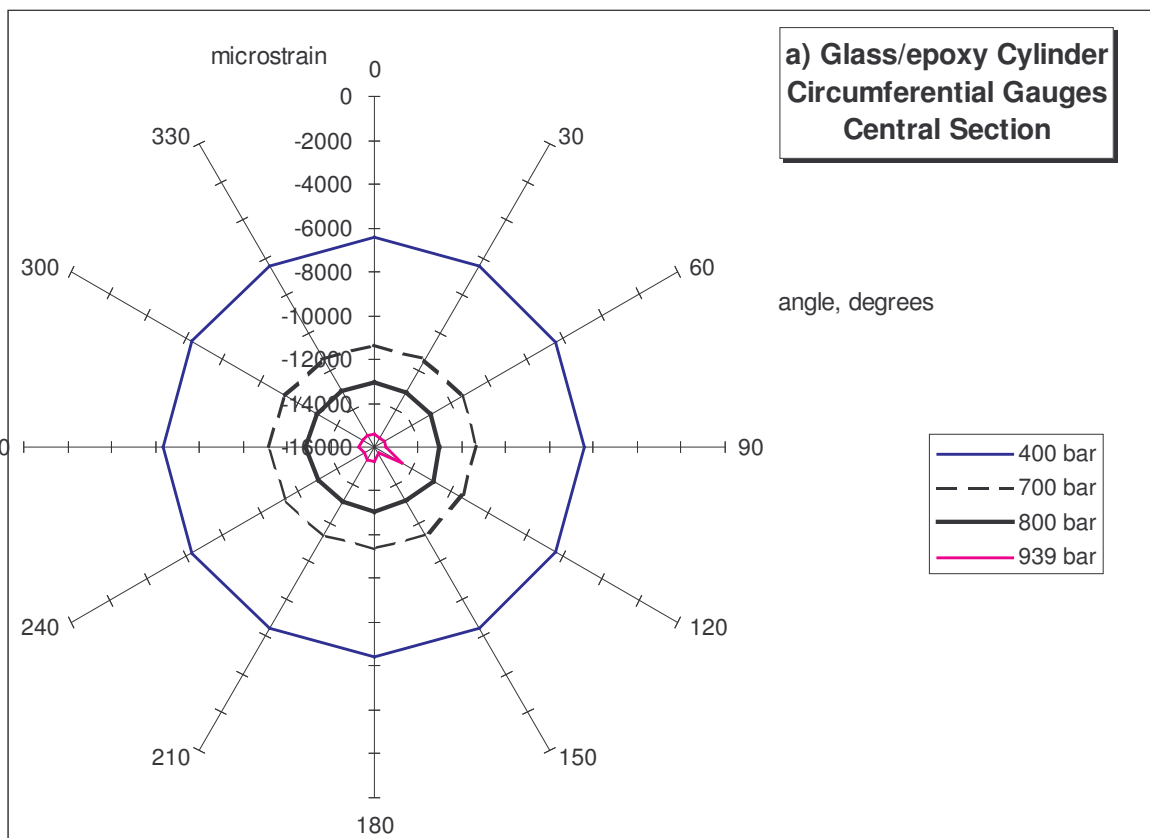
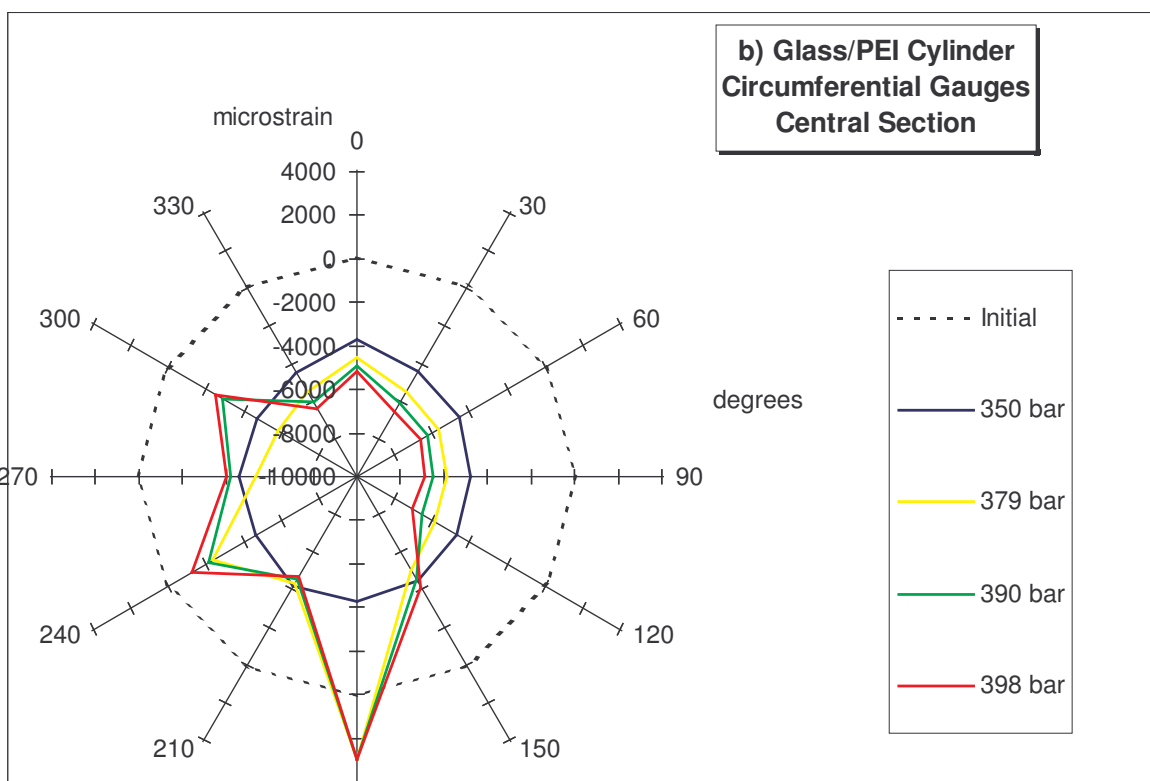
Figure 12. Central section inner wall hoop strains, a), glass/epoxy and b) glass/PEI.

Figure 12 shows all the central hoop strain recordings at different pressures.

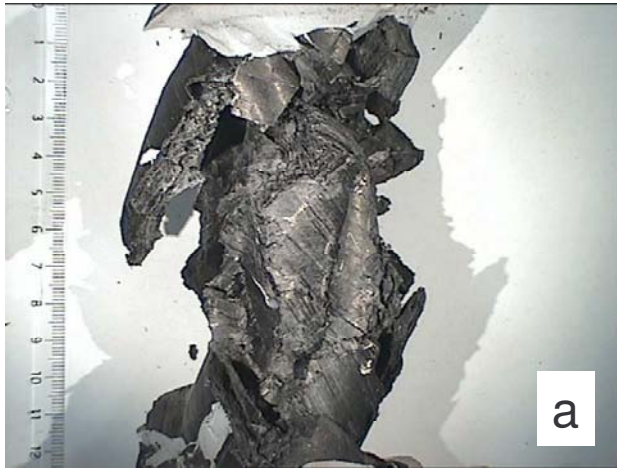
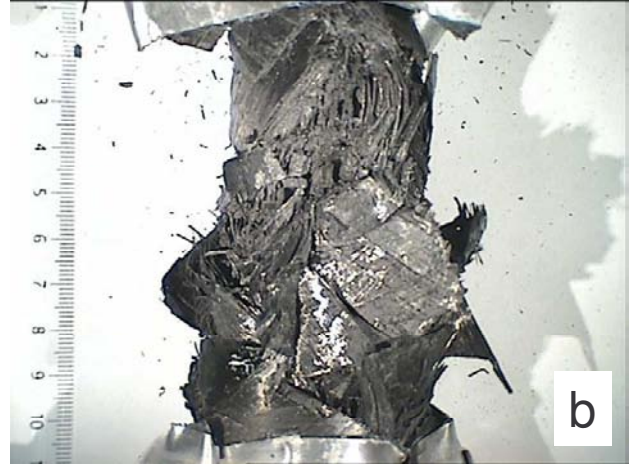
Figure 14. Cylinders after implosion a) carbon/epoxy, b) carbon/PEEK

Two undamaged 55 mm diameter cylinders were imploded for each material. Failure pressures of 105 and 117.5 MPa for the C/epoxy and 89 and 94 MPa for the C/PEEK were measured. The cylinders after testing are shown in Figure 14.

In both cases the cylinders imploded completely with no sign of a buckling failure. The two strain gages placed at 90° on the inner wall of the tubes indicated very similar values and linear readings up to failure, Figure 15.

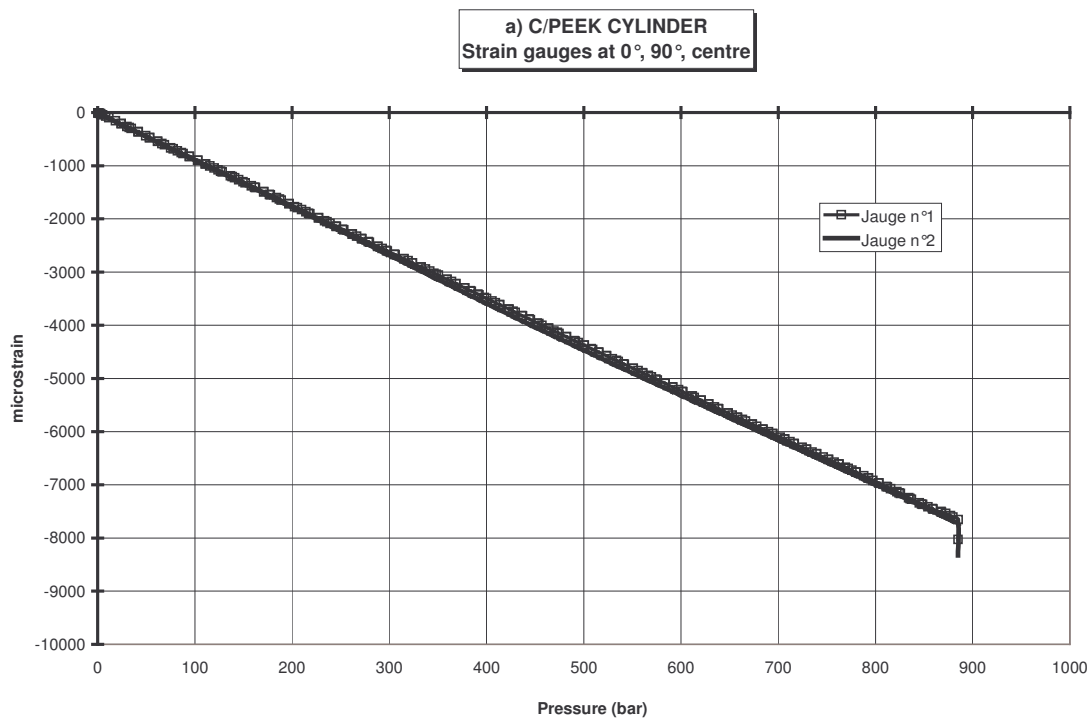
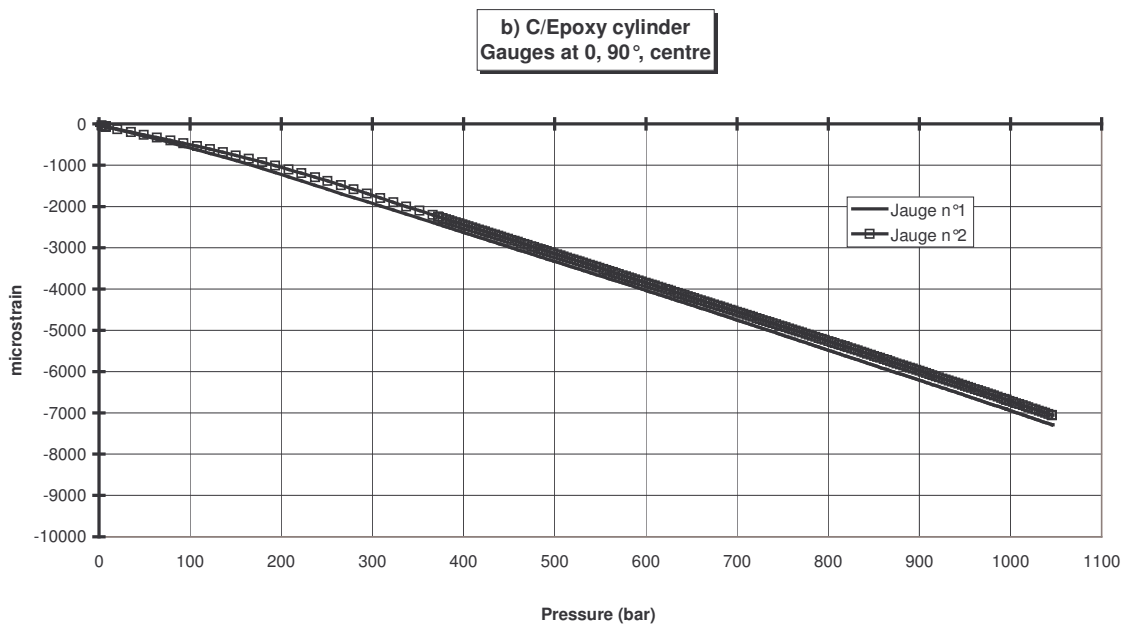
Figure 15. Hoop strain gauge readings, inner wall, mid-height
a) carbon/PEEK, b) carbon/epoxy cylinders.

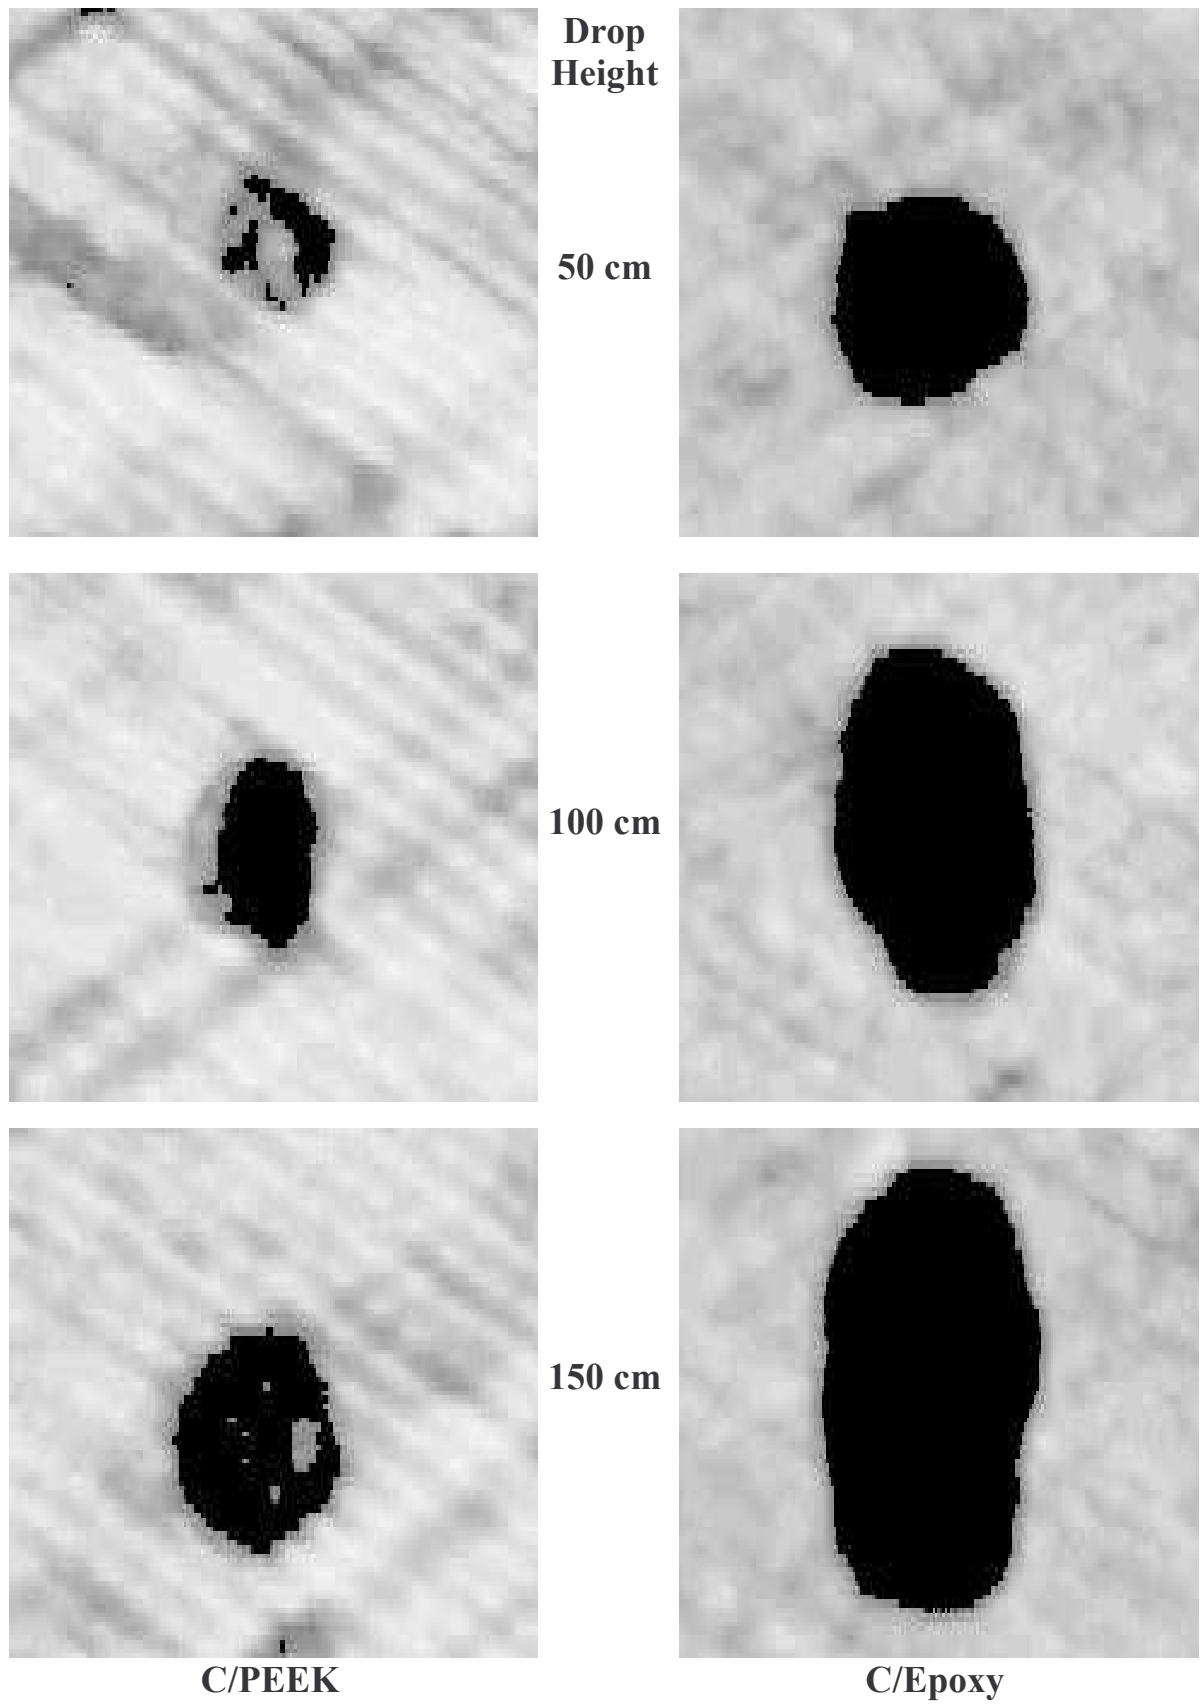
Figure 17. Damaged areas detected by ultrasonic C-scan.
Each photo represents an 80 mm x 80mm area.

Each cylinder was C-scanned before impact. After impact the damage introduced was identified by two methods, first ultrasonic C-scan and then sectioning. A focalised 2 MHz transducer was used. This enabled clear damage regions to be defined, Figure 17, and the areas of these are plotted in Figure 18.

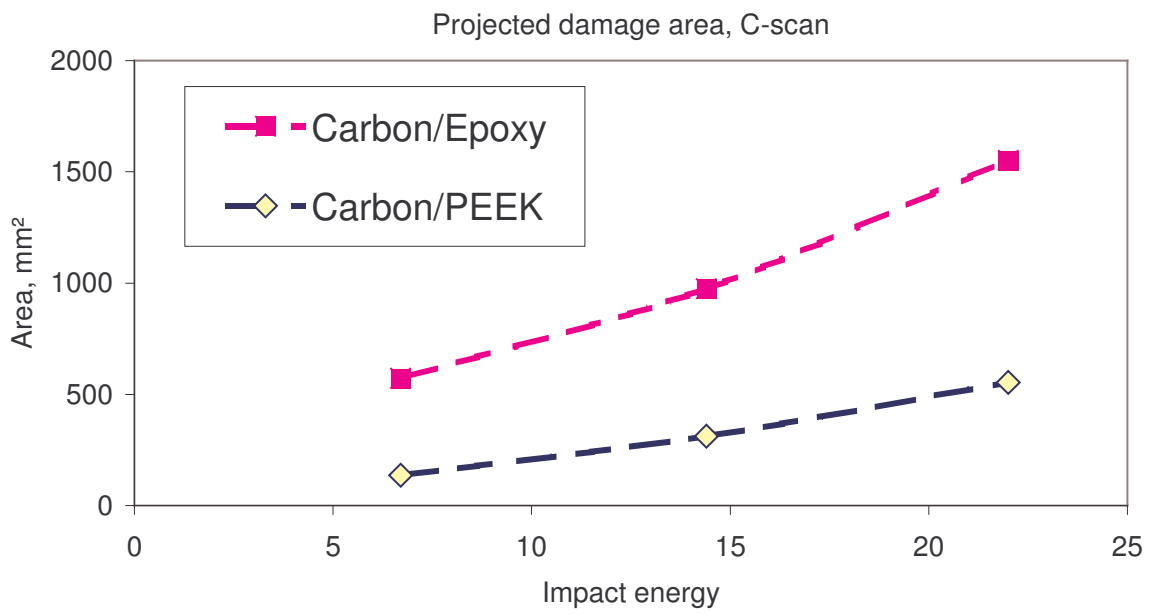
Figure 18. Projected damage area versus impact energy

It is apparent that these energy levels result in much smaller projected damage areas in the thermoplastic composite than in the carbon/epoxy cylinders. Similar results have been reported previously [33,34].

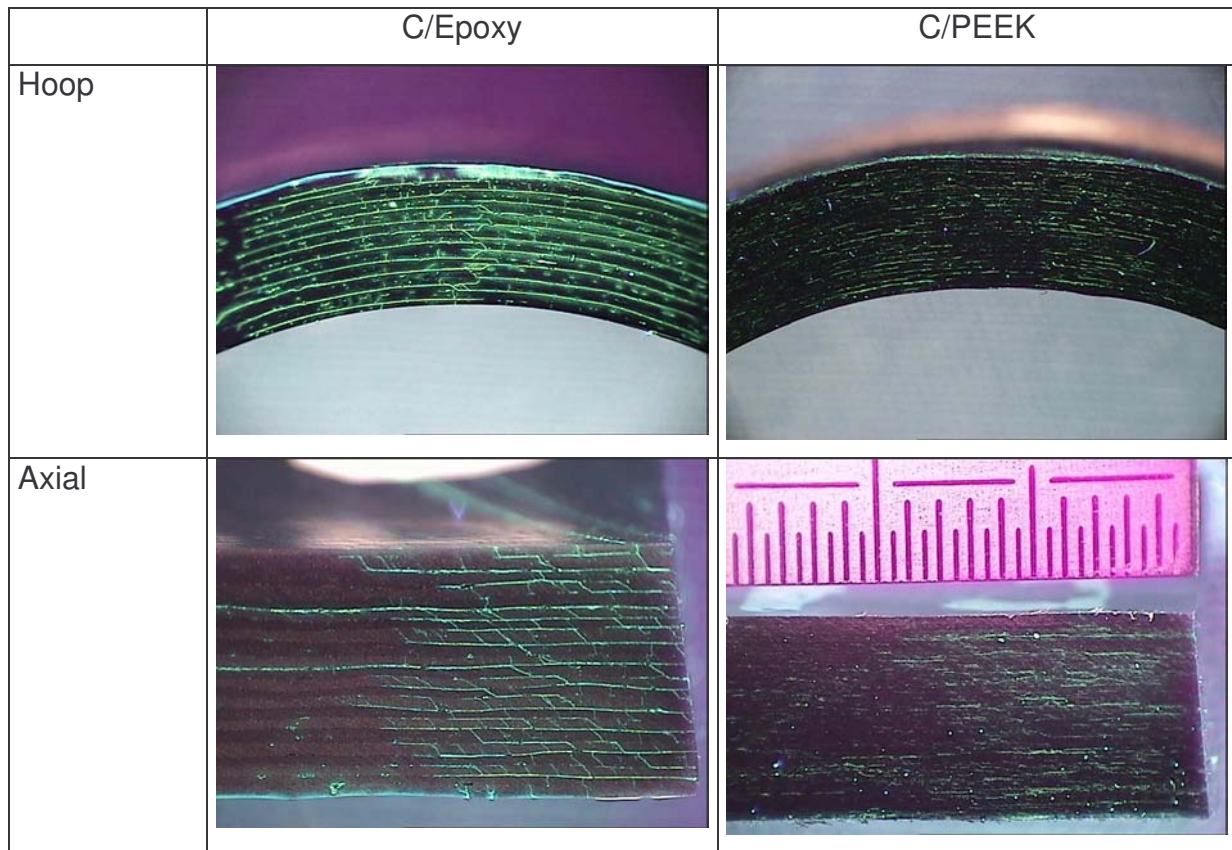
Figure 19. Polished sections of cylinders with dye penetrant showing impact damage in the axial and hoop directions, one meter drop height

Cylinders impacted at each energy level were then sectioned in the axial and circumferential directions and polished. A fluorescent dye was allowed to soak into the surface for 4 hours before re-polishing the surface. This enabled the impact damage to be visualised under an ultraviolet lamp. Figure 19 shows examples of the damage detected. The carbon/epoxy delaminates at all the interfaces between covers (a cover is a $\pm 55^\circ$ layer) and a very clear damage zone can be identified in the hoop direction. In the axial direction there is also delamination but with more intraply cracking. The damage in the thermoplastic composite is less easy to visualise but there are some delaminations and small cracks.

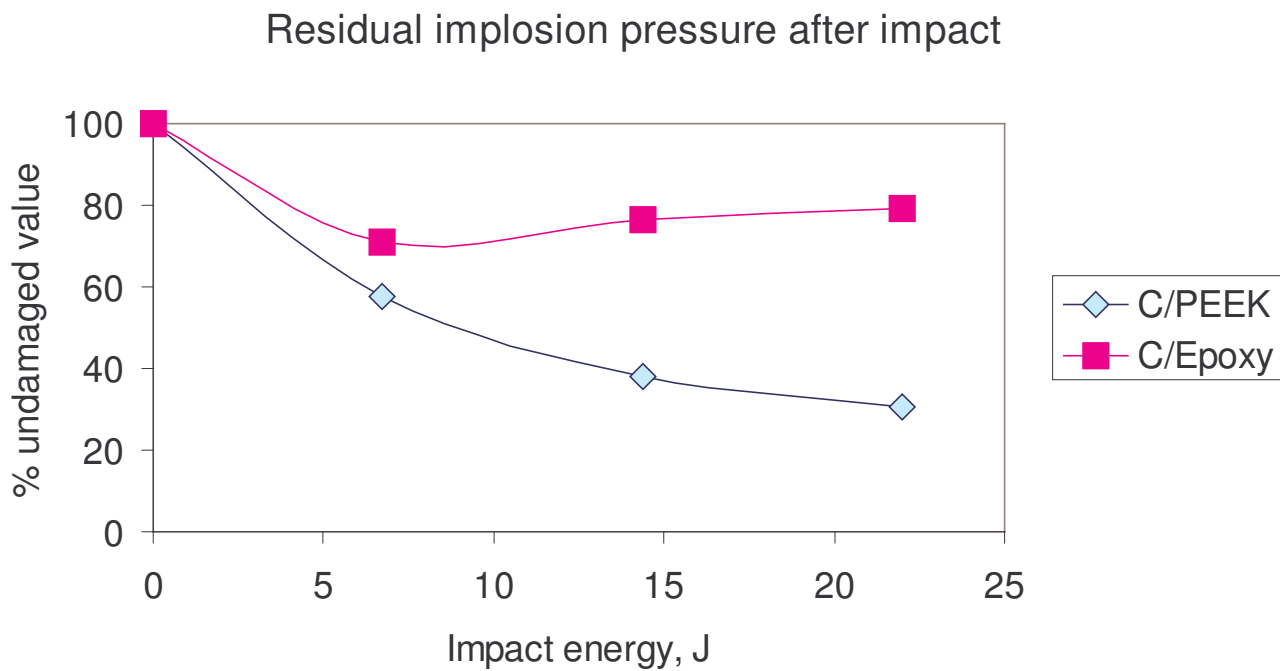
Figure 20. Residual implosion pressure versus impact energy

After impact three carbon/epoxy and three carbon/PEEK cylinders were subjected to hydrostatic pressure tests in order to determine their residual implosion pressure. Figure 20 shows the results from these tests.

It is surprising to note that in spite of the excellent intrinsic toughness of the carbon/PEEK system [33,35] there is a stronger drop-off in implosion pressure after impact for the thermoplastic composite than for the carbon/epoxy. Examination of the C/PEEK cylinders after implosion indicated that premature buckling had been initiated by the impact damaged regions, Figure 21. This is quite different to the crushing mode seen in Figure 14, whereas the crushing failure mode of the epoxy cylinder remained unchanged after impact.

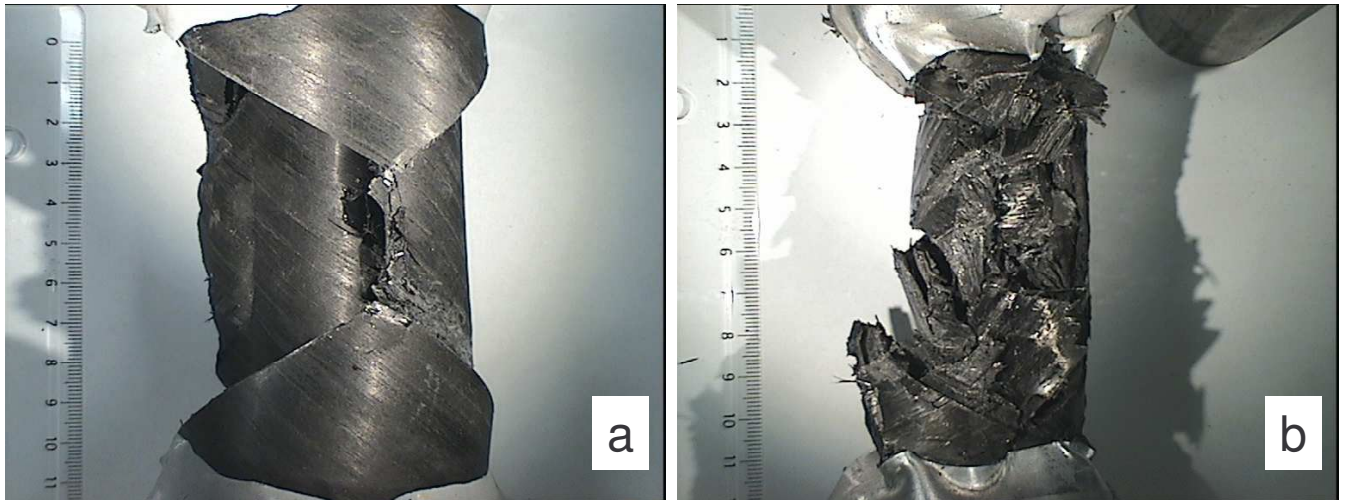
Figure 21. Examples of impacted cylinders after implosion
a) C/PEEK, b) C/Epoxy
