Polymer Testing

April 2014, Volume 34, Pages 168-174

Life time prediction of polymer used as thermal insulation in offshore oil production conditions: Ageing on real structure and reliability of prediction

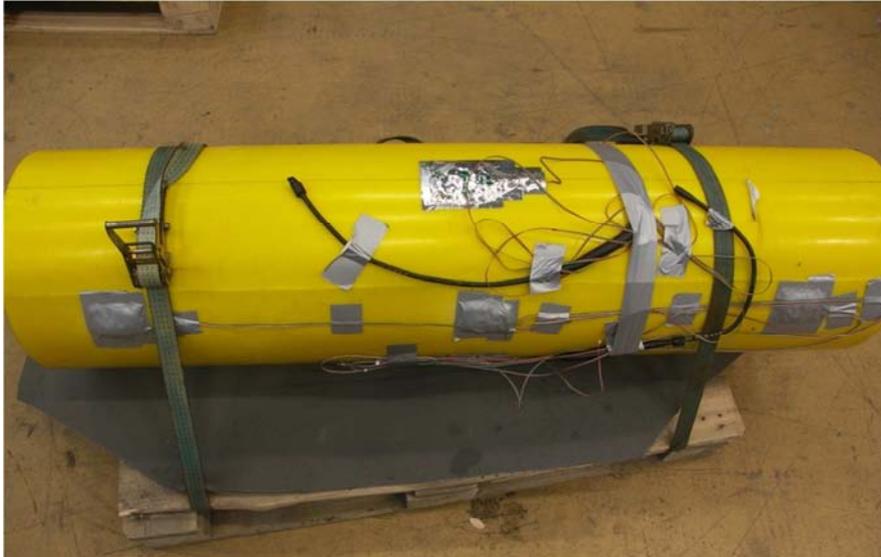
Figure 1 : Photo of the coated pipe before ageing

The structure used in this study was a steel pipe with an internal diameter of 10 inches (254mm) and 2m long, coated with 63mm thick PU insulation material. The material used for the coating is a polyether-based polyurethane widely used for passive thermal insulation made by reacting polyether polyol with MDI using 1,4-butanediol as chain extender. Figure 1 shows the structure before ageing.

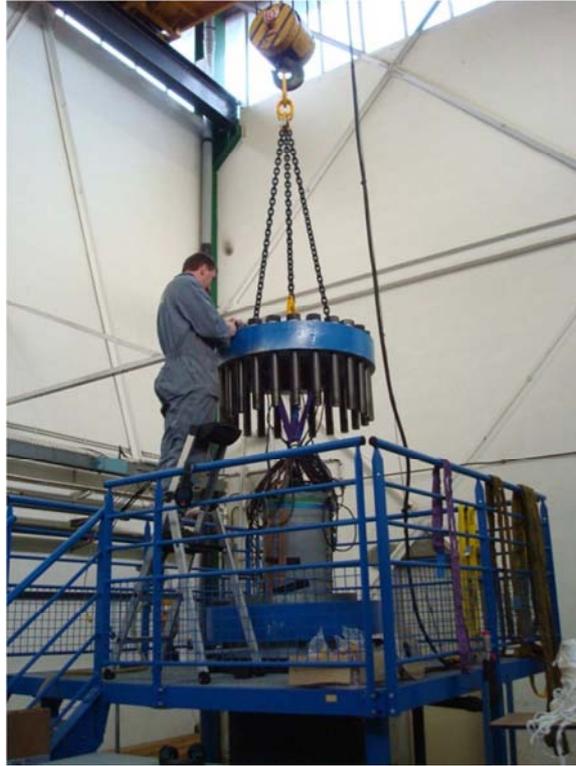
Figure 2 : Ifremer ageing tank

Ageing of the structure was performed in natural water under hydrostatic pressure in a pressure vessel for more than a year (Figure 2). In order to simulate the effect of hot oil, the pipe was internally heated by a heating blanket. This blanket was placed directly in contact with the inner surface of the tube and covered the whole internal surface of the tube (ref Bassompierre Scientax 3500W 760*1185 mm). Both internal and external temperature (i.e. water) were controlled and measured throughout the ageing period.

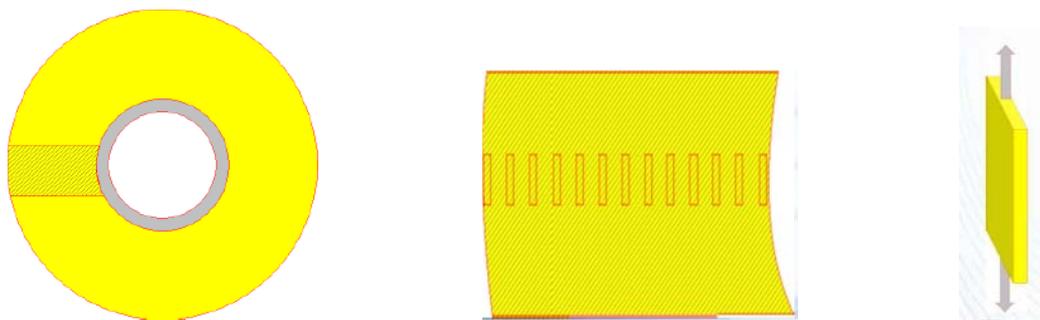
Figure 3 : Schematic representation of sampling in PU coating after more than one year of ageing

In order to characterize degradation in the coating at the end of the ageing period, a slice of the pipe has been sampled. Tensile measurements have been performed on 200 micron thick films taken from different positions in the PU coating, as shown in Figure 3.

Specimen geometry was 3 x 10mm². Tensile measurements were performed at 10mm/min using an Instron machine with a 50N load cell.

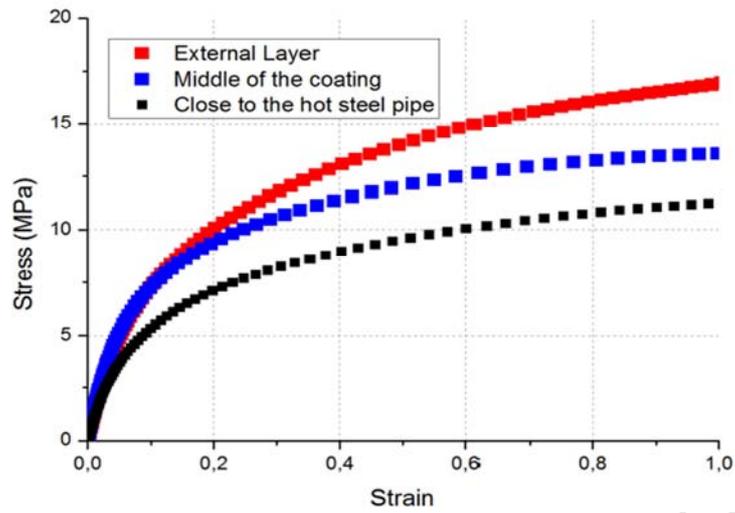
Figure 4 : Evolution of tensile behavior as a function of position in the PU coating (external layer is directly in contact with water)

Figure 4 shows the tensile behavior of 200 micron thick films extracted from the coating at different positions. Because samples are not dumbbell shaped, ultimate properties such as elongation and stress at break cannot be considered, thus we will focus on tensile behavior up to 100% elongation.

In the same way as what has been observed during accelerated ageing, degradation of PU leads to a decrease of material stiffness. Moreover, it appears that the closer to the hot pipe the more degraded is the polyurethane due to the temperature profile through the coating thickness. In order to compare experimental results with predictions from the

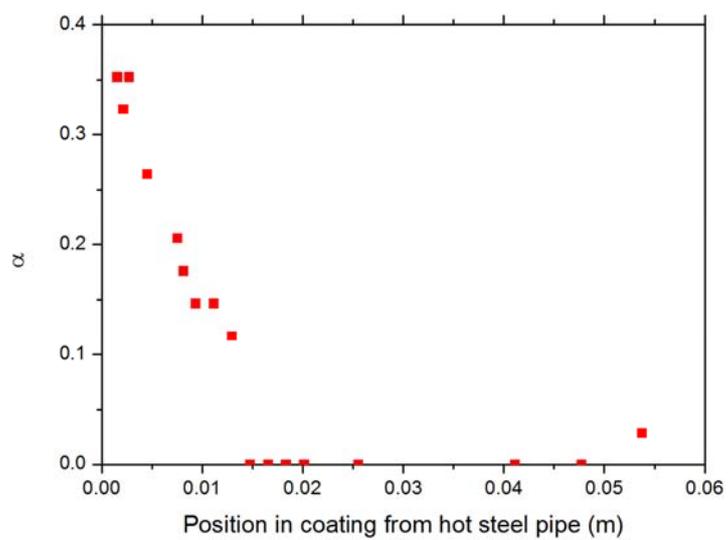
Figure 5 : Degradation profile measured after ageing in the coating used on top of steel pipe

This means that when PU is not degraded α is equal to 0 whereas when the material is fully hydrolyzed α is equal to 1. Both remaining and initial urethane concentration are calculated from tensile results in the same way as for accelerated ageing [6]. The alpha value as a function of the position through coating thickness is plotted in figure 5.

Polyurethane degradation occurs mainly close to the hot steel pipe (left side in Figure 5). A clear gradient through coating thickness is observed due to limitation of polyurethane hydrolysis by diffusion of water from the cold side to the hot side. Sample close to water at low temperature (right side in Figure 5) is similar to unaged material. Prediction of this behavior will be considered in the next section.

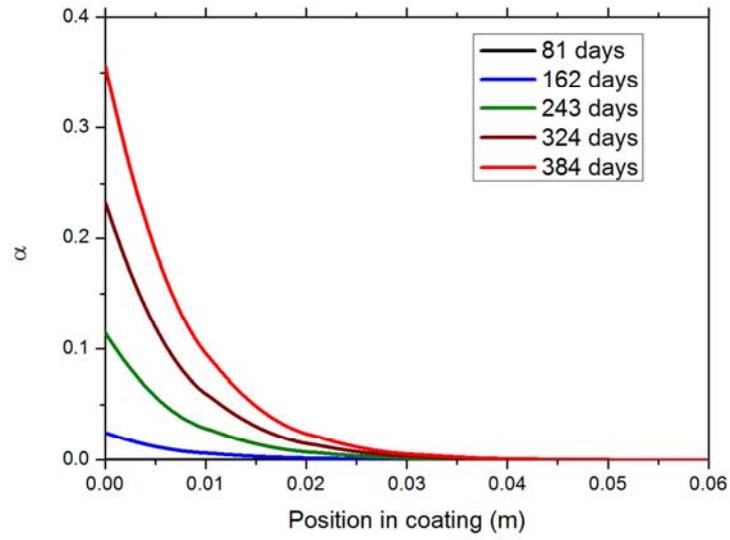
Figure 6 : Predicted degradation level through coating thickness for different ageing times (the hot steel pipe is on the left side, cold water is on the right)

In the same way as for experimental results and in order to evaluate the reliability of the prediction, the damage factor α has been considered as a degradation marker; figure 6 shows predicted α value as a function of position in the coating for several ageing times. A degradation profile through the coating thickness is observed. In fact, degradation occurs mainly close to the hot pipe (left side in figure 6) but this degradation is limited by water diffusion from the external side of the coating (right side in figure 6).

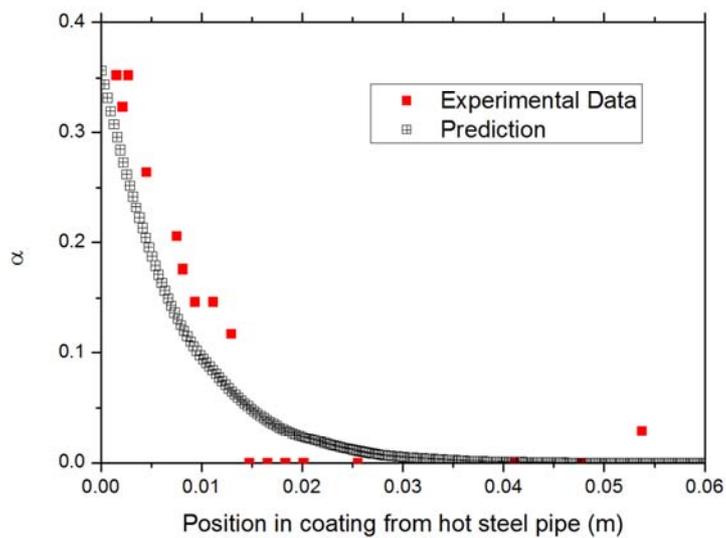
Figure 7 : Comparison between predicted degradation (line) and experimental data after 12 months of ageing

In order to evaluate the reliability of this prediction a comparison between predicted results and experimental data after 384 days of ageing is plotted in figure 7. It is clear that good correlation is observed between experimental and predicted degradation levels (i.e. α values) and position in the coating thickness. Thus, this model can be used to predict coating behavior under service conditions.

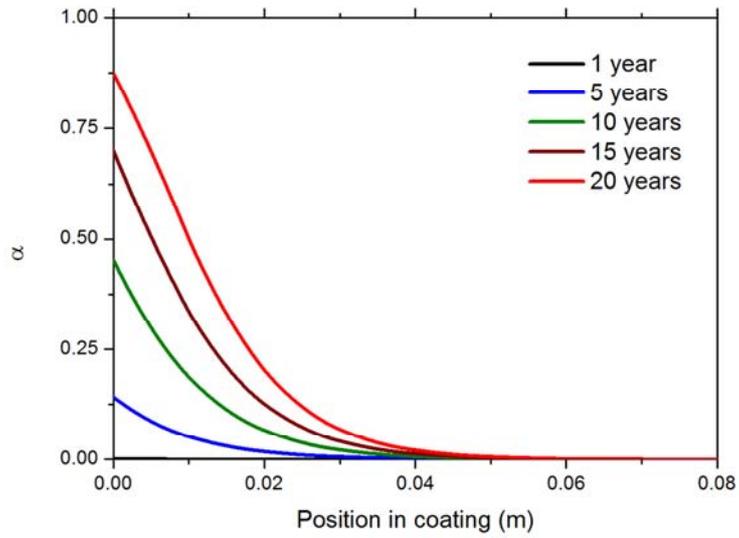
Figure 8 : Degradation profile through coating thickness (hot pipe is on the left side, cold water on the right)

This section is devoted to lifetime prediction of polyurethane coating in service conditions for 20 years duration. Here, an 80mm thick coating has been considered with an internal temperature of 80°C and an external temperature of 5°C (all other parameters are the same as in table 2). Figure 8 shows a profile of the degradation factor through the coating for different ageing durations up to 20 years.

If we consider alpha = 0.5 as an end of life criterion, which is completely arbitrary (this point will be discussed later with respect to limitation of the model), after 20 years about 1cm of the coating is useless, that is to say about 12 %. Using this prediction it is possible to evaluate the effect of different parameters on degradation level in the coating. In the

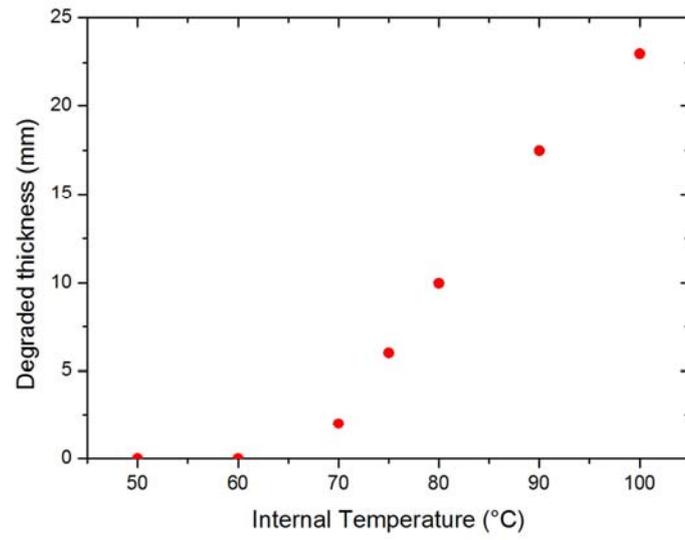
Figure 9: Effect of internal temperature on degraded thickness in the coating

Changes in temperature inside the steel pipe affect both kinetic reactions and water diffusion; the effect of internal temperature on the degraded thickness (i.e. thickness where α is higher than 0.5) in the coating after 20 years is plotted in Figure 9.

An increase in the internal temperature in the pipe leads to a large increase in the degraded thickness of the coating after 20 years of service due to faster water diffusion from the external layer and an increase in hydrolysis kinetics.

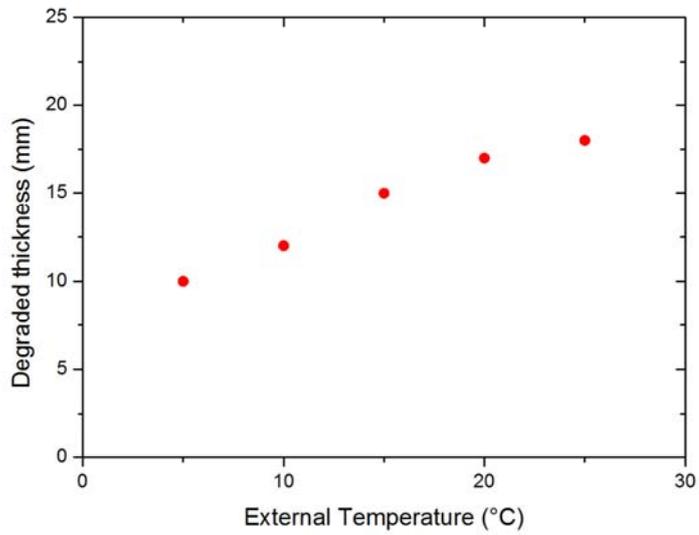
Figure 10 : Influence of external temperature on the degradation level in a 80mm thick coating

In deep sea exploitation, external water temperature is usually about 5°C, but for some specific shallow water fields the water temperature can be up to 25°C. The influence of external temperature on degradation level in the coating is plotted in figure 10. Furthermore, due to natural convection of water a thermal boundary layer appears at the coating surface. Because of this boundary layer there is a temperature profile between the surface of the coating and external sea water, leading to a real surface temperature which is higher than the actual water temperature.

Because degradation in the coating is limited by water diffusion from external water to the hottest part of the topcoat, an increase in the external temperature leads to an increase in the degradation level. In fact, the external part of the coating can be considered as a barrier material that delays the entry of water into the hot part of the polymer, so if the external temperature is raised the barrier properties decrease.

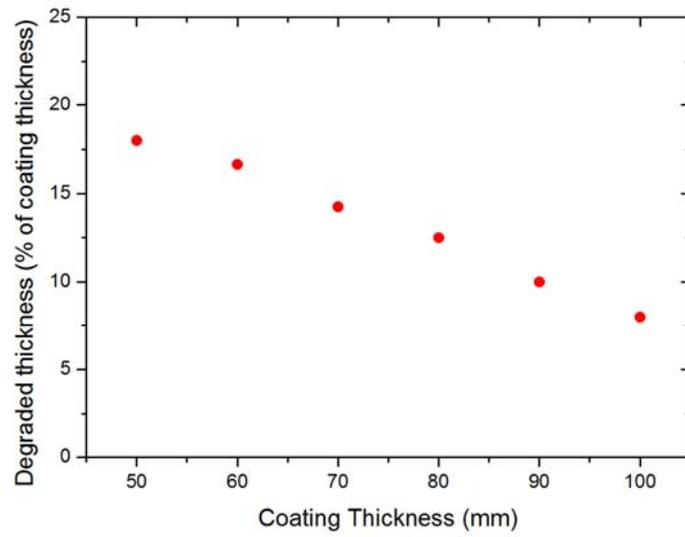
Figure 11 : Effect of coating thickness on degradation level in coating

Coating thickness for this application is usually chosen based on thermal properties of the structure, nevertheless, when coating durability is an issue it is possible to overcome it by using a thicker coating. Figure 11 shows the evolution of degraded thickness normalized by coating thickness after 20 years with an internal temperature of 80°C and an external temperature at 5°C for different coating thicknesses.

One way to delay water diffusion to the hot part of the coating (i.e. close to the steel pipe) is, therefore, to increase the thickness of the coating on the pipe. Although this solution is costly, it remains an option to improve durability.
