# Project DEGREE

Development of fishing Gears with Reduced Effects on the Environment

## Report from a cruise onboard RV G. O. Sars 22.11 – 03.12.2008: Comparing the impact of two bottom trawls

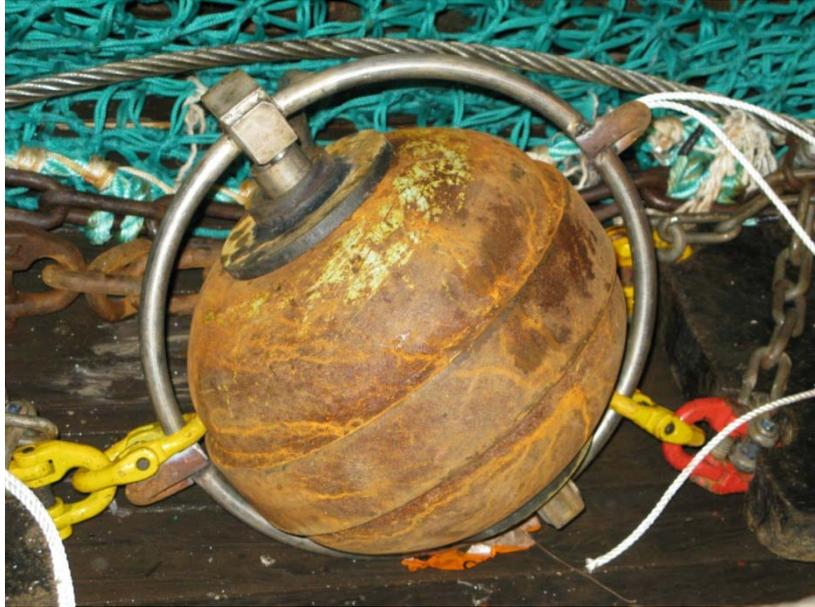
**Figure 12. One of the bobbins specially designed to always roll in the towing direction of the trawl.**

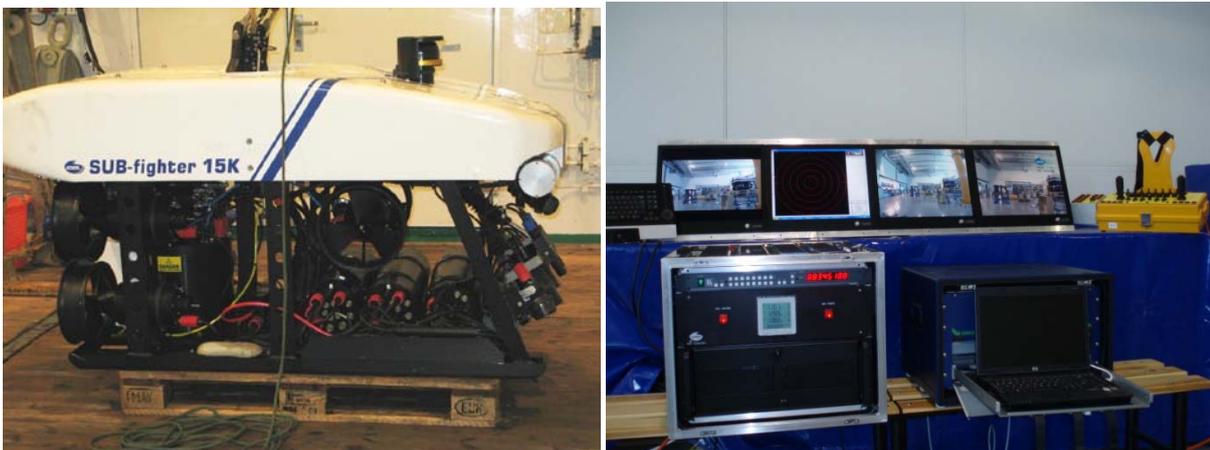
**Figure 13. The ROV Subfighter 15K (left) used for bottom habitat mapping. The right picture shows the surface control equipment and observation screens.**

The ROV was fitted with a HIPAP positioning system which enabled communication between the ROV and the DP (Dynamic Positioning) system of the vessel. During ROV surveys the vessel was set in “follow target” modus, so that the movements of the ROV controlled the movements of the vessel. Navigation data from the vessel and ROV was stored using NaviPac format.

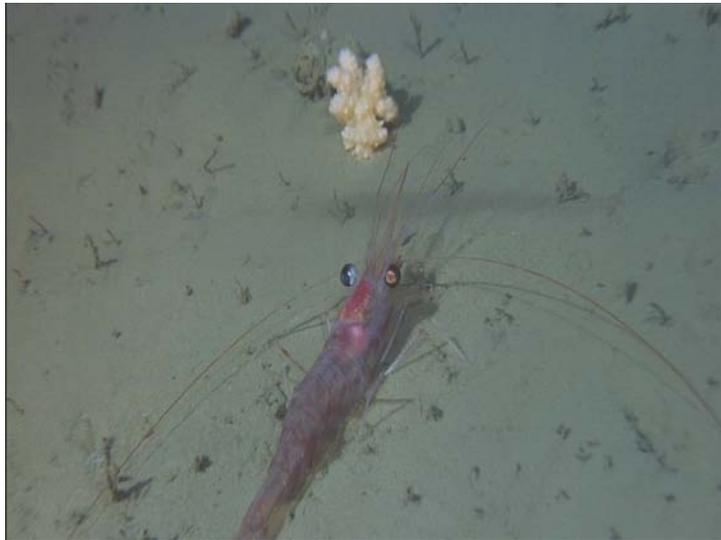
Figure 21. A typical bottom in the experiment area with the tubes of sedentary polychaeta protruding from the sediments. In addition a octocoral (Anthozoa) and a shrimp (*Pandalus borealis*) can be seen.

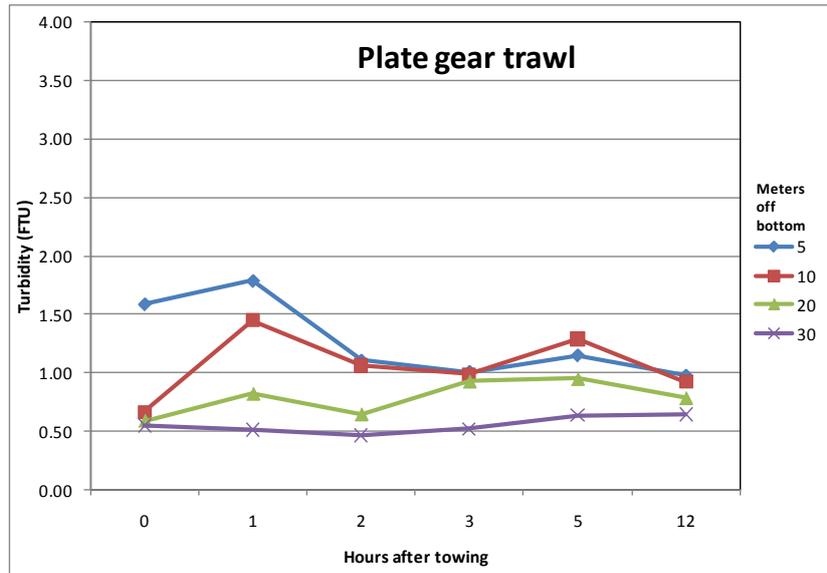
Figure 23 shows the development of the turbidity 1, 2, 3, 5 and 12 hours after towing. For the plate gear trawl there seems to be an increase in turbidity at the lower measure point 5 m off bottom, decreasing with time after towing. For the rockhopper trawl the turbidity at the lower measuring point was much more variable. This may be caused by drifting of the particles due to currents, or they may be caused by artifacts like high densities of plankton and other organisms. The immediate impression is, however, that the rockhopper gear causes a higher turbidity, probably by digging more into the bottom sediments. More measurements should be done to control these findings. I must be stressed, however, that the closest measuring point to the bottom was at 5 m distance. It is reason to believe that the highest particle density was in the area closes to the bottom, at least initially.

Figure 23. Measured turbidity above trawl paths of plate gear and rockhopper trawls. Turbidity was measured at varying times after towing and at different distances from the bottom. “0 hours” is control measurements done off the trawl paths

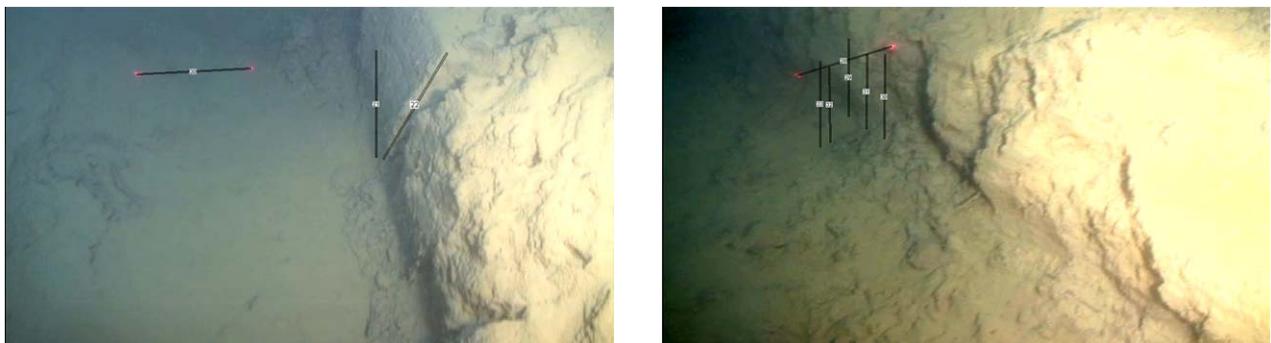
**Figure 24. Tracks of door from the rockhopper trawl. The black bars shows measurements done to size the track. The distance between the red laser lights was 10 cm.**

Only the rockhopper trawl had doors touching the bottom (Figure 24). Initially we strived to make the doors of the plate gear barely touch the bottom, believing that it was difficult to lift the doors while simultaneously keeping the door spread. The initial hauls inspected with the towed vehicle Focus showed, however, that the doors were lifted a short distance from bottom while the trawl configuration was maintained. The lifting was confirmed during the ROV observations of the trawl paths. No tracks could be seen from doors in the path of the valid plate gear hauls. In the track of haul no 355 where the plate gear trawl by mistake was run with longer warps (700 m instead of 600 m, i.e. as long as in rockhopper hauls), deep furrows from the doors were found.

One interesting observation was that the doors did not seem to follow a steady track on the bottom. The depth of the door path varied, and also the amount of aggregated mud within the path. It seemed that the mud aggregated in front of the door while towed along until the dung of mud reached a certain size/weight. Then the door seemed to flip over the sediment pile, and stay floating above the bottom for some meters. It thereafter landed on bottom, started to dig into the mud and build up a new sediment pile, and a new cycle started.

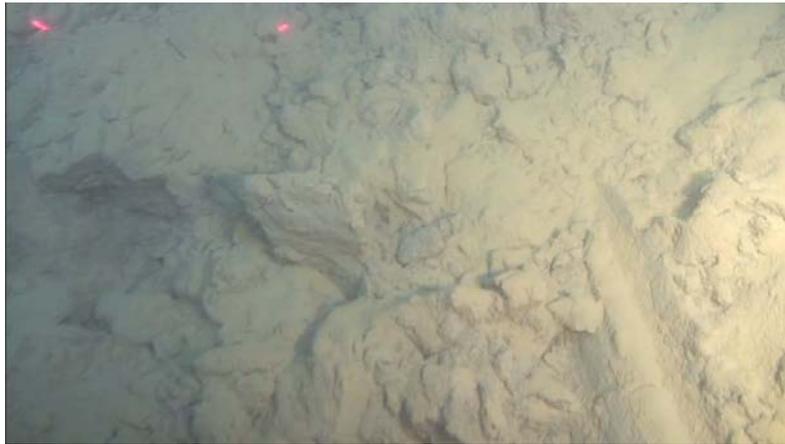
**Figure 25. A pile of mud sediment deposited by a trawl door on the rockhopper trawl.**

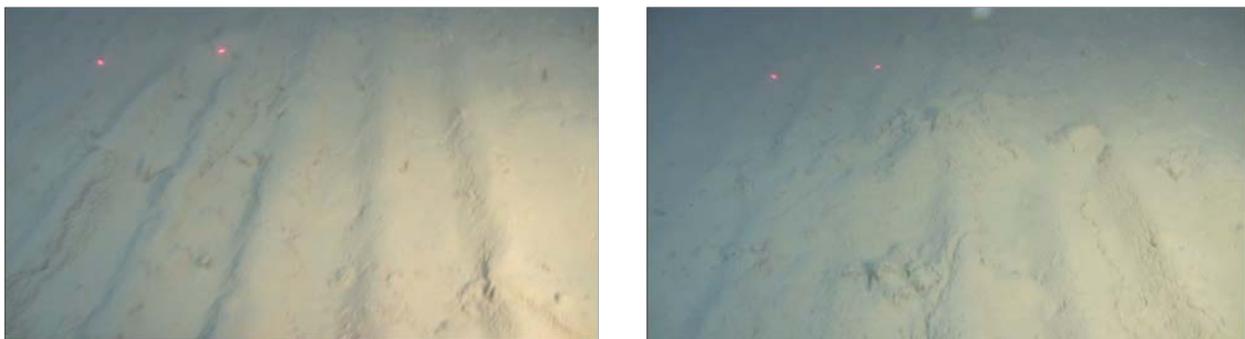
**Figure 26. Track from chain part of the sweep. Small piles of mud can be seen scattered above the chain tracks. The distance between the red laser spots is 10 cm.**

The chain part of the sweeps had a higher bottom contact. In the tracks of both trawls the chain made a regular undulating pattern on the bottom where the dimensions of the waves fitted perfectly to the size of the chain links (Figure 26). Small piles of mud were scattered irregularly over the bottom.

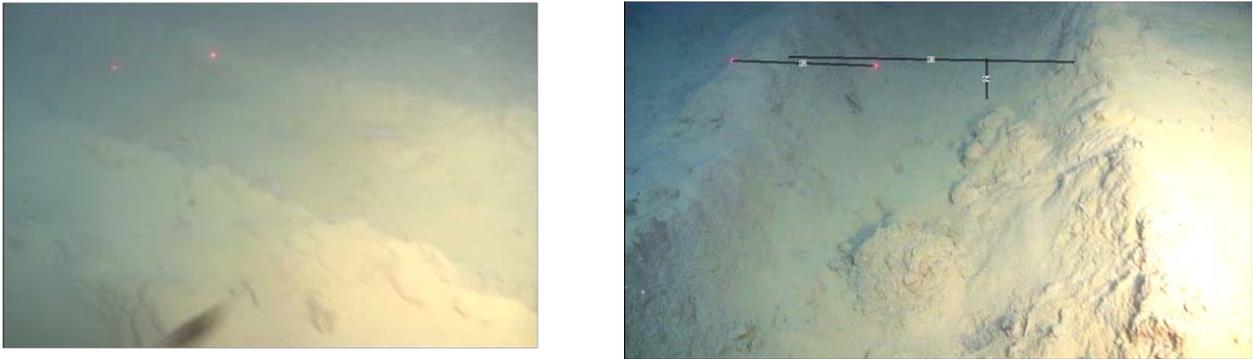
**Figure 27. Two tracks from bobbins on the sweeps. Black bars are used for measuring of tracks. The distance between the red laser points is 10 cm.**

The different parts of the sweeps were linked with steel or rubber discs (see Figure 4), which made clear tracks on the bottom (Figure 27). These tracks had an average cross section of between 15 and 25 cm, and were more or less identical on both trawls.

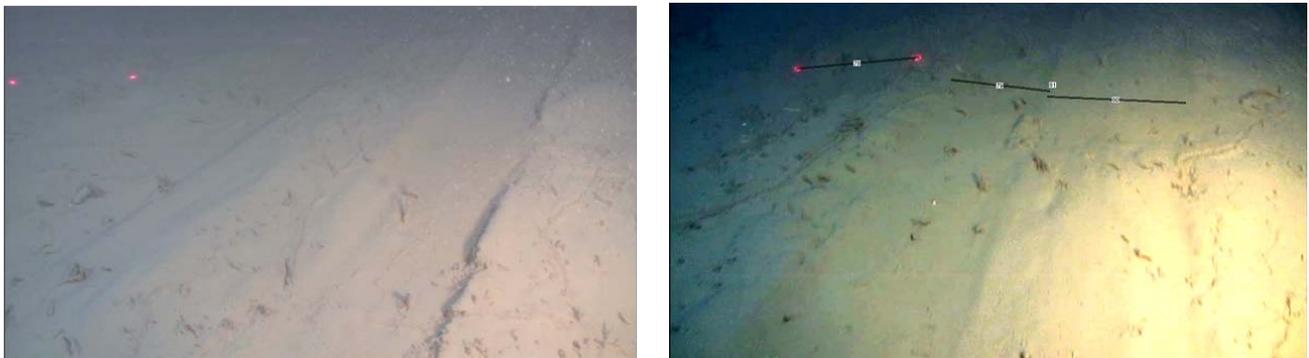
**Figure 30.** Tracks from plates on the sea bed.

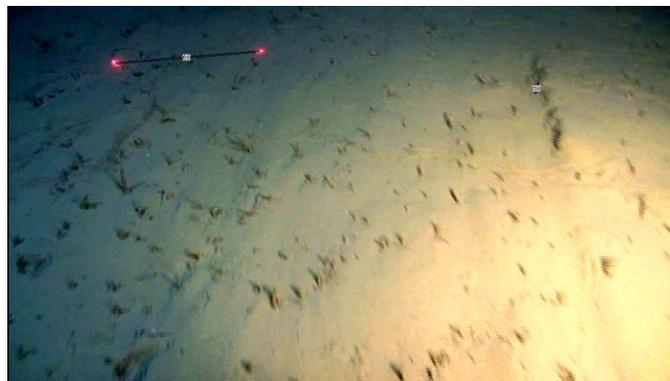
**Figure 31.** Tracks from plates of the plate gear. Tubes from tube dwelling polychaets has been exposed by removal of sediments.

In some areas the tubes of *Spiochaetopterus* could be seen protruding from the sea bed more than in the control areas, obviously exposed by the passage of the ground gear (Figure 31).
