OCEANS 2015 – Genova. ITALY, MAY 18-21, 2015

## Biofouling protection by electro-chlorination on optical windows for oceanographic sensors and imaging devices

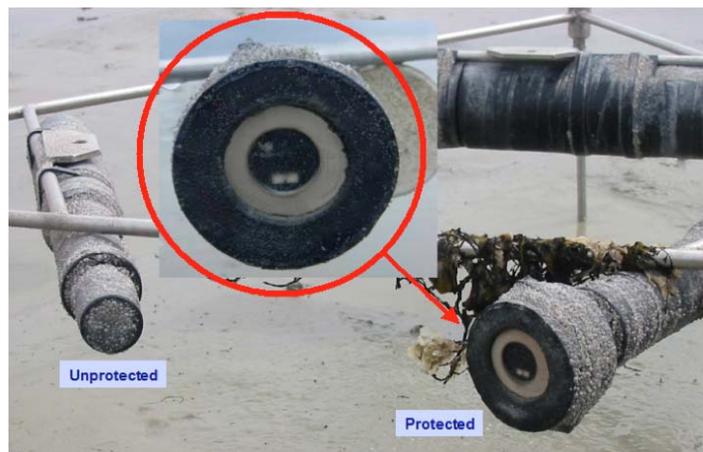
**Figure 1** - Biofouling protection by seawater electrolysis on turbidimeter  
Mont St Michel Bay – March to May – 80 days  
(Photo: Ifremer - L.Delauney)

A technique to produce a biocide in seawater as close as possible of the transducing interface is to perform in this area electrolysis of seawater. Hypochloric acid is produced at the working electrode that surrounds the transducing area of the sensor [2]. The figure below shows such protection scheme on an *in situ* turbidimeter. On the left side, the unprotected turbidimeter shows an important coverage of barnacles after 80 days of deployment. The protected turbidimeter, that uses a flat washer as a working electrode shows a clean transducing interface after the same deployment. As shown, this technique can be used on the sensor without modifying its design. So, it can be used on existing instruments.

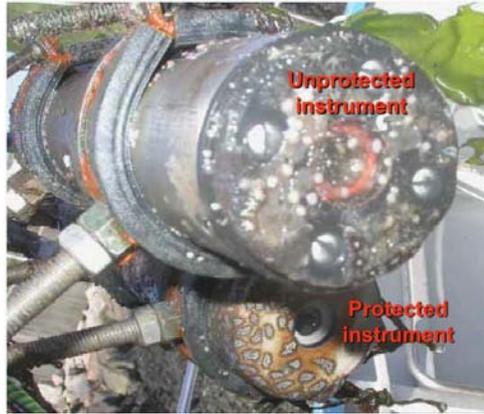
**Figure 2**  
 Biofouling protection of a fluorometer  
 by seawater electrolysis  
 on a conductive transparent layer  
 Helgoland – June to September – 70  
 days

In the specific case of optical sensors (based on a “transparent” optical window), cameras or lights, the electrode, where the biocide generation takes place in case of seawater electrolysis, can be a conductive and transparent coating based on doped tin dioxide and sprayed straightforwardly on the optical windows of the device. Ifremer on Helgoland Island, originally, has tested this protection scheme once during summer 2005 (BRIMOM<sup>4</sup> EU project). The figure 2 below shows biofouling colonization on the unprotected instrument and a successful protection of the optical window of the protected instrument.

This *in situ* test has been the first example of an optical sensor effectively protected by local chlorination based on a conductive coating on its optical windows. This technique offers a high level of robustness (no moving parts), a high level of integration and uses 20 times less energy than the conventional method based on titanium electrode. It has the advantage to be an active technique that can be turned ON and OFF in order to arrange free biocide generation period.

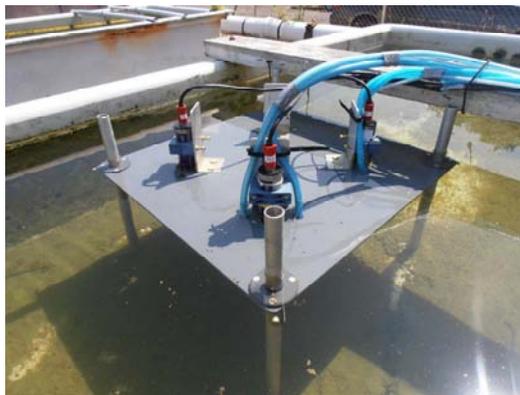
**Figure 7:** *In situ* testing bench for biofouling protection efficiency.  
(Photo: Ifremer - L.Delauney)

The Ifremer *in situ* testing facilities has been used to performed the experiment. A seawater continuous renewed testing tank was equipped with a sensors testing bench for the 3 tested sensors (figure 7). The 3 sensors were connected to an acquisition device in order to continuously record the measurement produced. Real time monitoring was possible since the acquisition system was connected to the internal Ifremer network.
