Fatigue of improved polyamide mooring ropes for floating wind turbines

This paper describes a study of the fatigue characterization of polyamide mooring ropes for floating wind turbines. Under some conditions polyester ropes, which are favoured for offshore oil and gas platform station-keeping, are too stiff for wind turbine moorings, and polyamide may be a suitable alternative. While early studies on fatigue of braided nylon ropes showed very short lifetimes some recent results have indicated that it is possible to significantly enhance lifetime by modifying rope construction and improving fibre coatings. In this paper yarn-on-yarn abrasion testing is used first to evaluate a new yarn coating. Significant lifetime enhancement was noted, so fatigue testing of ropes was then performed. Results confirm that excellent fatigue lifetimes can be achieved, superior to those for steel chain. Finally, failed yarn and rope samples were examined by microscopy, in order to improve understanding of the fatigue mechanisms leading to failure.

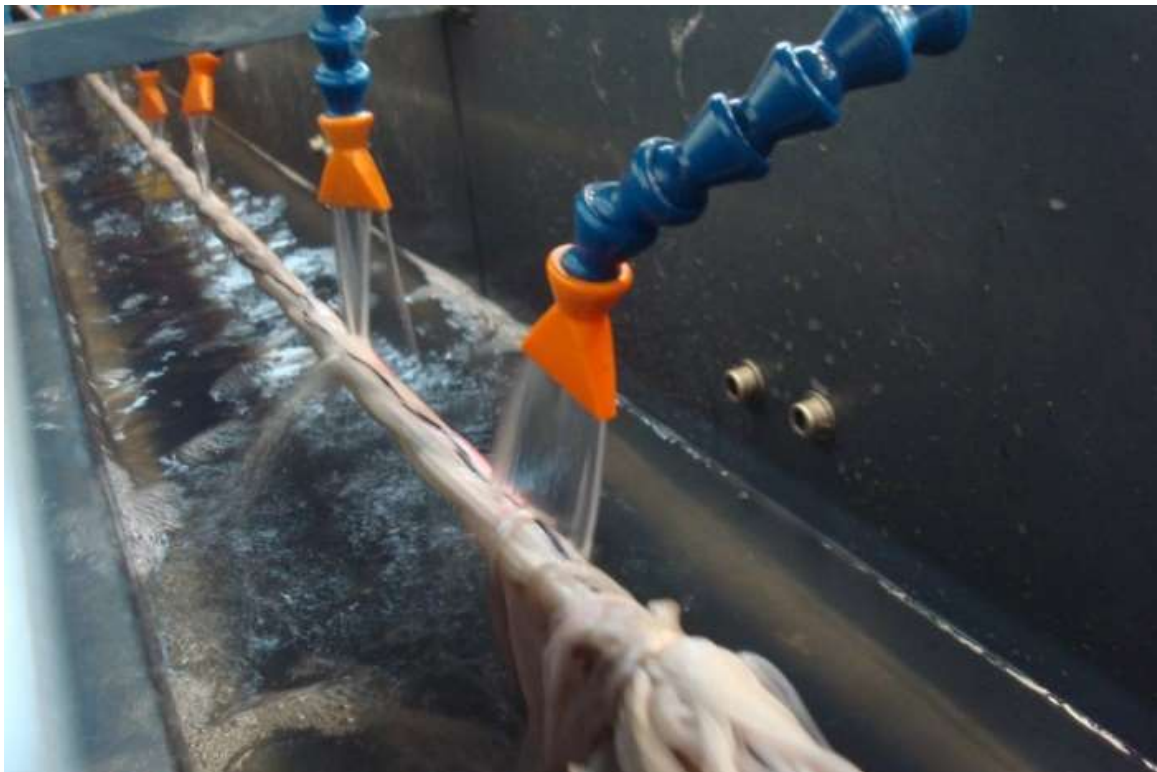
It is well known that polyamides are sensitive to water, and moisture has been shown to affect the long term behaviour of polyamide 6 fibres (ISO18692, 2007; Miri, 2009; Hunt, 1980; Humeau, 2018) so it is essential to perform tests in the wet state. Before each test, the rope sample was fully immersed in tap water for 4 hours on the testing machine without load. It was then continuously sprayed with tap water throughout the test as shown in Figure 2.

Figure. 2. Rope during a fatigue test

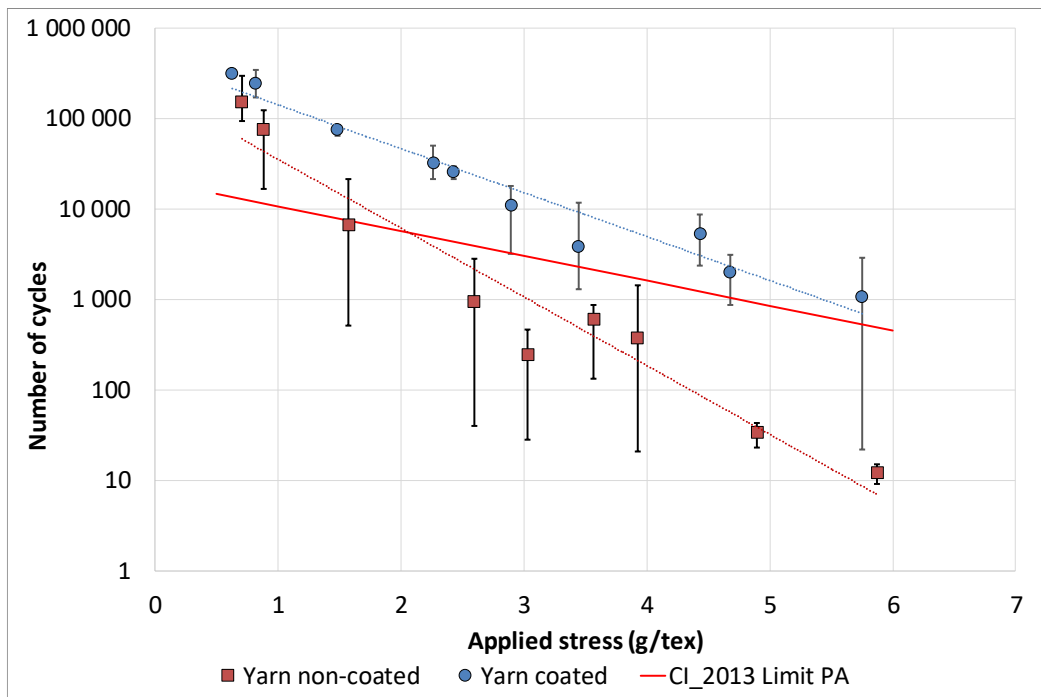
Yarn on yarn abrasion tests were performed up to failure, which occurred in the inter-wrapped section of the yarn in all cases reported on Figure 3. On this curve, each point represents 3 to 8 test repeats at each applied stress level, defined in grams/tex, depending on the scatter. The error bars represent the minimum and maximum numbers of cycles found at each load. The dashed lines show a linear best fit on the semi-log scale. The continuous red line corresponds to values in a Cordage Institute guidance document (Flory, 2013), which recommends a minimum lifetime for each load level for offshore hawsers.

Figure. 3. Yarn on yarn results for uncoated and coated polyamide 6 yarns.

Cycles to failure are significantly higher for coated yarn samples and there is more scatter in results for uncoated yarns. There is a minimum performance criterion (number of cycles versus applied tension) defined for polyamide yarns for offshore use in hawsers, given by the CI document (Flory, 2013), which is represented as a red line on Figure 3. The coating enables the mean test values at all applied stresses to satisfy this criterion, though the criterion is only satisfied for all individual test lifetimes below an applied stress of 3g/tex.

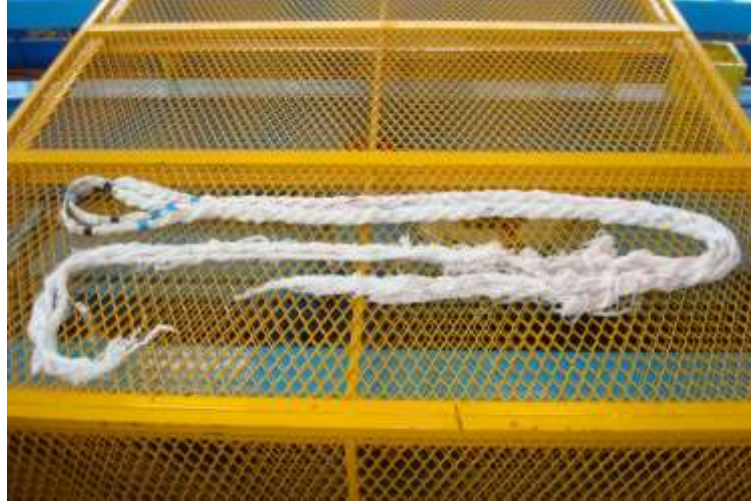
Figure 8. Failed sample after test, showing two broken parts superposed.

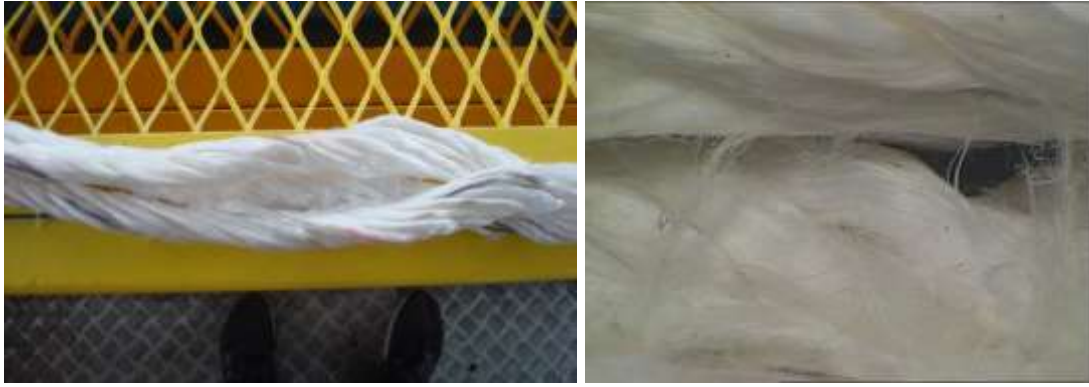
The results discussed by Mandell (1987) suggest that two failure mechanisms dominate cyclic response of nylon ropes. At high loads, creep rupture is the main failure mode, while at low loads abrasion can cause failure, either external abrasion on bollards or internal abrasion between fibres. However, it should be noted that there is not a distinct cut-off between these two mechanisms, both may occur if loading amplitude (and hence relative internal movement within the rope elements) is sufficient. As coatings are improved, one would also expect the abrasion mechanism to be shifted to higher numbers of cycles. Most samples were taken from broken ropes at 200mm from the final failure zone, in order to detect damage but without the final high energy failure mechanisms. Additional observations on samples from tests interrupted before final failure, and from areas of failed samples away from the break region, revealed significant areas of abrasion in the contact areas between the rope strands, Figure 13. The outer surfaces of the strands are intact but the inner surfaces in contact reveal broken fibres.

Figure 13. Example of internal abrasion in rope sample (coated)
