R/V YUNUS-S (Istanbul University) cruise report
November 19-20, 2019
Istanbul – Istanbul

Summary

The objective of this cruise was to recover from the Central Basin an instrumented frame deployed during a previous Istanbul University R/V *Yunus-S* cruise, May 8-9, 2019, recover the data recorded by the instruments, do maintenance, and redeploy the frame at another site, in Imrali basin.

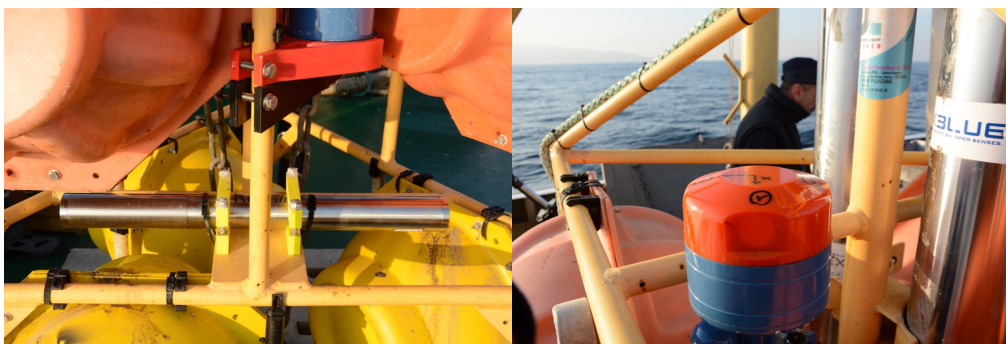
Figure 3: Instrumented frame before redeployment. (left) RBR sensor; (center) Seaguard Z-pulse sensor with XY orientation and transducer number indicated.

To test the possibility of calibrating the 0 of a Digiquartz sensor during a cruise, an atmospheric barometer (VAISALA PTB330TS) was brought on board the ship. The accuracy of the barometer is 0.1 hPa at lab temperature. It was set to record pressure every minute from 19/11/2019 07:09:18 to 20/11/2019 10:45:18 UTC. Raw pressure records, uncorrected for clock error, are available as ASCII csv and column tabulated files (2019-11-19_7_09.csv, 2019-11-19_7_09.m70, 2019-11-19_7_09.txt). While on board the ship, the RBR was set horizontally in the same position as on the frame (lettering up, horizontal flat spot) and recording (Figure 3).

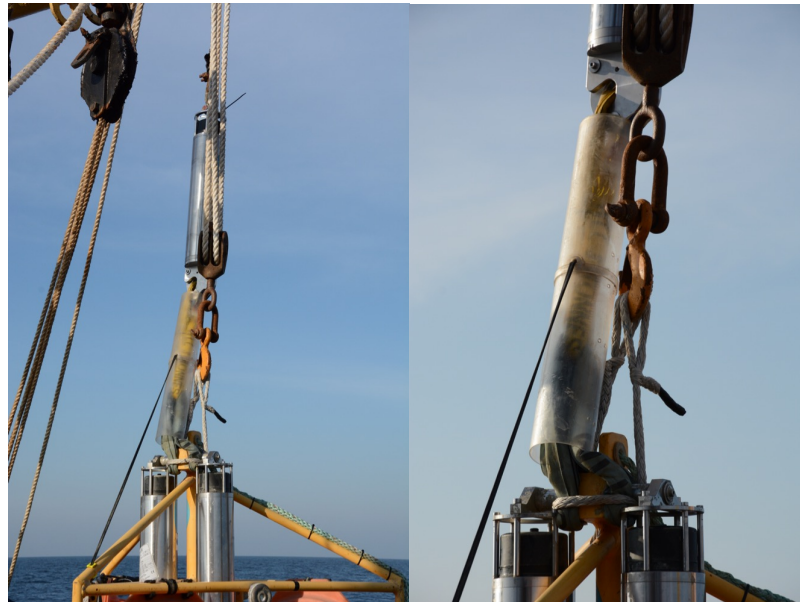
Figure 4: Deployment setup. (Left) complete view of hoisting assembly with hook and tackle used for lifting the device overboard and acoustic releaser on steel wire for used for lowering and deployment at the seafloor; (Right) detail of hook assembly

Deployment was done without difficulty. A lifting tackle and the warping head of a winch were used to lift the frame/ballast assembly overboard and two ropes passing through slots in the concrete slab allowed lateral stabilization. The assembly weight was then transferred to the acoustic release device attached to the main winch cable (Figure 4). The Seacatch releasable hook was not available this time but this only brought minor changes in the operations as the aramide link used to hoist the frame already needed to be recovered manually while the frame was hanging overboard on the main winch cable.

Water depth at the target deployment site is 406 ± 5 m according to multibeam maps while the shipboard sounder indicated 404 m. The device was first lowered at about 1 m/s down to 350 m wire out. At this point, acoustic range to the acoustic device on the cable (n° 1973) was measured at 388 m (assuming 1500 m/s sound speed). The device was then lowered at 0.5 m/s, while interrogating acoustic device n°1973 every 10s. Touch down occurred between 07:52:13 and 07:52:25 for an acoustic range of 427 m. The device acknowledged execution at 12:52:55 after first release order. Effective release was verified by checking acoustic range to acoustic devices n°853 and n°394 on the frame and to n°1973 on the wire while wiring in. The location of the frame on the bottom was then determined by triangulation (Figure 6 and Table 3). Two acoustic range measurements (assuming velocity 1500 m/s) were performed at each of three points 470 m WSW, ESE and N from the target point. The frame location thus determined was 40 m NW of ship position at release, with an acoustic immersion of 429 m and a theoretical wire out of 431 m. The position of the device is 20 m from the target location in a N153° azimuth, on the floor of Imrali Basin (Figure 6).

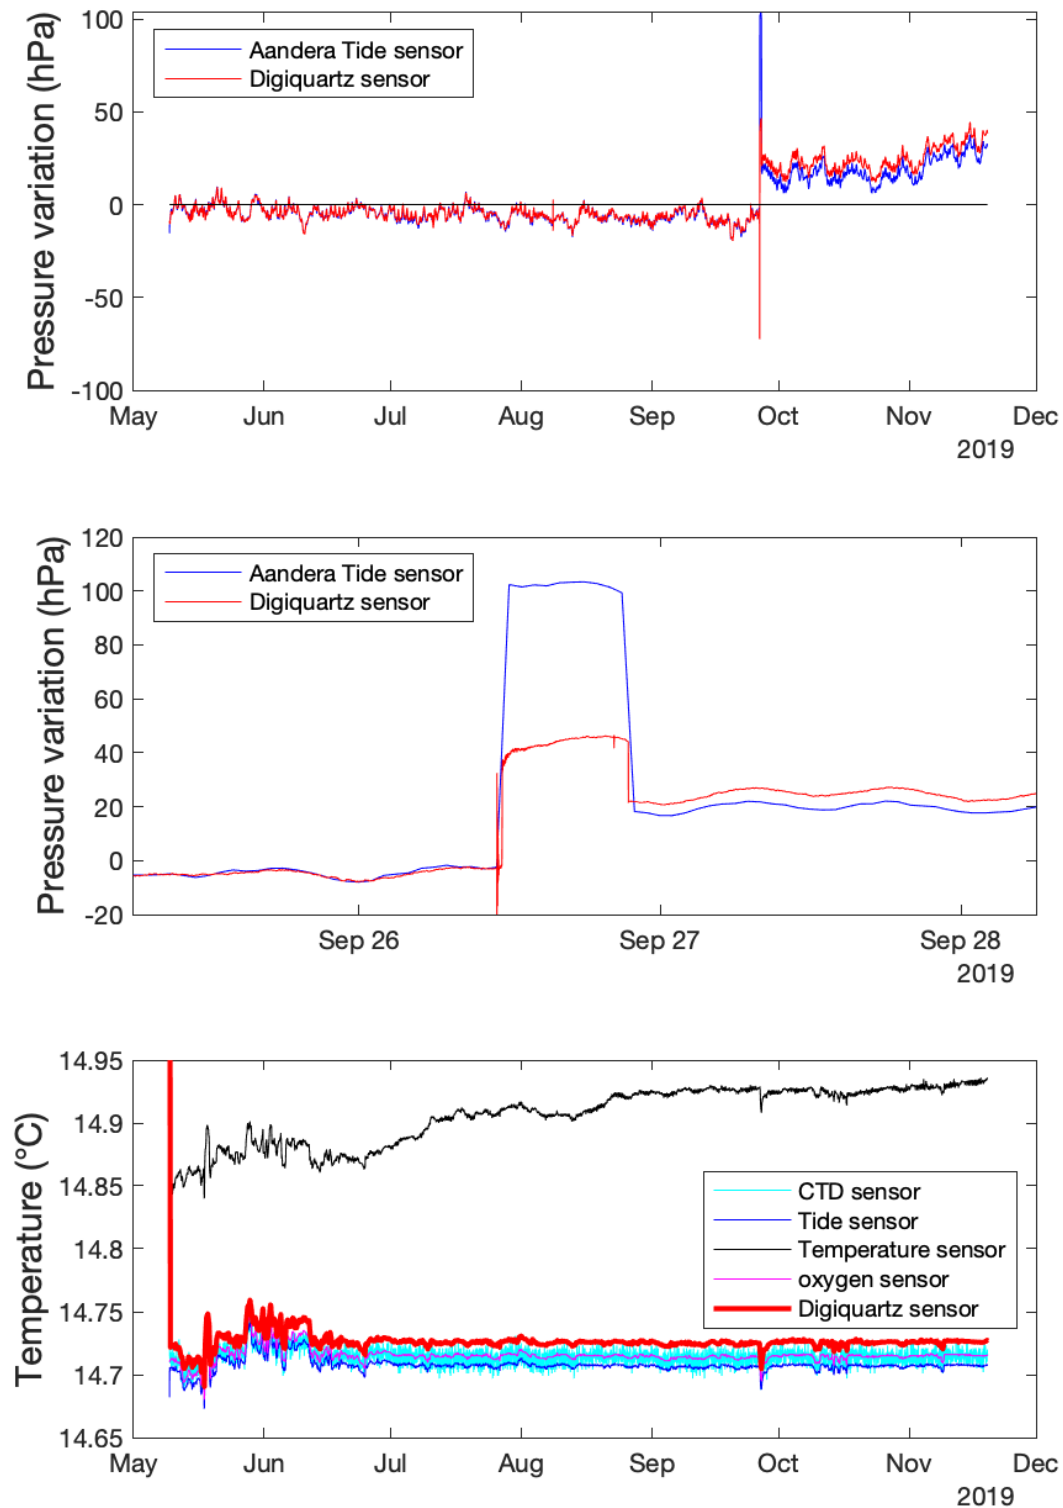
Figure 8: Comparison of pressure and temperature records obtained at the seafloor with the various sensors fit to the Seaguard and RBR data loggers

The Seaguard data logger acquired data at the seafloor every hour over the whole deployment interval while the RBR PBR was also operating. The *pressure and temperature* time series acquired with the various sensors are compared in Figure 10. Before the Sept 25, the earthquake the average offset between the Digiquartz and the Aandera tide sensors is 116 hPa, 4 hPa larger than the offset measured during the previous deployment, 112 hPa (Digiquartz values being higher), determined during the first month. During the 4.5 months of deployment between May 9 and Sept 26, there is no significant relative drift of the 2 sensors, and variations of pressure offset after the earthquake may be attributed to the tilting of the device. In order to compare the records from both sensors the pressure measured by the RBR was averaged over 5 minutes every hour to match the Seaguard recording schedule. For the time period before the earthquake the rms of the difference between these two time-series (after removal of 116 hPa offset) is 0.3 hPa (Figure 11). The high frequency fluctuations of the Tide sensor pressure data without averaging during the previous deployment were somewhat larger (± 0.5 hPa). The Seaguard data logger recorded temperature variations with 4 different sensors: a specific temperature probe, and temperature sensors on the conductivity meter, on the tide sensor and on the oxygen optode. As during the previous deployment, the temperature probe yields very poor results with random drifts and jumps. The CTD temperature is stable, but with a noise amplitude of ± 0.01 °C, appears too noisy to resolve short term natural variations. The tide and optode sensors provides the best temperature records, with variations consistent with that recorded by the temperature sensor of the RBR BPR, but with static offsets between instruments. The average temperature measured from the beginning of the deployment to the time of the earthquake are 14.7074°C for the tide sensor 14.7143°C (+0.0059°C) for the CTD sensor, 14.7158°C (+0.0074°C) for the oxygen sensor, 14.7262°C (+0.0178°C) for the Digiquartz sensor. Also, the Digiquartz of the BPR sensor is an internal sensor that has a slower response to short term seawater temperature variations and may thus average out rapid variations.
