Mechanical performance after service of hybrid synthetic mooring lines for weather buoys

Peter Davies^{a,*}, Nicolas Lacotte^a, Gaspard Fourestier^b, Iroise Petton^b

^a IFREMER Centre Bretagne, Research and Technology Development Unit, 29280 Plouzané, France

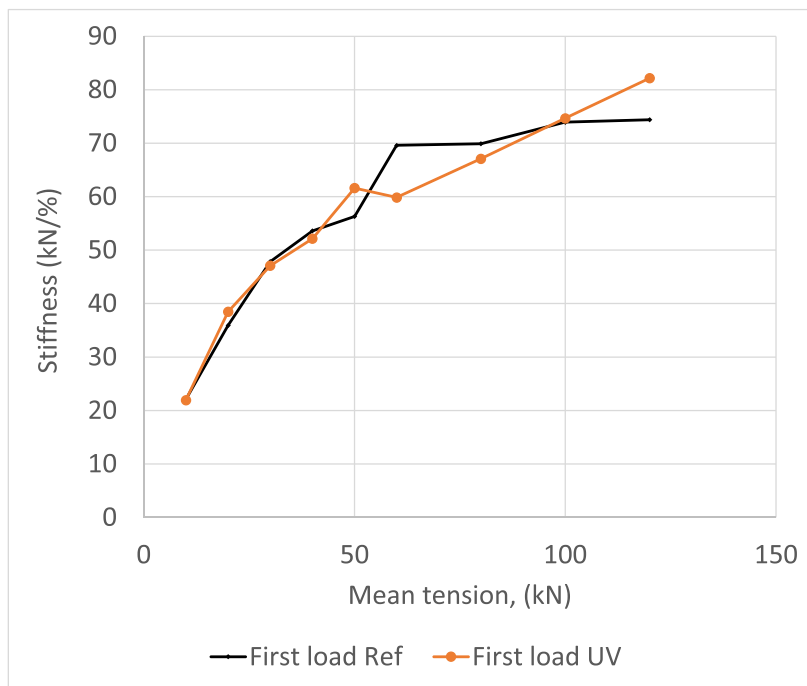
Fig. 6. Stiffness values, new and UV aged ropes, first loading.

A comparison between the stiffnesses measured on new and UV aged ropes (first loading, no bedding-in) is shown in Fig. 6. The values are

very similar, within experimental scatter, and there is a significant influence of mean load on KrD values. This mean load effect, a higher stiffness at higher mean loads, has been shown previously for polyester ropes (François and Davies, 2008).

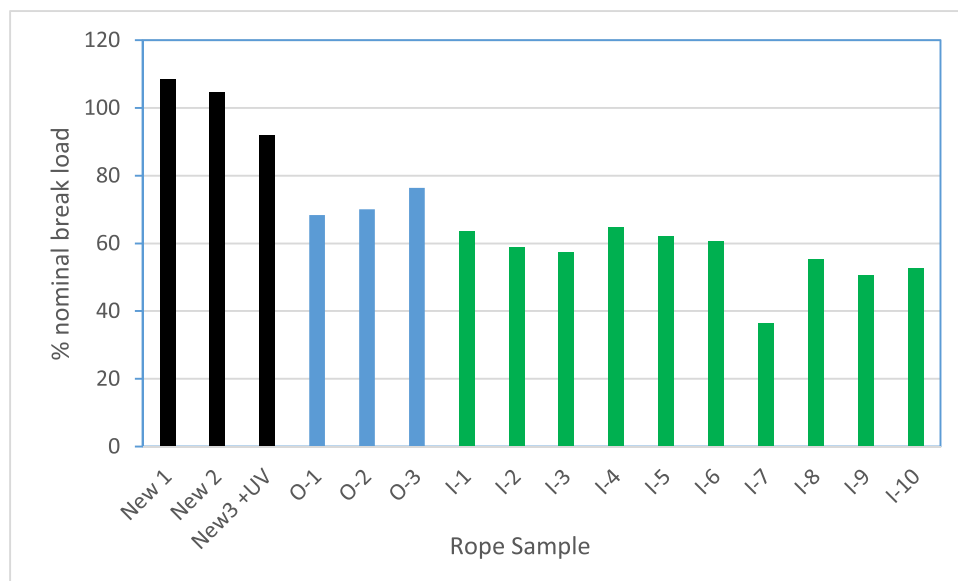
Fig. 7. Summary of break loads as a percentage of nominal break load (493 kN) O : Oleron. I : Irish Sea.

Fig. 7 shows all the break loads for the used ropes, plotted as a percentage of the nominal break load value (taken as 493 kN).

It is apparent that all the recovered samples have lost tensile strength

The results presented in the previous section indicate very significant losses in the strengths of these mooring lines after less than 3 years in service (Fig. 6). The average strength for the Irish Sea ropes which failed at the end of the splices and not in the original terminations is around 300 kN (40% reduction). The Oleron average is around 350 kN (30%

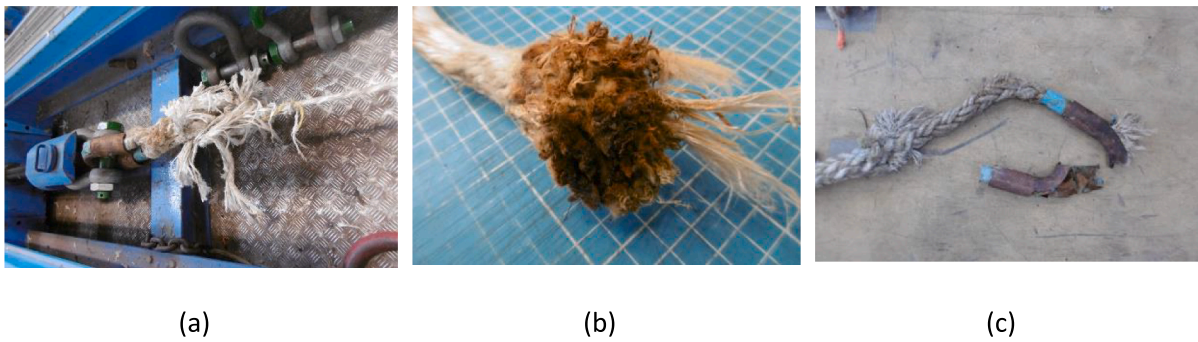
Fig. 8. Failure zones, a) at end of splice, example I-2, b) damaged strand due to thimble, sample I- 7, one of three severed strands, c) broken steel thimble, I-9.

during service. The majority of the used samples failed at the end of the splices, Fig. 8a; this was the case for the three Oleron samples and the first six Irish sea ropes. The two lowest break loads, for Irish sea samples 7 and 9, correspond to termination damage related to the steel thimbles, Fig. 8b and c respectively.

In the first case there appears to have been extensive wear between the end of the thimble and the rope; the blue protective sheath was no longer in place, and three of the eight strands were completely severed (Fig. 7b). In the second case the thimble was badly corroded and cracked after 23 months at sea, Fig. 7c, resulting in rope failure at the back of the eye.

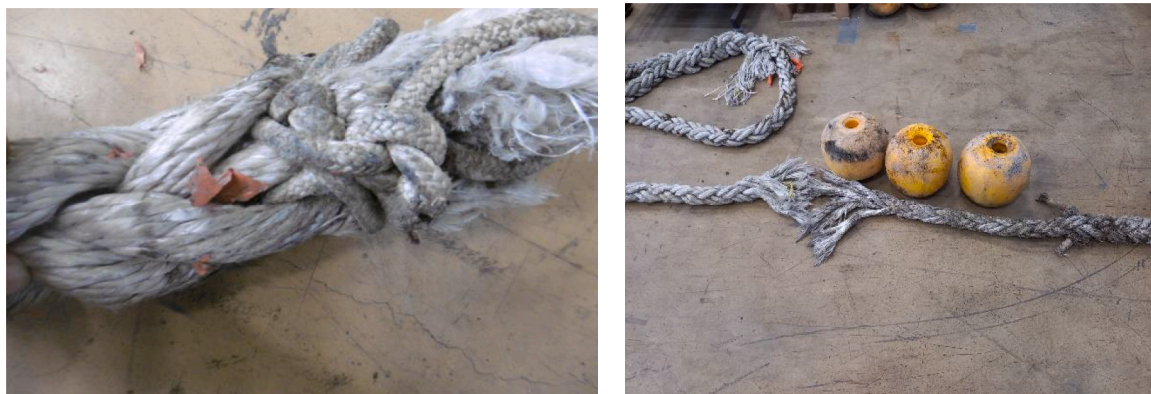
Fig. 10. Failure zones of ropes tested with floats.

Two samples were tested with floats on the lines, (used to avoid seafloor contact), Fig. 9, in order to examine whether this affected the rope behaviour. These were Irish sea ropes 8 and 10. The break loads were lower than for the ropes which failed at the end of the splice. Fig. 10 shows the failure zones, which are at the interface between the rope and the end of the floats in the free length between the splices. These floats were held in place by small diameter cords and those may be responsible for the premature ruptures. This will be discussed further below.

The second aggravating factor is the presence of floats. This is another important issue, as floats are required for many marine applications and here they are used to keep the lower part of the line off the sea bed. In order to maintain them at the required depth they are attached to the anchor line with small diameter cords, Fig. 10. These restrict local movement of the strands and can produce a stress concentration. The break loads recorded for the two tests with floats were around 10 and 14% lower than the mean of those without (I-1 to I-6). This is a relatively small difference, but the fact that in both cases failure was observed close to the floats suggests that this may be a problem in applications where longer durability is needed. While there have been some modelling studies on submerged buoys (Palm and Eskilsson, 2020) more work is needed to quantify their influence on fibre rope behaviour.

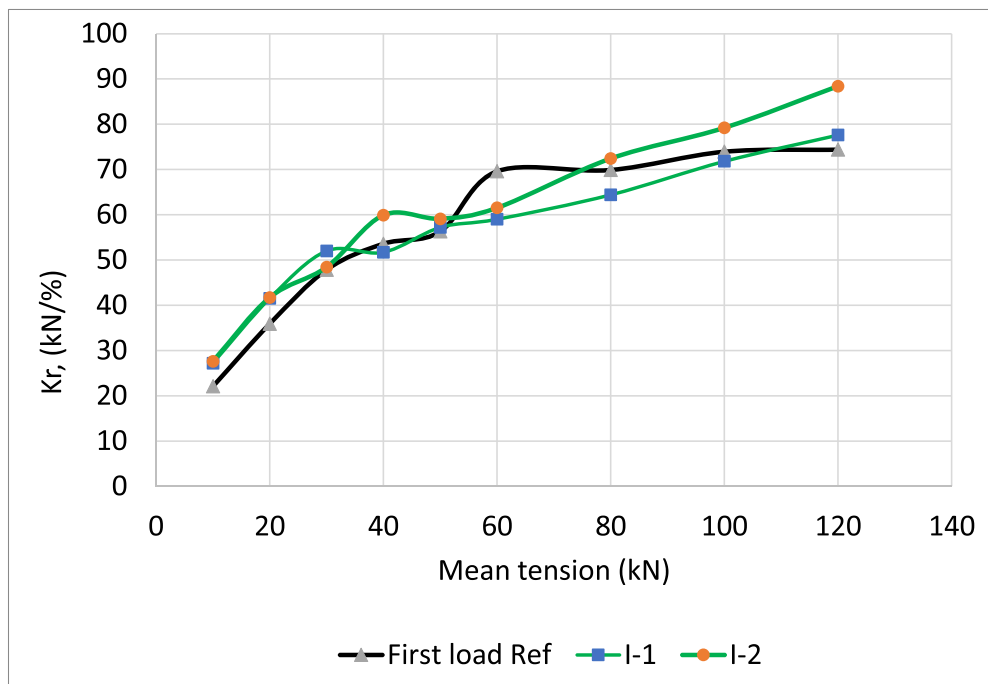
Fig. 11. Example of stiffness test results during first loading after service.

Finally, Fig. 11 shows examples of stiffness measurements made on used ropes. The values are quite close to those measured on the new ropes. These and other measurements suggest that over these service lives the rope stiffness for these loading conditions remains very close to the values for new ropes.

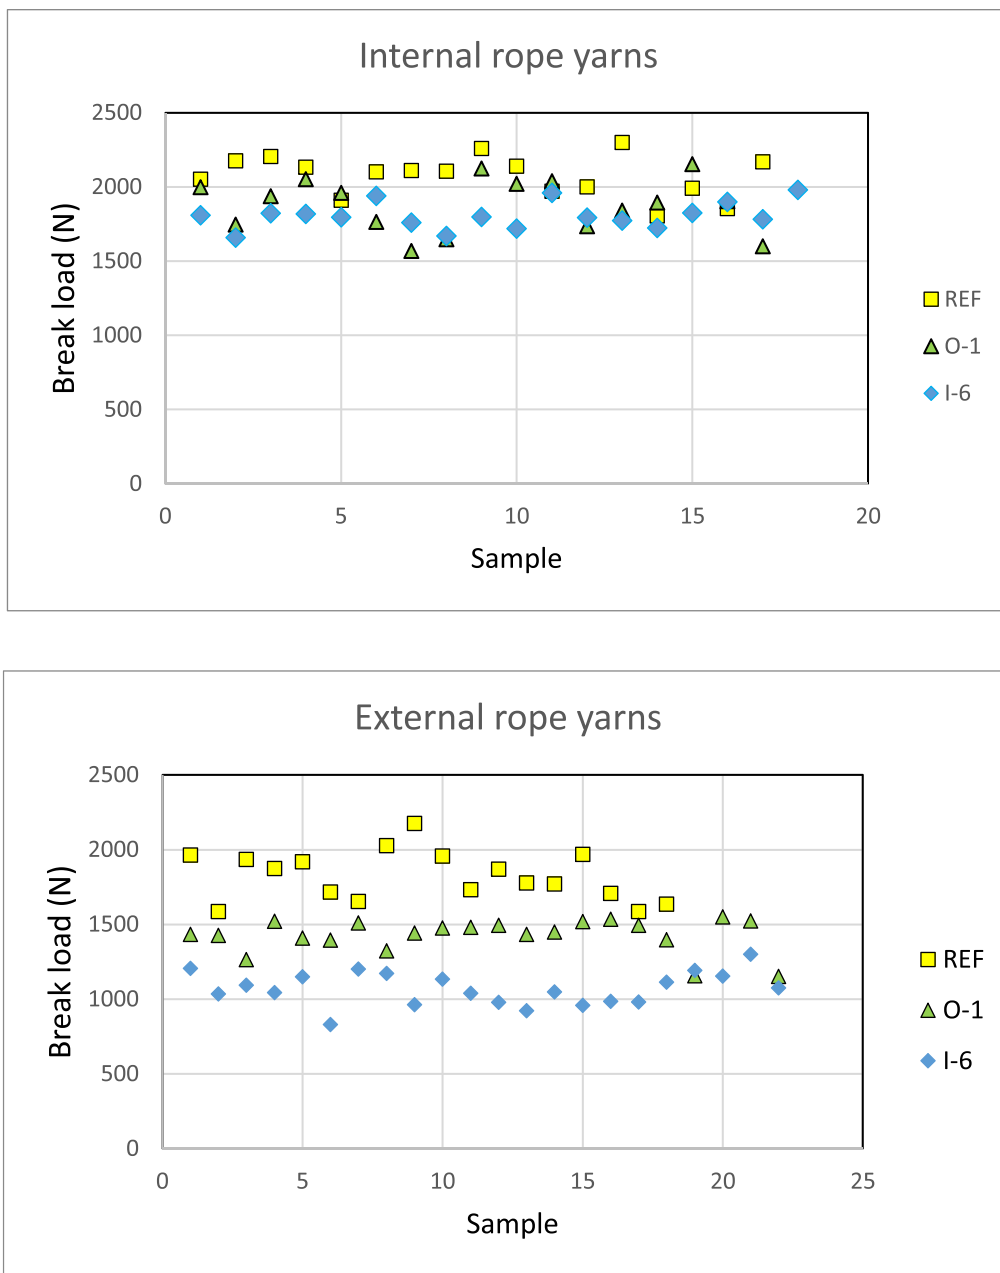
Fig. 15. Tensile test results, inner and outer rope yarns from New, Oleron-1 and Irish Sea-6 strands

Fig. 14 shows examples of typical load-strain results for the different tensile tests, Fig. 15 summarizes the tensile test results. The initial stiffnesses are similar for all conditions but loads and strains to failure drop after service.

in external rope yarn break loads for the Irish Sea samples, on average around 50%. New mean outer and inner rope yarn strengths are 1826 N and 2075 N with coefficients of variation (CV) of 7 and 9%. The corresponding values for aged rope yarns are 1072 N (CV 10%) and 1806 N (CV 5%) for the Irish sea and 1427 (CV 8%) and 1880 N (CV 10%) for Oleron. For both sites the mean strengths of inner yarns are similar, around 90% of the reference strength. However, the outer yarn strengths of Oleron samples are much closer to the original new values (around 80% compared to 60% for the Irish Sea). To a first approximation, based on 22 outer rope yarns in a strand and 18 inner yarns, a purely additive use of these values would indicate residual strengths of 84 and 72 % for these two ropes. Measured residual values, with respect to the mean measured new rope strength (taken as 525 kN), were lower, 64% for Oleron and 54% for the Irish sea. This may reflect the braided rope geometry and the degradation in the interfaces between elements shown by the rope yarn-on-rope yarn results. A more realistic rope model would be needed to include these effects. Such a model was used in previous work on hybrid ropes (Khalid et al., 2020), and by using degraded rope yarn properties as input data could help to optimize mooring design.

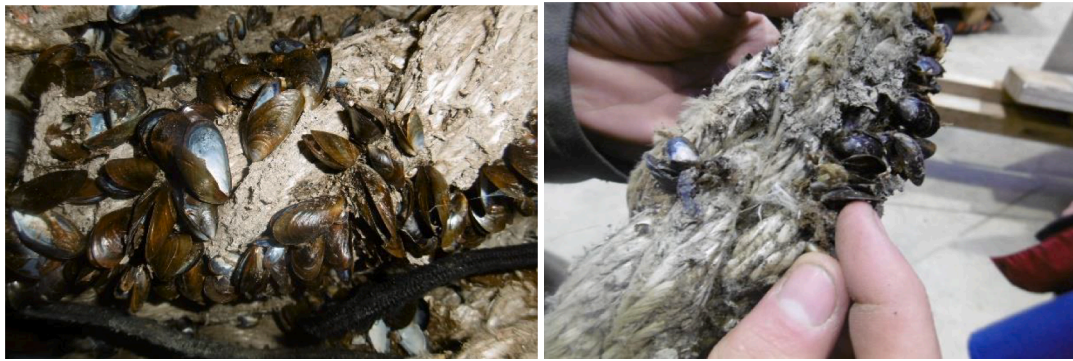
Fig. 16. Upper: Mussels fixed on mooring line before cleaning (strand diameter 18 mm) Lower: SEM images of damaged, bonded fibres on rope surface.

Examples of the state of mooring lines after recovery before cleaning are shown in Fig. 16. These buoys are moored in shallow water and there is considerable marine growth attached, particularly mussels (Fig. 16a, b). While many of these drop off during transport and handling some remain, and these were usually removed manually or with high pressure water cleaning. An examination of the removal of mussels revealed that some are strongly bonded and hard to remove without damage to fibres. Mussels adhere to surfaces by secreting 'byssus' fibres which act as anchor lines, with adhesive plates as the anchors. Their adhesion properties have been extensively studied (Brown, 1952; Crisp et al., 1985; Waite, 1987; Bell and Gosline, 1966; Waite and Harrington, 2022). If this adhesive anchor can surround fibres on the rope surface, in a similar way to rope-grown mussel farming, it will indeed be very difficult to remove them without damaging the rope. Fig. 16c and d show SEM images of an area where PET fibres appear to be bonded to the biological adhesive deposited by the mussel. We suggest that the reduction in rope strength is primarily caused by macro-fouling causing multiple damage initiation sites.

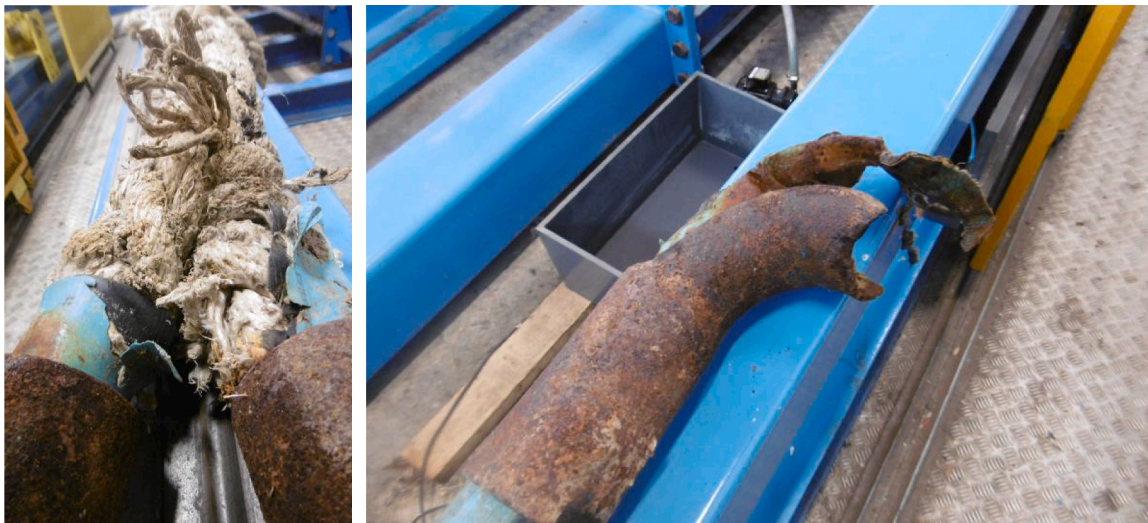
Fig. 17. Thimble contact causing damage to strands after protective cover failure (I-7) or corroded thimble failing during test (I-9).

In addition to the change in rope behaviour due to surface damage, the test results also highlight two additional causes of premature failure which can result in even larger strength losses. The first is the influence of the thimble at the termination. Fig. 17 shows the importance of protecting the rope from the steel thimble. In this case the impregnated fabric interface has been severely damaged on the right hand side so the rope could rub against the steel, which led to the sectioning of strands such as the one shown previously in Fig. 8b.
