# **Observations of suprapermafrost and intrapermafrost groundwater on Svalbard**

## **Summary**

## S1. Observations of suprapermafrost and intrapermafrost groundwater on Svalbard

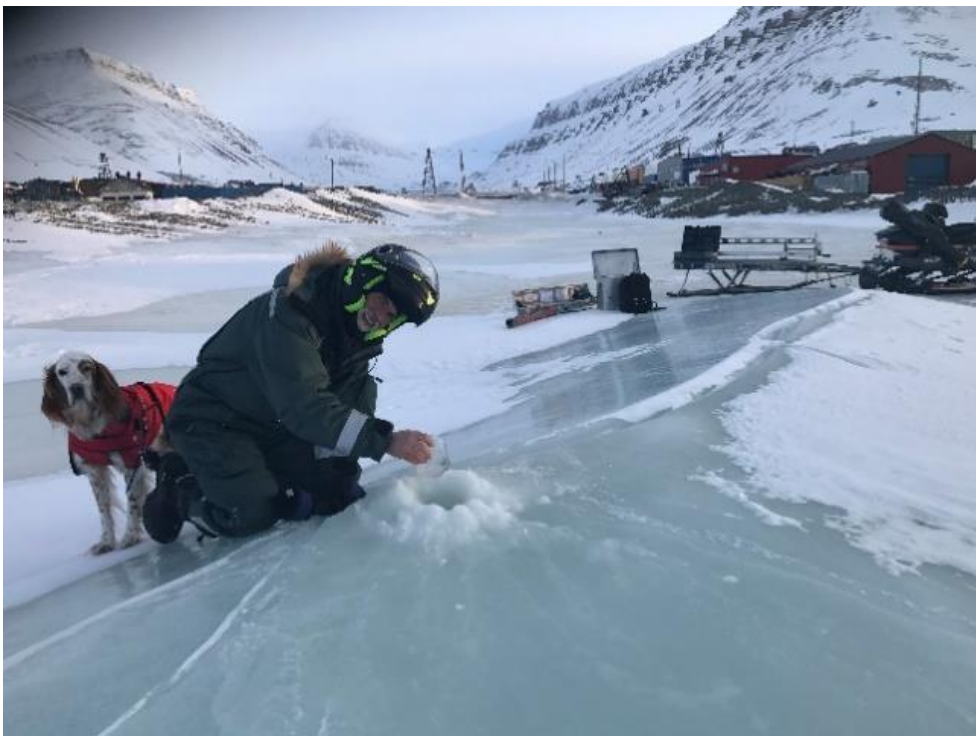
**Figure S1.a1-4. Small, cracked "mound" icing at Longyearelva below the bridge across the Road 600 (18.04.2017, location a1 in Table S1), drilling revealed water at artesian pressure. The water had distinct taste and smell of diesel. Photo: © Anatoly Sinitsyn.**

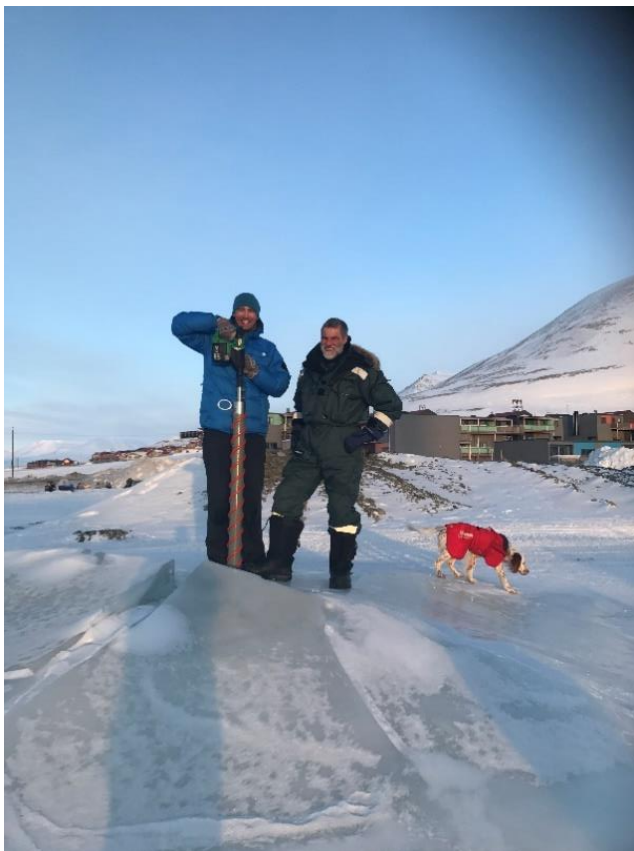
**Figure S1.a2-1. Drilling through small, cracked "mound" icing at Longyearelva behind Elvesletta Nord (18.04.2017, location a2 in Table S1). Photo: © Anatoly Sinitsyn.**

Figure S1.a2-1 Figure S1.a2-2 Figure S1.a2-3 Figure S1.a2-4 Figure S1.a2-5  Video S1.a2-1 (Sinitsyn, 2023a)  Video S1a2-2 (Sinitsyn, 2023a)	Suprapermafrost groundwater of Type II	Figure S1.1, location a2	Small, cracked "mound" icings were observed in April 2017 behind Elvesletta Nord. Ice thickness was found to extend 1 m below the surface of the icing after drilling with a core sampler. After that, through the drilled hole, fresh water with no smell or flavor appeared on the icing's surface.
	Figure S1.a3	Suprapermafrost groundwater of Type II and probably intrapermafrost groundwater	Figure S1.1, location a3	Medium-size, "flat and spread" not cracked icing was observed in June 2017 under the building Nr. 1 and Road 509, Elvesletta Nord. Such icing may be considered as one of the issues which caused deformations of the building (inclined flooring, issues when closing windows, etc.).
	Figure S1.a4	Suprapermafrost groundwater of Type II and/or intrapermafrost groundwater	Figure S1.1, location a4	Medium-size, not cracked icing was observed in April 2017 at the turn of the main pipeline with hot water.

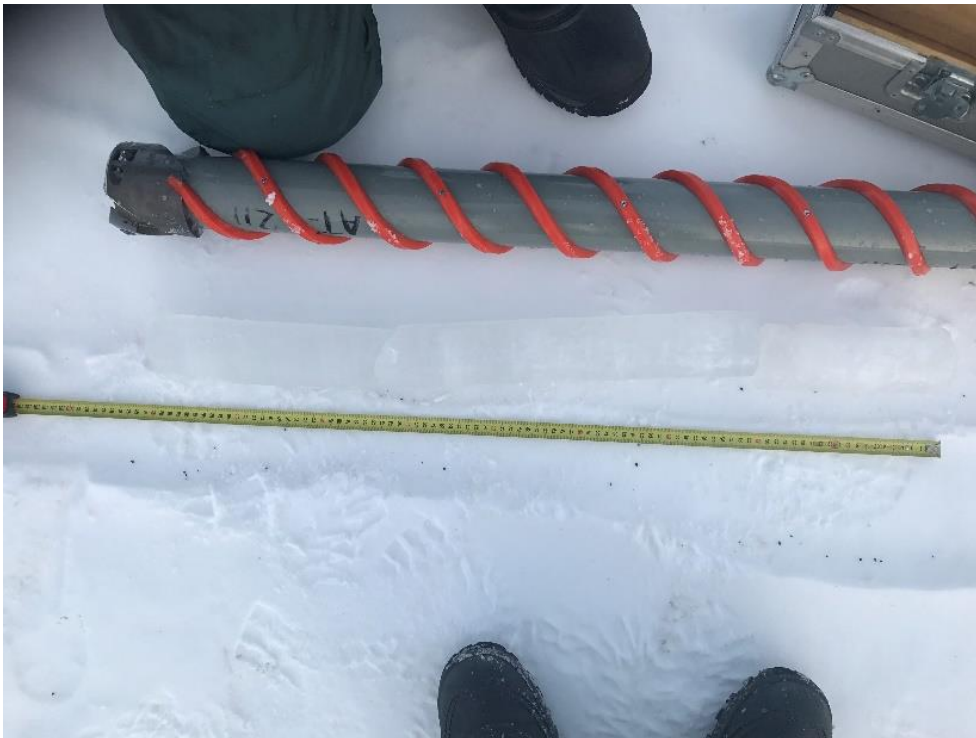
Figure S1.a2-3. Ice core retrieved at the icing at Longyearelva behind Elvesletta Nord (18.04.2017, location a2 in Table S1). Photo: © Anatoly Sinitsyn.

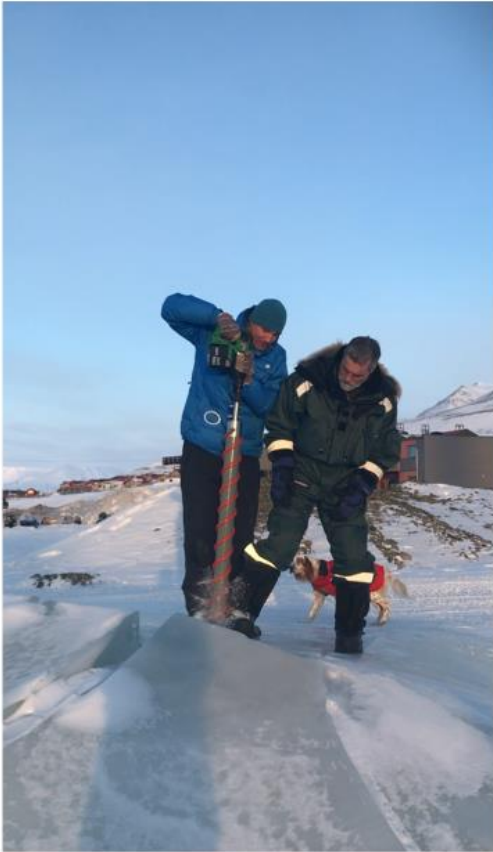
**Figure S1.a2-4. Snapshot from Video S1.a2-1 (Sinitsyn, 2023a). Drilling through small, cracked "mound" icing at Longyearlva behind Elvesletta Nord (18.04.2017, location a2 in Table S1). Video: © Anatoly Sinitsyn.**

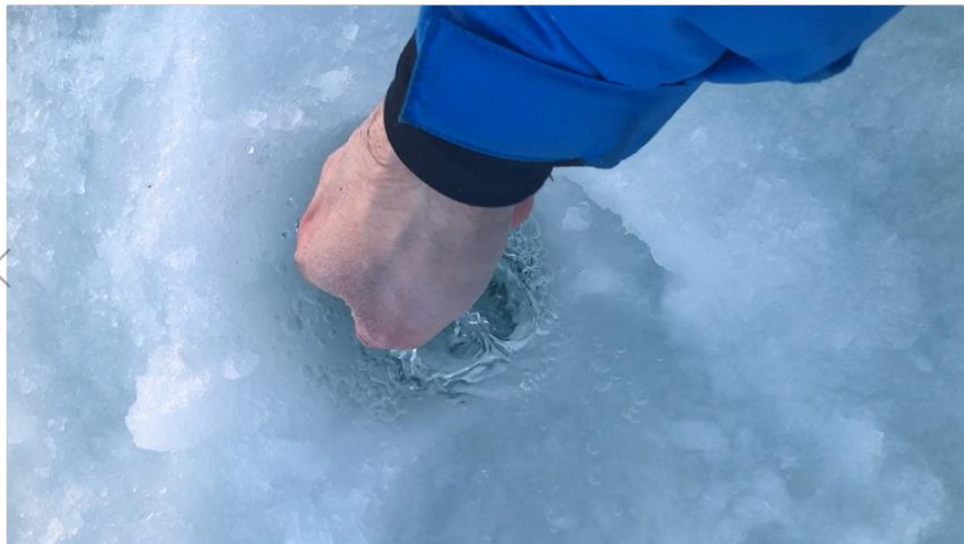
**Figure S1.a2-5. Snapshot from Video S1.a2-2 (Sinitsyn, 2023a). Water at artesian pressure, which appeared on the surface of icing at Longyearlva behind Elvesletta Nord (18.04.2017, location a2 in Table S1). Video: © Anatoly Sinitsyn.**

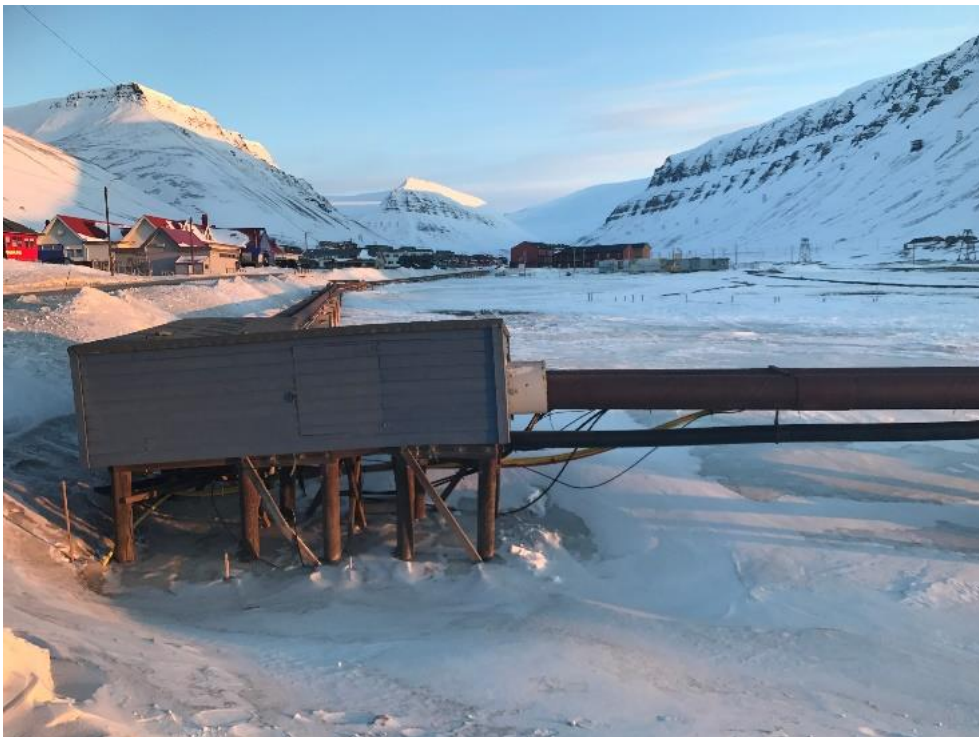
**Figure S1.a4. Medium-size, not cracked icing at Elvesletta affecting supporting structure for pipeline on its turning point (18.04.2017, location a4 in Table S1). Photo: © Anatoly Sinitsyn.**

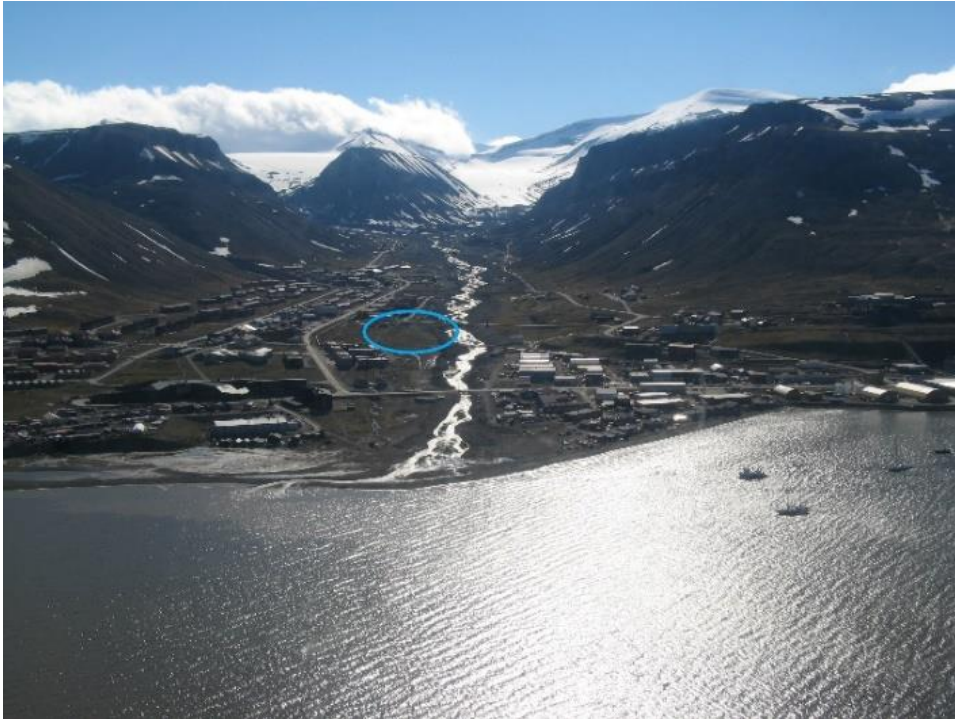
Figure S1.a10-1. Longyearrelva channelled into one large riverbed equipped with rock- protection of riverbanks against erosion (2017). Blue circle depicts approximate location of Elvesletta. Photo: © A. Skoglund / Norwegian Polar Institute.

<b>Direct observations of groundwater in Longyeardalen</b>  Geotechnical investigations and installations of deep pile foundations has revealed several cases of groundwater in the district of Elvesletta and at the riverbed of Vannledningsdalen valley (Norwegian, "the water supply valley").	Figure S1.a10-1 Figure S1.a10-2 Figure S1.a10-3 Figure S1.a10-4	Intrapermafrost groundwater and suprapermafrost groundwater of Type II	Figure S1.1, location a10	Geotechnical field investigations were performed by Ramboll Norge AS (2019a) and conducted for Svalbard Utbygging AS, Elvesletta (2019). Investigations did not identify groundwater in this area. At the same time, soil layers, which may serve as potential aquifers were found. The survey also depicted two icings in the area, which were observed in 2018–2019.  Pedersen (Ramboll Norge AS, 2019a) points out that potential aquifers detected on the site (gravel at depths 3–11 m at all drilling locations) are devoted to coarse-grained sediments of former river channels in Longyearelva. Those channels (as pointed out by Pedersen (Ramboll Norge AS, 2019a)) can be seen on the aerial image of Longyearbyen and Longyearelva from 1936 (Figure S1.a10-2). At the present time, most of the old and small river channels are leveled, and Longyearelva is channeled into one large riverbed equipped with rock- protection of

<p>riverbanks against erosion (Figure S1.a10-1, Figure S1.a10-3, Figure S1.a10-4).</p> <p>The absence of water in identified potential aquifers was explained by a preceding prolonged period without precipitation and mild weather. However, there was an emergence of groundwater beneath some residential buildings in the adjacent sites (2018–2019), which happened in periods of low precipitation and mild weather conditions (Ramboll Norge AS, 2019a). In one of those cases, ice formed around an elevator shaft installed in the basement of the building. It was suggested that the construction of that shaft created a new pathway for groundwater.</p> <p>Similar investigations at adjacent building areas (2018) revealed groundwater and hydraulic conductivity between some of the drilled boreholes (tested via applying air pressure at one borehole and observation of lifted groundwater from the other one). However, hydraulic conductivity between other boreholes at the same site was absent (Ramboll Norge AS, 2019a). Installation of a well equipped with a pump was suggested for tackling the issues with groundwater around the buildings in this area, i.e., such a well would handle possible issues with groundwater in the periods of heavy rainfalls and/or snow melt.</p>

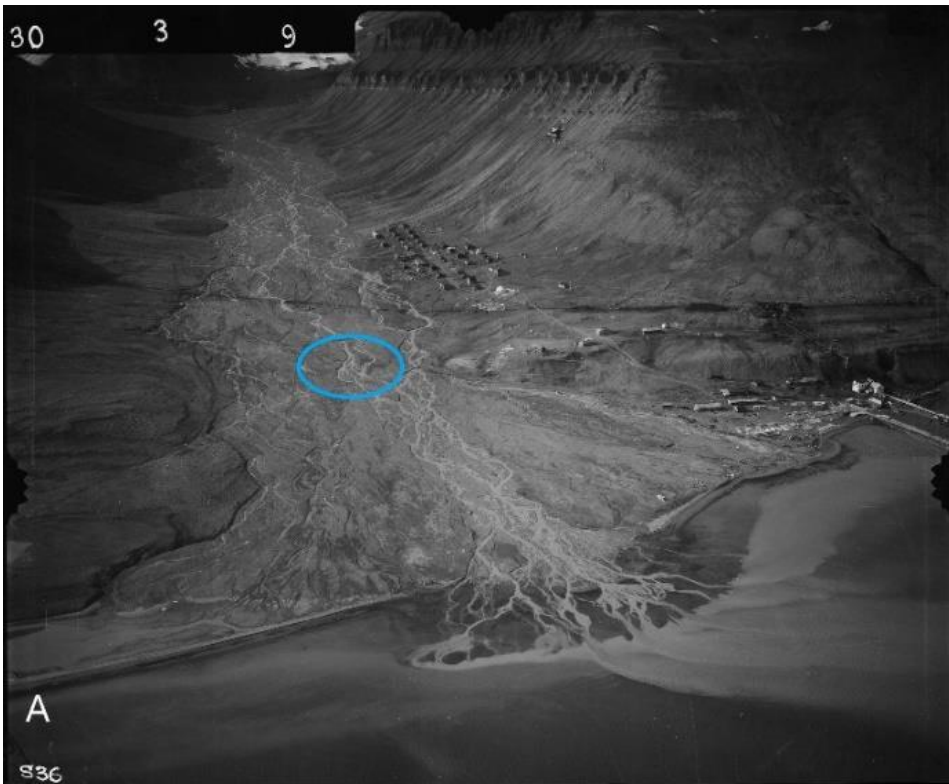
Figure S1.a10-2. Longyearbyen and Longyearrelva in its natural, unconfined state, running in several channels (1936). Blue circle depicts approximate location of Elvesletta. Photo: © Norwegian Polar Institute, image number S36\_3039.

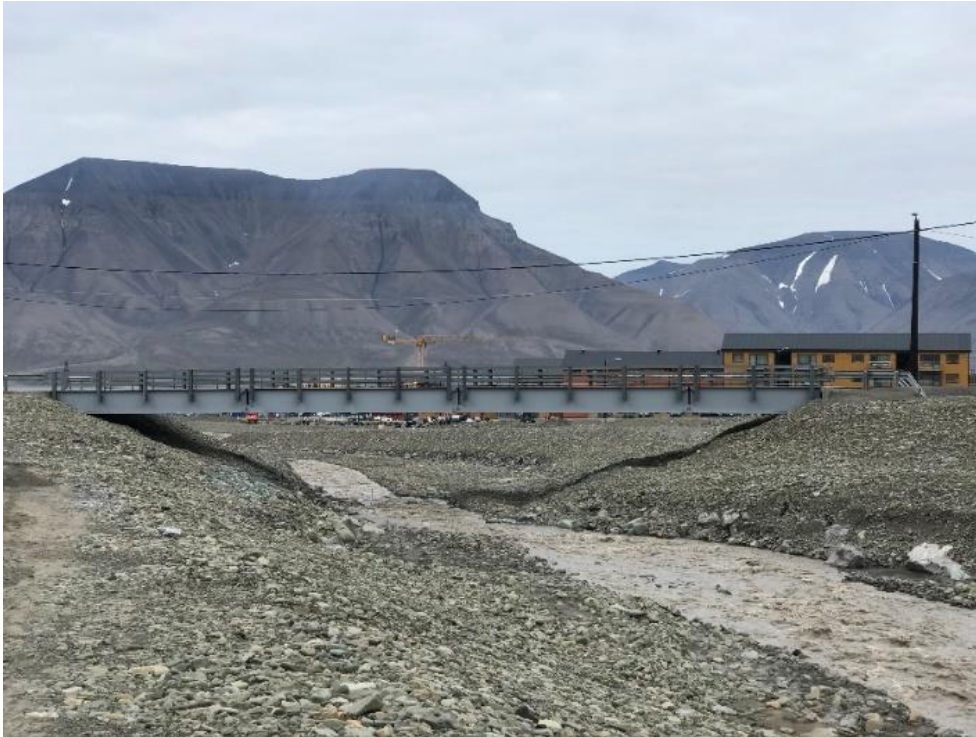
**Figure S1.a10-3. Longyearelva running through engineered riverbed below the bridge over the Road 501 (17.08.2021).  
Photo: © Anatoly Sinitsyn/Sintef.**

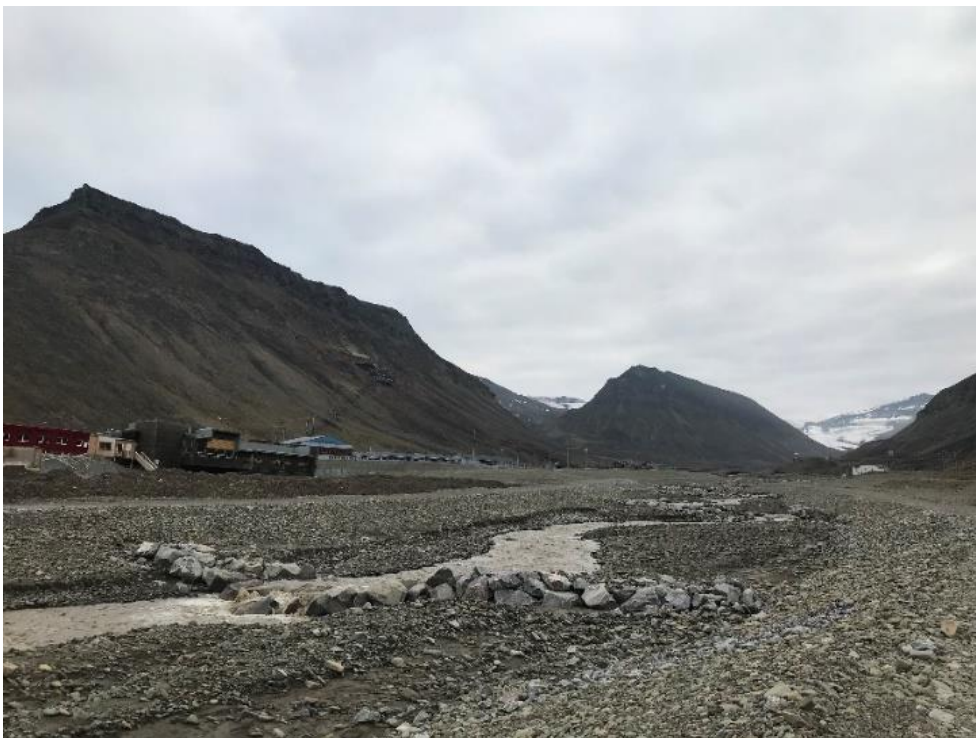
**Figure S1.a10-4. Longyearelva running through engineered riverbed above the bridge over the Road 501 (17.08.2021).  
Photo: © Anatoly Sinitsyn/Sintef.**

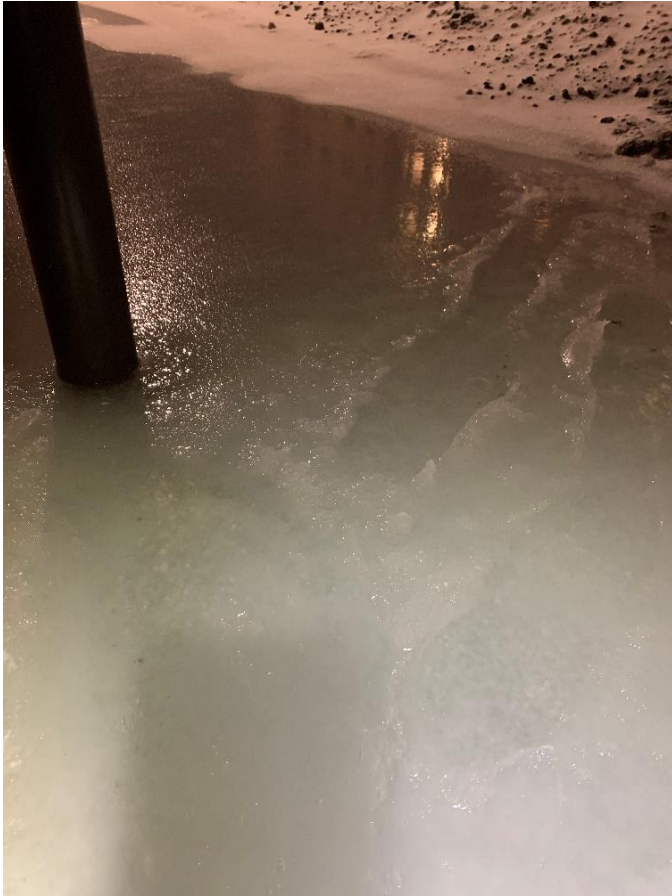
**Figure S1.a11-1. Icing below housing for student's accommodation in Elvesletta (09.11.2021, location a11 in Table 1).  
Photo: © Tove Trondsen/Norges arktiske studentsamskipnad.**

<p>Figure S1.a11-1 Figure S1.a11-2 Figure S1.a11-3</p>	<p>Intrapermafrost groundwater and suprapermafrost groundwater of Type II</p>	<p>Figure S1.1, location a11</p>	<p>Geotechnical field investigations were performed by Ramboll Norge AS (2018) for Norges arktiske studentsamskipnad (Norwegian Arctic student organization), Elvesletta (April 2018)). Investigations were performed at one of two medium- to large icings in the area using drilling. The icings were up to 1.7 m high.</p> <p>Drilling was performed at three locations across the icing, i.e., on the top, foot, and the "flat" part of the icing. Drilling on the top and foot of the icing revealed loose ground material and pure ice (with a total thickness of approximately 1.5 m) underlain by a 3 m thick aquifer (there was no resistance to drilling in the upper 3 m) at artesian pressure (Figure S5.a-11-3). Drilling revealed frozen soil to the depths of 3–6 m. Drilling on the "flat" part of the icing revealed approximately 1 m of ground ice in the top 2 m of frozen material, which was underlined by a thawed layer to a depth of 6 m.</p> <p>Later, groundwater was detected during the deployment of pile foundations for the student accommodation buildings erected in the area from summer to winter 2020 (Norges arktiske studentsamskipnad, 2020). Groundwater was detected at depths from 4 to 18 m during the installation of some of the piles. After the buildings were constructed, ice formation due to emerging groundwater was noted below the</p>

buildings (Figure S1.a11-1, S1.a11-2), as predicted by Pedersen (Ramboll Norge AS, 2018).
	–	Intrapermafrost groundwater and suprapermafrost groundwater of Type II	Figure S1.1, location a12	Geotechnical field investigations revealed aquifers at several locations under the riverbed of Vannledningsdalen valley (Ramboll AS, 2019). Aquifers were located under the upper 3–4 m of frozen soil and were mostly aligned with the riverbed. These investigations, performed in February 2019 suggested year-round water flow in the detected aquifers.
	See Table 2 in (Ramboll Norge AS, 2017).	Intrapermafrost groundwater and suprapermafrost groundwater of Type II	Figure S1.1, location a13	Geotechnical investigations of Ramboll Norge AS (2017) were conducted for Longyearbyen Lokalstyre, Elvesletta. Investigations have revealed groundwater at the depths of 1, 4, and 6.8 m in this area. In one case the amount of groundwater was so high that it was not possible to perform a description of ground ice from retrieved soil samples.

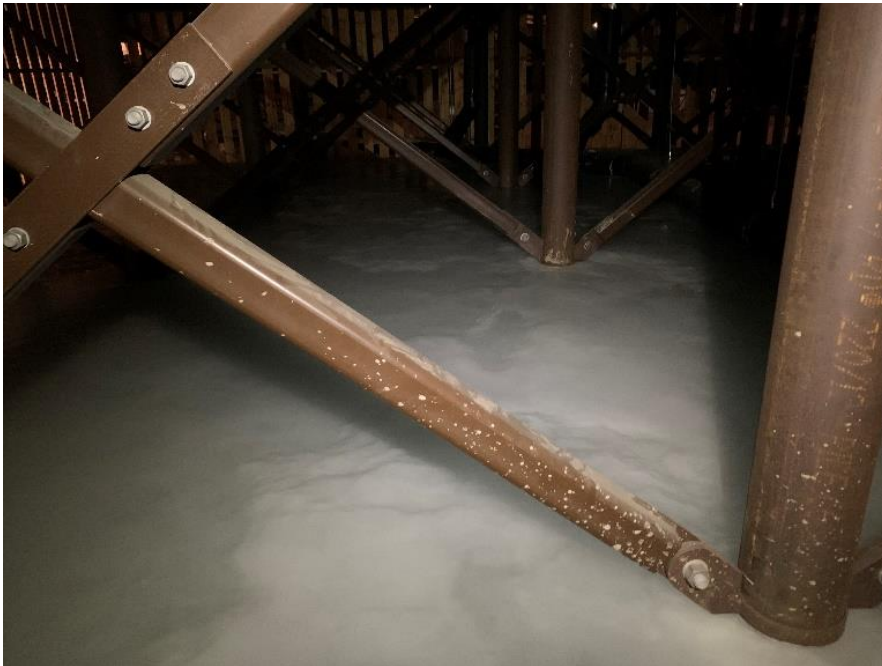
**Figure S1.a11-2. Icing below housing for student's accommodation in Elvesletta (09.11.2021, location a8 in Table 1).  
Photo: © Tove Trondsen/Norges arktiske studentsamskipnad.**

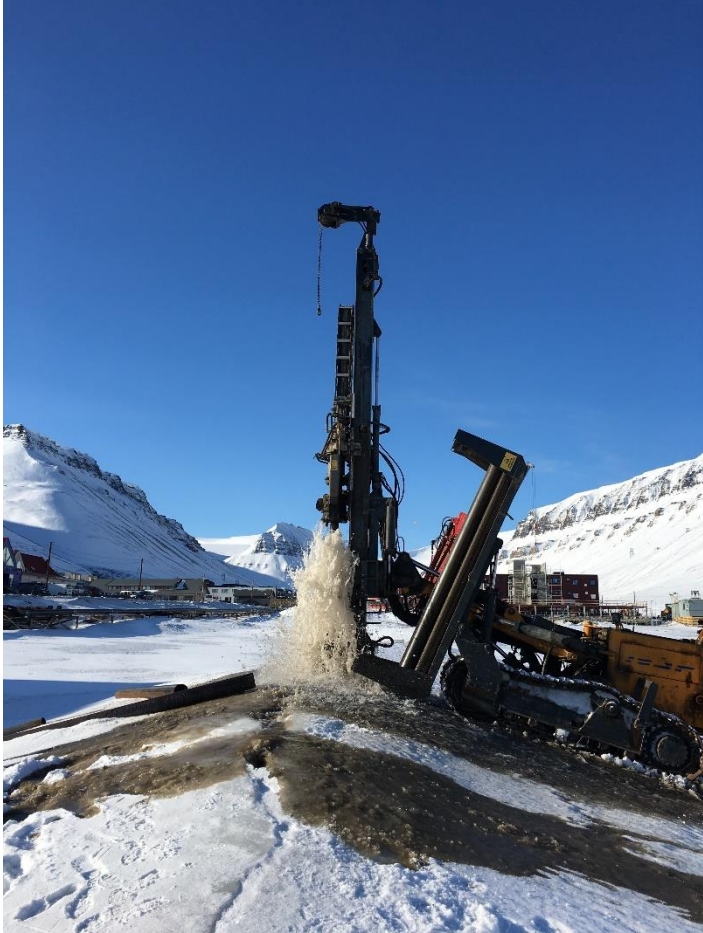
Figure S1.a11-3. Emergence of water at artesian pressure when drilling through an icing in Elvesletta (23.04.2018, location a11 in Table 1). Photo: © Marit Pedersen/Ramboll AS.

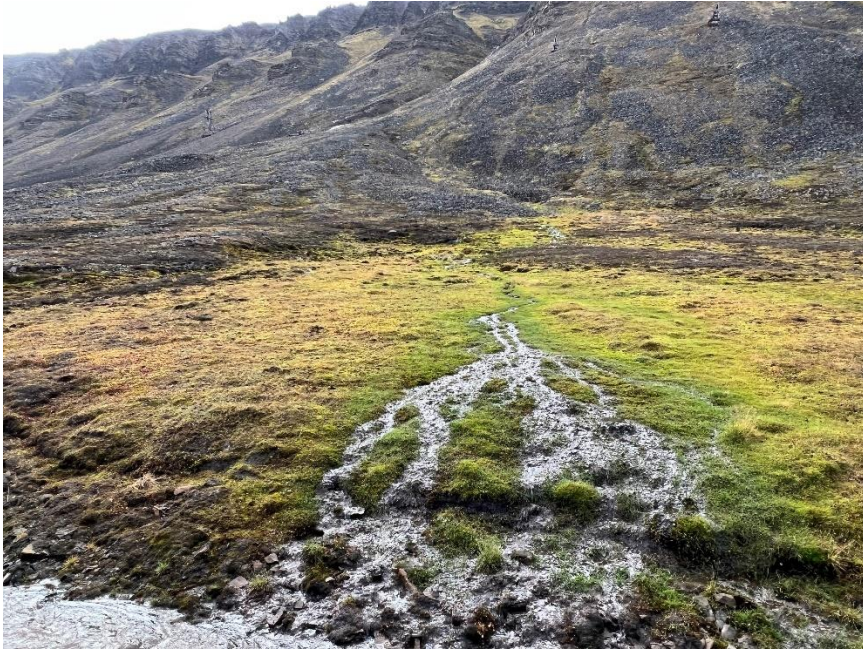
**Figure S1.a17. Water from a spring on the slope above Road 300 (09.09.2023, location a17 in Table 1). Photo: © Anatoly Sinitsyn/Sintef.**

<b>Large, continuously growing icings on a sloping terrain, outside of the riverbeds in Longyeardalen</b>	–	Intrapermafrost groundwater	Figure S1.1, location a14	An icing was observed in Longyeardalen, on the slope next to the building of Huset. It was a large (ca. 200 meters in length along the slope, and several tens of meters across the slope) "flat and spread" icing, which was noted during at least some (if not all) winters in 2012–2019. It had a thickness of approximately 0.5 m at the end of the winter season. The icing filled up the drain along the Road 300 and was completely "flooding" a stretch of the road. The latter caused traffic bans on this road during several winters. Also, several springs with artesian pressure were observed on this slope in springtime. The springs disappeared later in the season.
	Video S1.a16 (Sinitsyn, 2023a) Figure S1.a16 Figure S1.a17	Suprapermafrost, and probably intrapermafrost groundwater	Figure S1.1, locations a15–a17	Several springs were observed on the slope above Road 300 on September 9 <sup>th</sup> 2023 (location a15), the springs disappeared few days later. This was preceded by a heavy rain on September 5 <sup>th</sup> –7 <sup>th</sup> . Examples of springs are presented on Video S1.a16 and Figure S1.a16 (location a16) and on Figure S1.a17 (location a17).

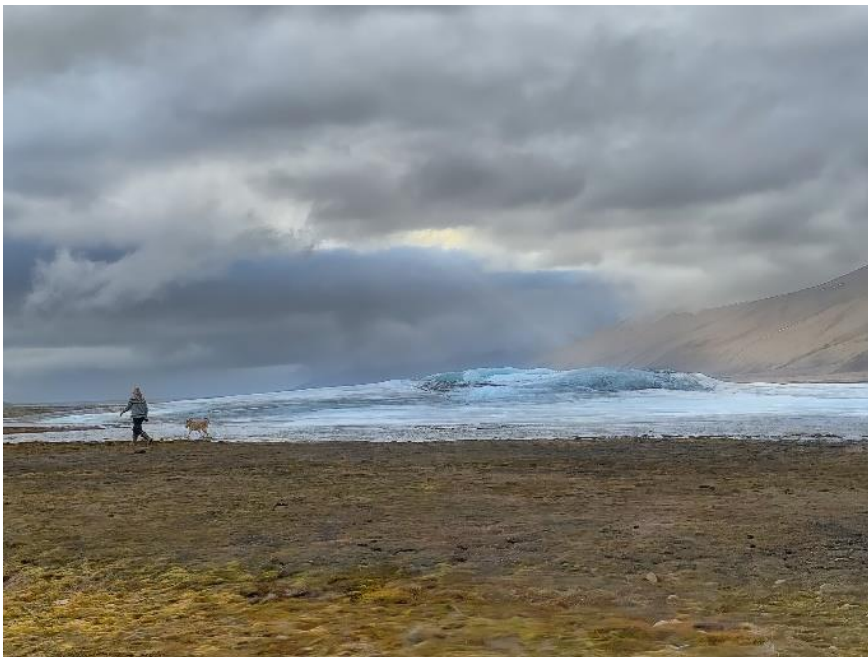
**Figure S1.b1. Large "mound" icings at the intersection of Adventelva and Bolterelva (12.06.2020, location b1 in Table S1). Photo: © Elizabeth Bourne.**

Figure S1.b1	Intrapermafrost groundwater and suprapermafrost groundwater of Type II	Figure S1.2, location b1	Large "mound" icings at the intersection of Adventelva and Bolterelva, observed by Bourne, (Sinitsyn, 2022a) in June 2020. This large icing existed during part of the summer season.
	–	Intrapermafrost groundwater and suprapermafrost groundwater of Type II	Figure S1.2, location b9	Large icing (a hundred meters wide, and several hundred meters long- in the direction along the valley), "flat and spread" in Adventdalen somewhere below the mountains of Arctowskijellet and Juvdalskampen. This icing was approximately 1–1.5 m thick and largely consisted of slush. The icing was a serious obstacle for snowmobile driving in this area, so that necessary to drive more on the shoulder of the valley to avoid getting stuck in it (one of the springs between 2012 and 2014).
<p><b>Indicators of the presence of icings in terrain</b></p> <p>Soil surface with patterns characteristic for icings (as for instance for location c: Figure d-2021-1 to Figure d-2021-3) was spotted in several locations around Isdammen.</p>	Figure S1.d-1 Figure S1.d-2 Figure S1.d-3	Intrapermafrost groundwater and suprapermafrost groundwater of Type II	Figure S1.2, location d	Such patterns were spotted in several places around Isdammen in late August 2021, for example at the sandbanks of the lower part of the Endalselva river.

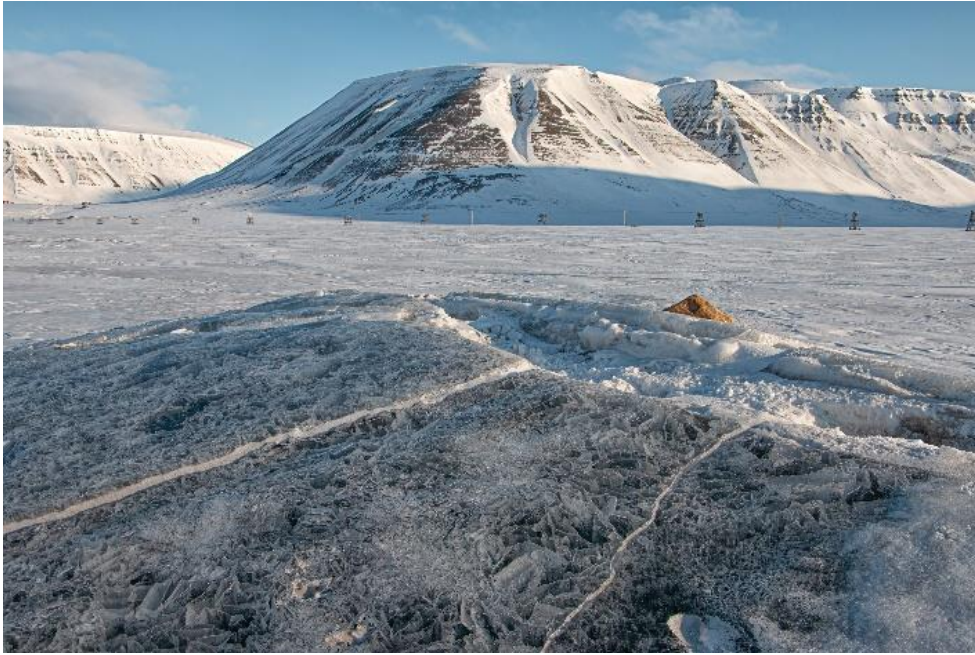
**Figure S1.b6-1. Small, cracked icing in Endalen, (01.05.2021, location b6 in Table S1). Photo: © Elizabeth Bourne.**

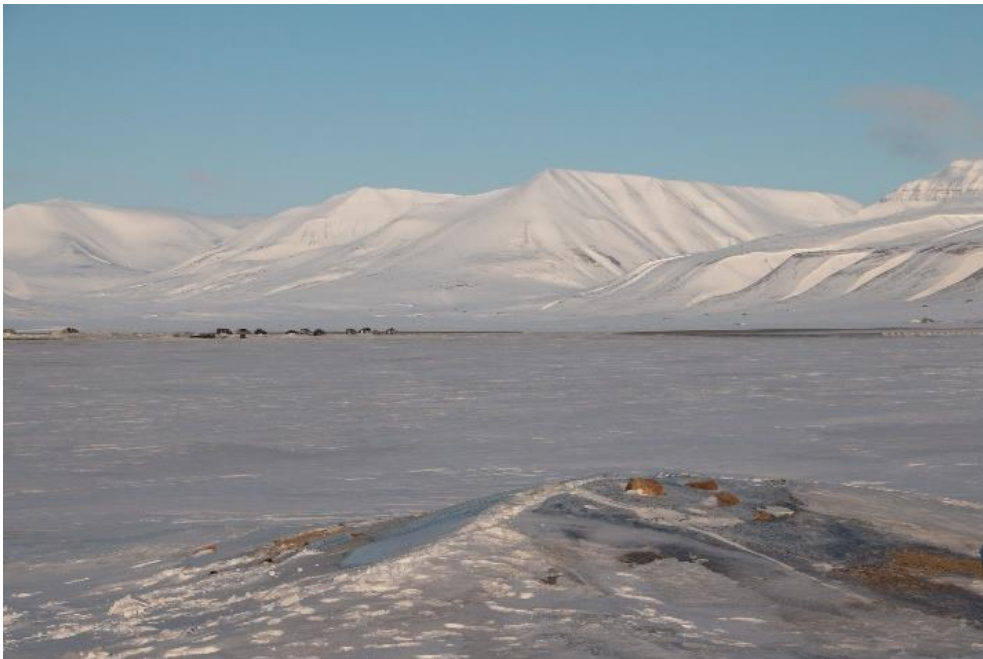
**Figure S1.b6-2. Small, cracked icing in Endalen, (01.05.2021, location b6 in Table S1). Photo: © Elizabeth Bourne.**

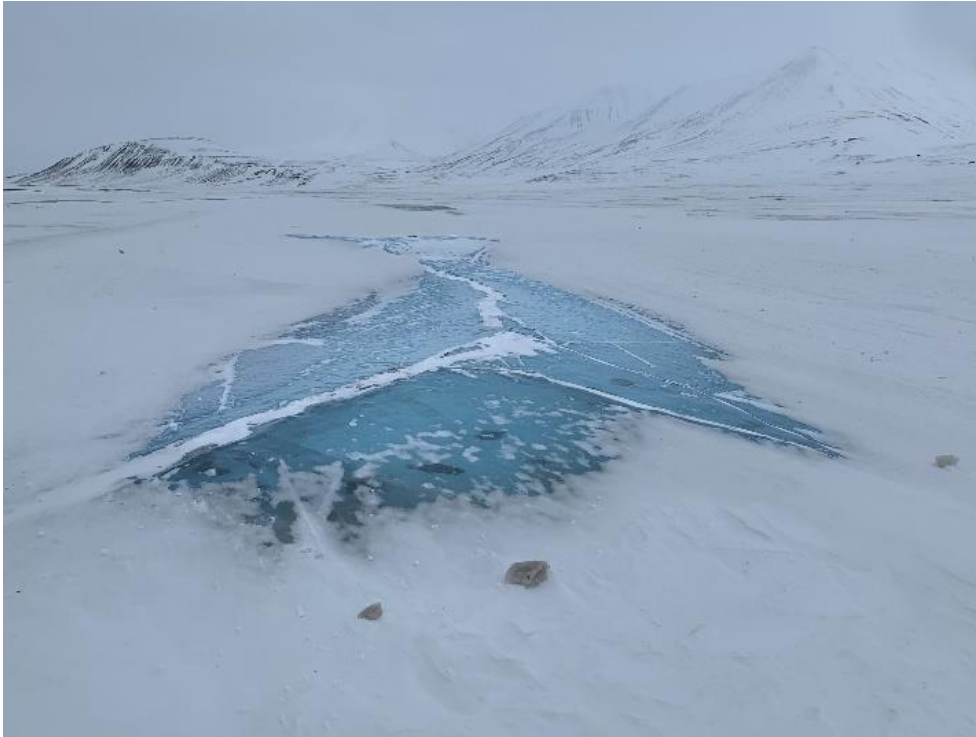
**Figure S1.b7. Small, cracked icing in Adventdalen close to the entrance to Eskerdalen (13.04.2020, location b7 in Table S1). Photo: © Elizabeth Bourne.**

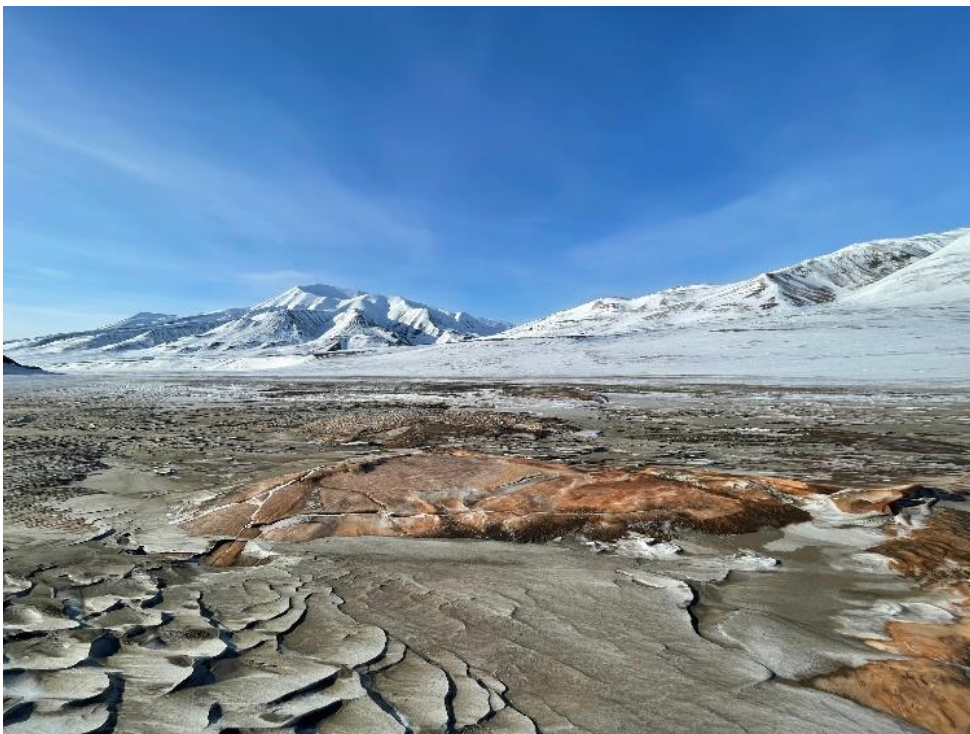
**Figure S1.b8. Small, cracked icing in Adventdalen close to the entrance to Arnicadalen (14.04.2021, location b7 in Table S1). Photo: © Elizabeth Bourne.**

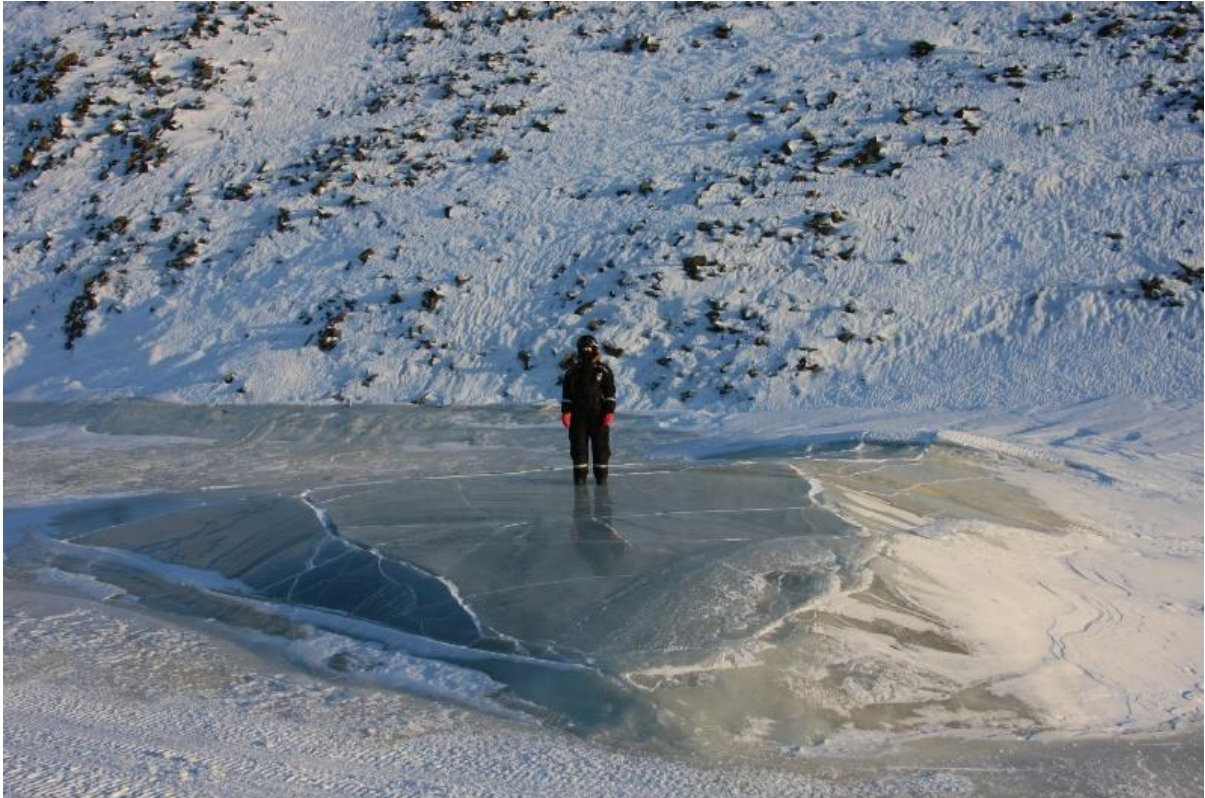
Figure S1.b9. Medium-size, "mound" icing in Fardalen (02.04.2010). Photo: © Aleksey Shestov.

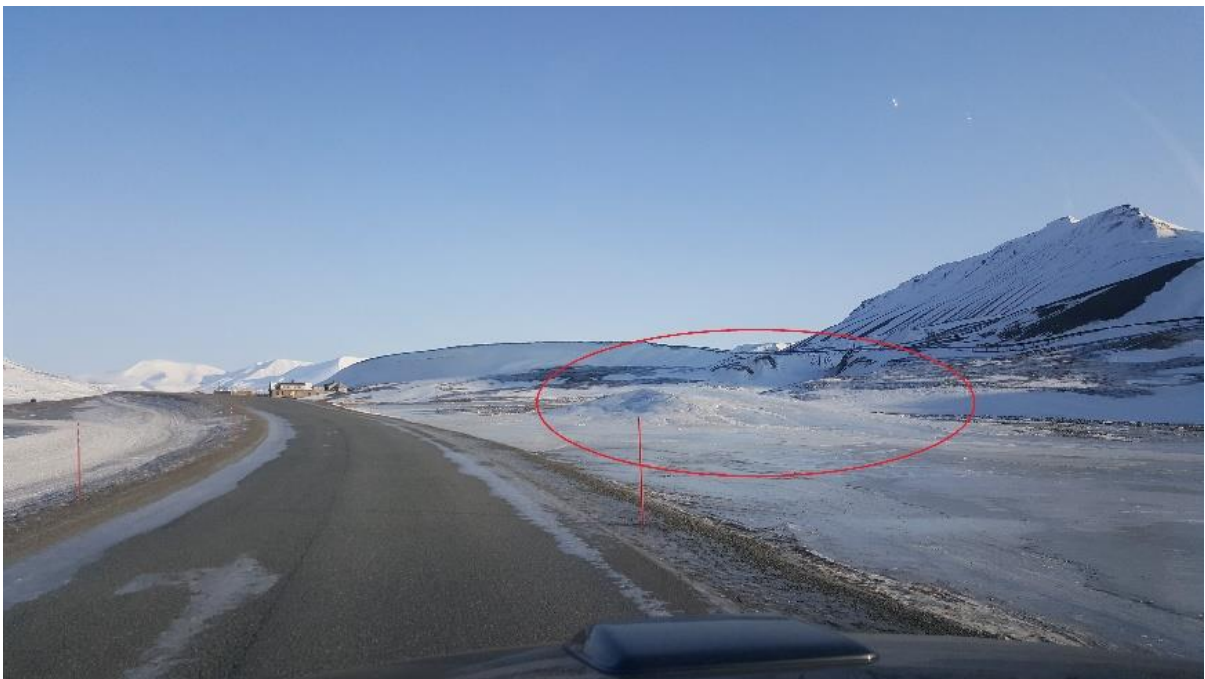
Figure S1.c-1. Large icing at the Road Nr. 400 and Steintippendalen/Gruvedalen (06.04.2018, location c in Table S1). Photo: © Kjersti Olsen Ingerø/Longyearbyen Lokalstyre.

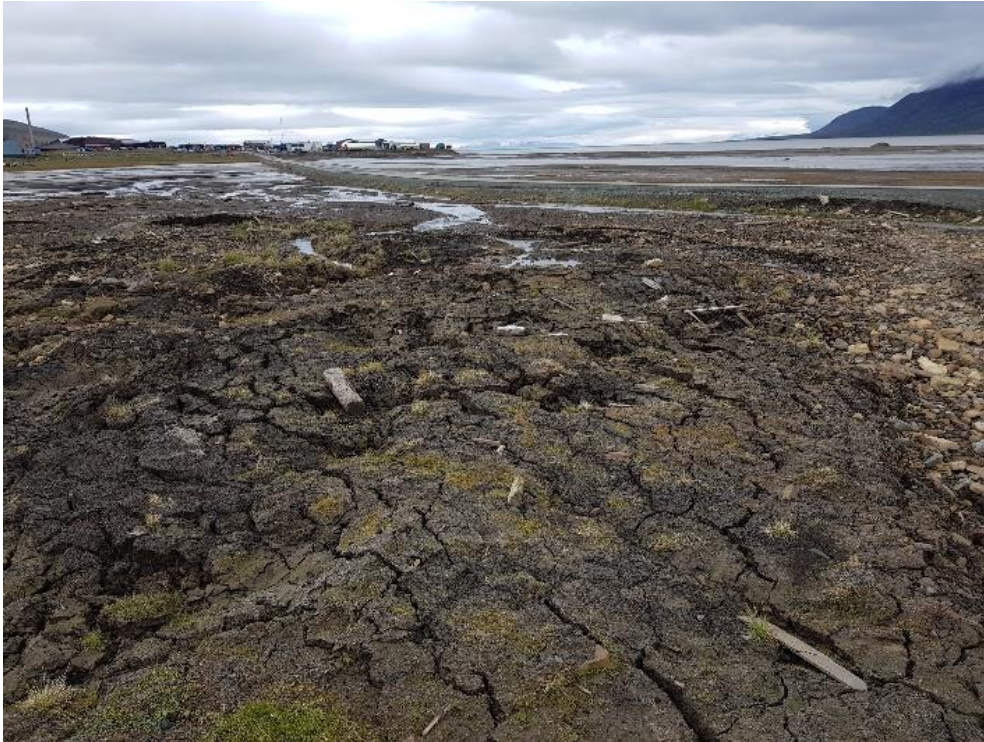
**Figure S1.c-2. Ground surface after disappearance of large icing at Road Nr. 400 and Steintippendalen/Gruvedalen (24.07.2018, location c in Table 1). Photo: © Kjersti Olsen Ingerø/Longyearbyen Lokalstyre.**

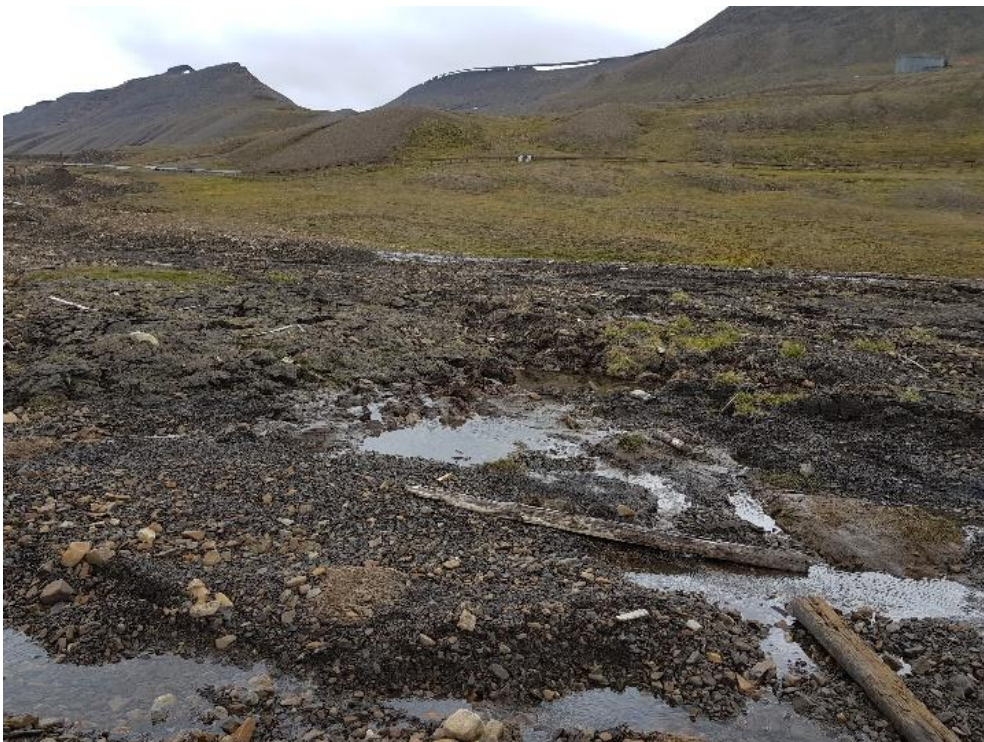
**Figure S1.c-3. Ground surface after disappearance of large icing at Road Nr. 400 and Steintippendalen/Gruvedalen (24.07.2018, location c in Table 1). Photo: © Kjersti Olsen Ingerø/Longyearbyen Lokalstyre.**

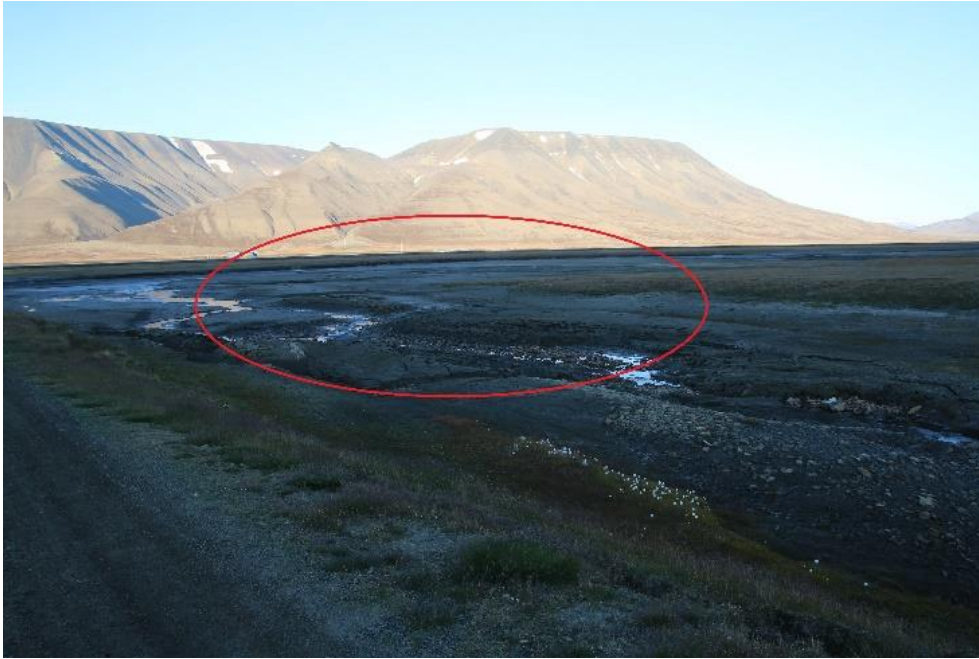
**Figure S1.d-1. Soil surface with the characteristic for icings pattern at sandbanks of lower part of the river of Endalselva (late August 2021, location d in Table S1). Photo: © Anatoly Sinitsyn.**

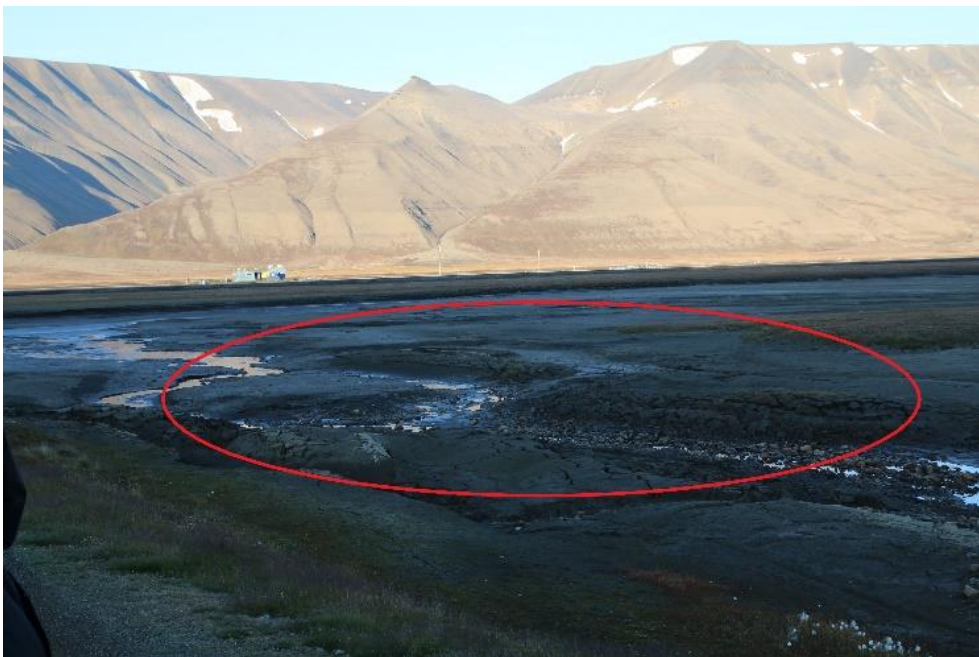
**Figure S1.d-2. Soil surface with the characteristic for icings pattern at sandbanks of lower part of the river of Endalselva (late August 2021, location d in Table S1). Photo: © Anatoly Sinitsyn.**

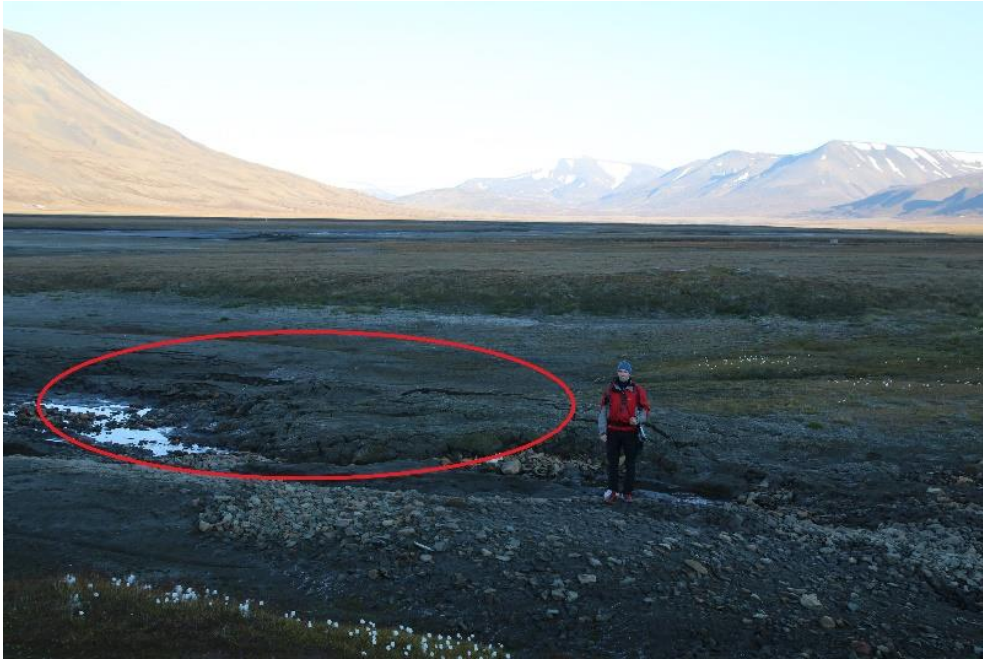
**Figure S1.d-3. Soil surface with the characteristic for icings pattern at sandbanks of lower part of the river of Endalselva (late August 2021, location d in Table S1). Photo: © Anatoly Sinitsyn.**

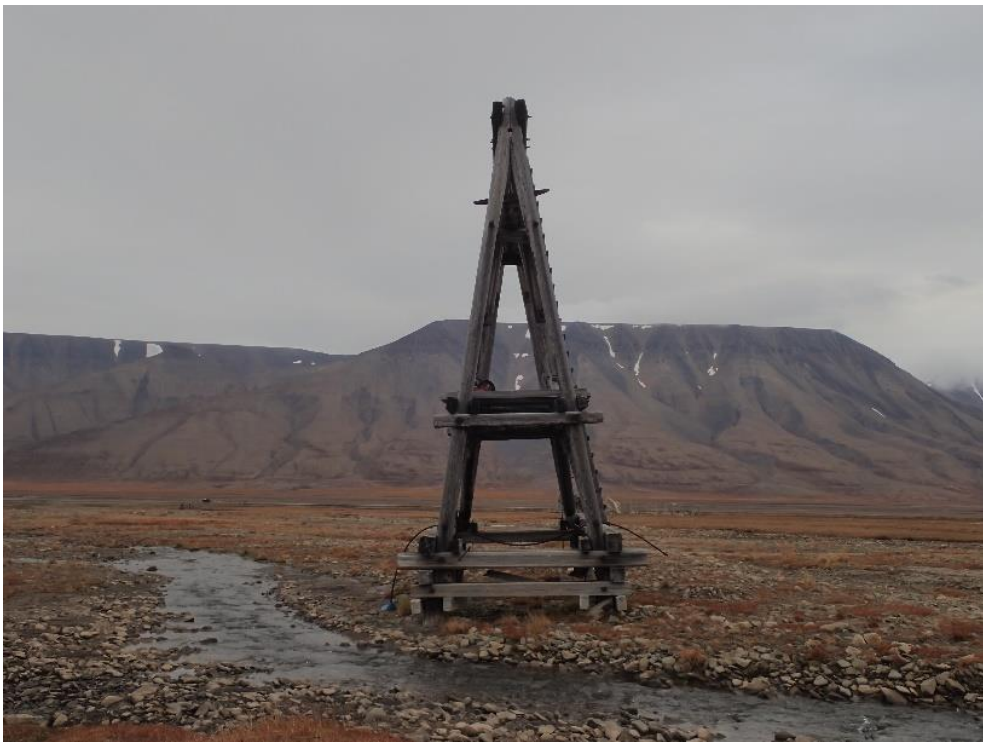
**Figure S1.f. Uneven settlement (tilt to the left) of the cable post Nr. 10 at Line 6 (05.09.2021, location f in Table S1), Adventdalen. It is suggested that the settlement occurred due to stronger degradation of permafrost due to warming effect of small river running next to it. Photo: © Anatoly Sinitsyn/Sintef.**
