# **Observations of suprapermafrost and intrapermafrost groundwater on Svalbard**

## **Summary**

## S1. Observations of suprapermafrost and intrapermafrost groundwater on Svalbard

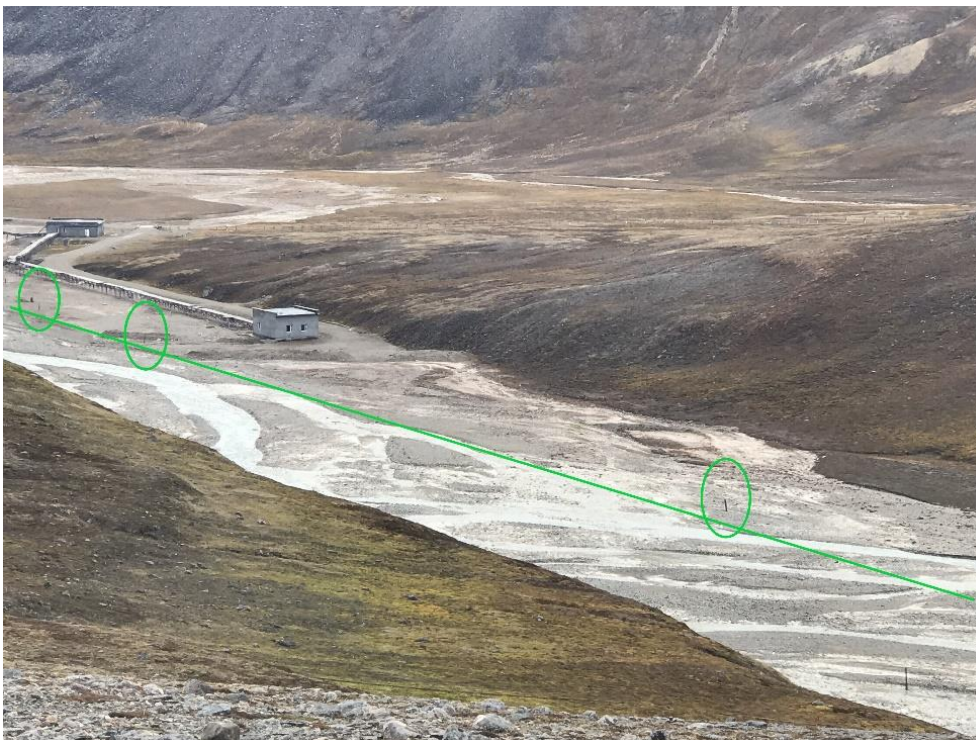
**Figure S1.h-2. Profile "Nr.2" boreholes in the riverbed of Odinelva in Pyramiden (27.08.2021, location h in Table S1). Photo: © Anatoly Sinitsyn.**

<p><b>Observations of abnormally thick active layer under the riverbeds of shallow rivers in Pyramiden</b></p> <p>Observations at Odinelva in Pyramiden has revealed abnormally thick active layer, which most probably cannot refreeze in winter and hence may serve as suprapermafrost aquifer. Utilization of such conditions for the needs of water supply was most probably studied already several decades ago in Pyramiden.</p>	Figure S1.h-1 Figure S1.h-2 Figure S1.h-3 Figure S1.h-4 Figure S1.h-5	Suprapermafrost groundwater of Type II	Figure S1.3, location h	Impressive installations were observed in the riverbed of Odinelva in Pyramiden. Deployment of the installations must have taken part earlier than 1998 when the settlement was abandoned. The installation consists of two profiles (one across and one along the river, see Figure S). Boreholes are equipped with steel casings (ca. 20 cm in diameter), which stick out approximately 1.5 m above the bottom of the river. These installations were "discovered" and observed by the authors in late August 2021. At this time, the water depth in the river was approximately 20-50 cm, but the water depth at the boreholes was approximately 3–4 m (measured with rope and a lead) from the bottom of the river. The bottom of the boreholes felt soft (when ticking on it by the lead attached to a rope). This gave the impression that the active layer at the riverbed is at least 3–4 m deep, which is 2 to 3 times thicker than for almost all (see Table 7.1.1. in (Hanssen-Bauer et al., 2019)) terrain settings on Svalbard. This confirms the pronounced thermal influence of the river on the active layer in its riverbed.

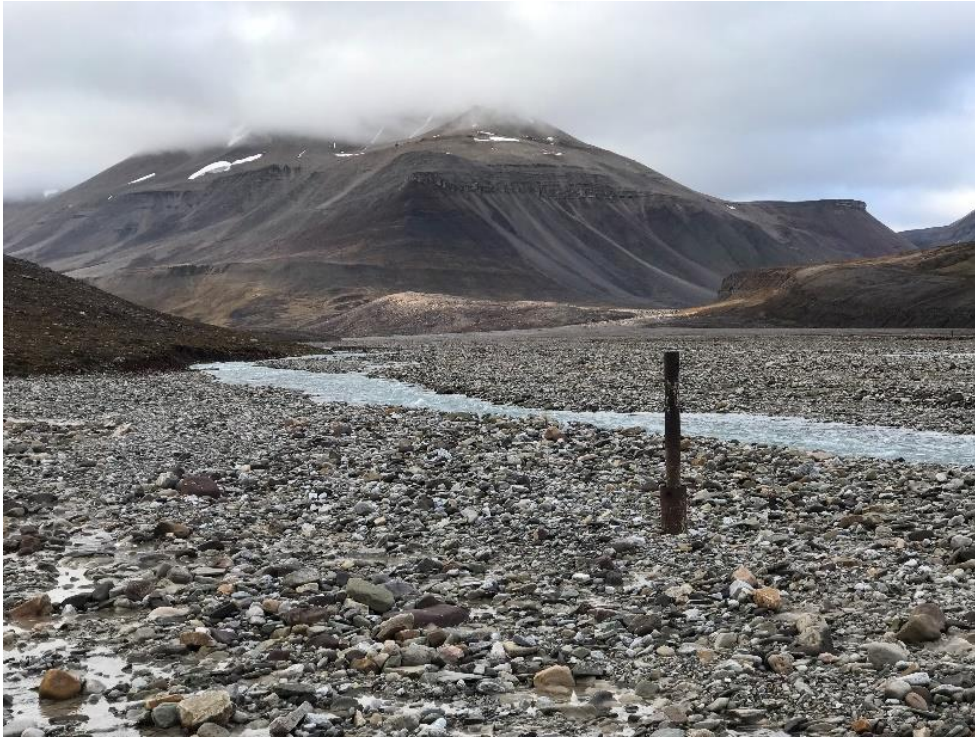
**Figure S1.h-3. First borehole on profile "Nr.1" in the riverbed of Odinelva in Pyramiden (27.08.2021, location h in Table S1). Photo: © Anatoly Sinitsyn.**

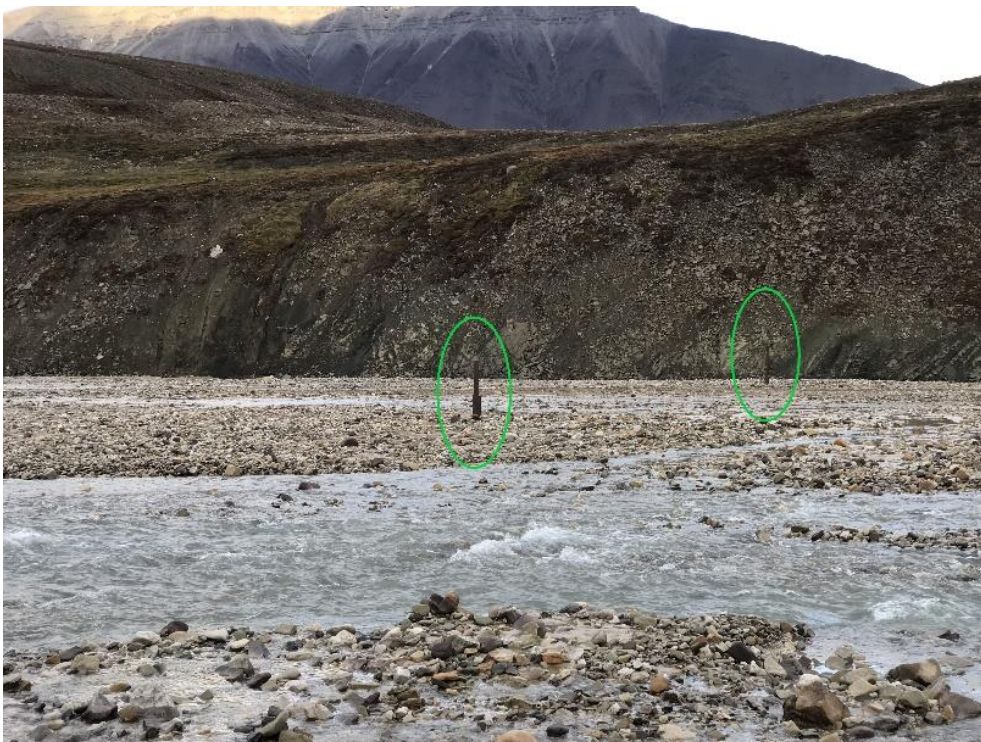
**Figure S1.h-4. Other two boreholes at profile "Nr.1" in the riverbed of Odinelva in Pyramiden (2021, location h in Table S1). Photo: © Anatoly Sinitsyn.**

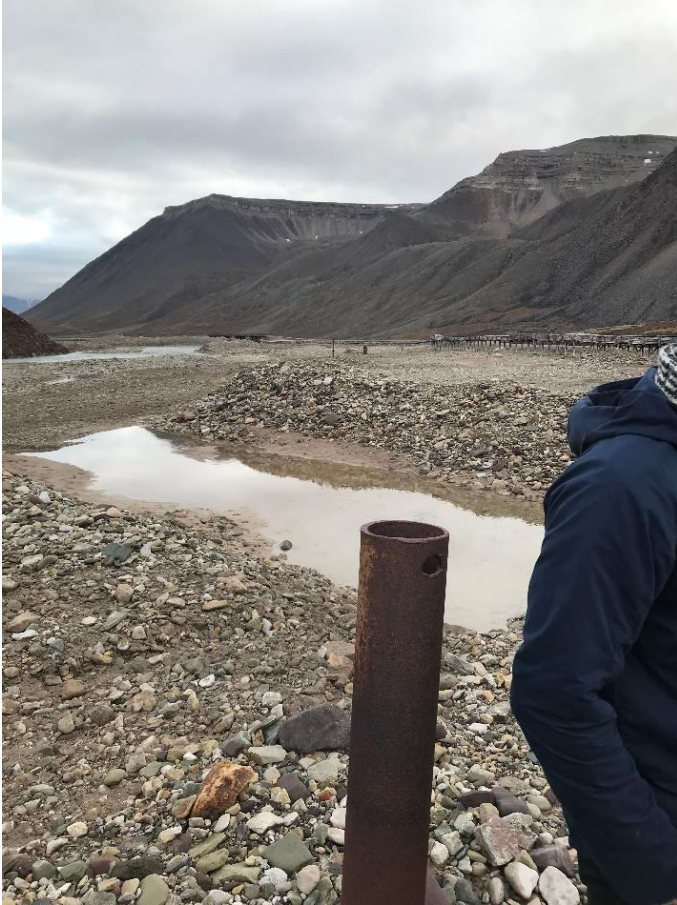
**Figure S1.h-5. Boreholes in the riverbed of Odinelva in Pyramiden (27.08.2021, location h in Table S1). Photo: © Anatoly Sinitsyn.**

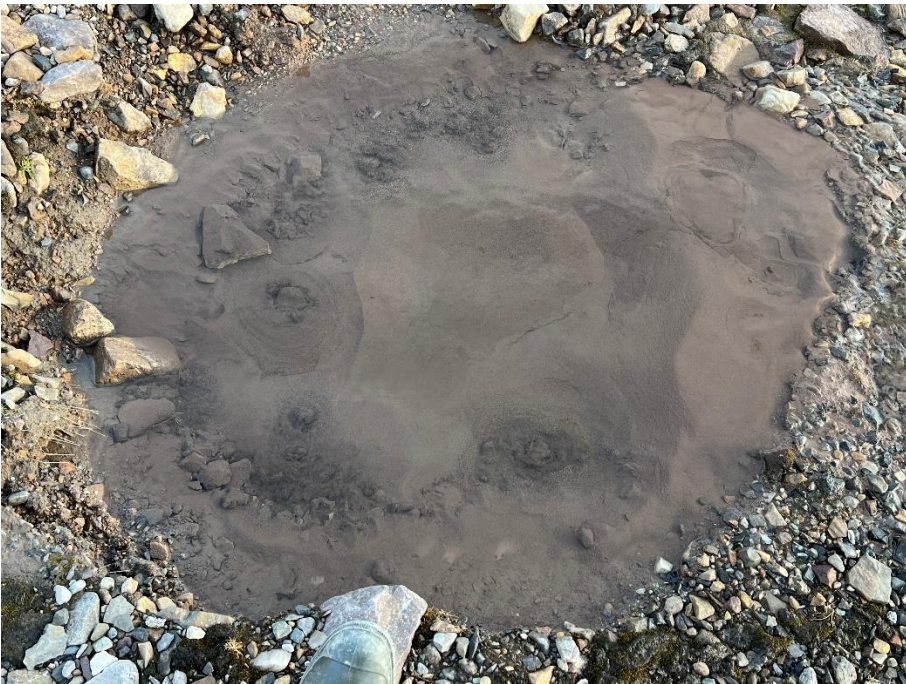
**Figure S1.j. Snapshot from the Video S1.j (Sinitsyn, 2023a). Spring at the foot of the Hovtinden mountain (10.09.2022, location j in Table S1). Video: © Anatoly Sinitsyn.**

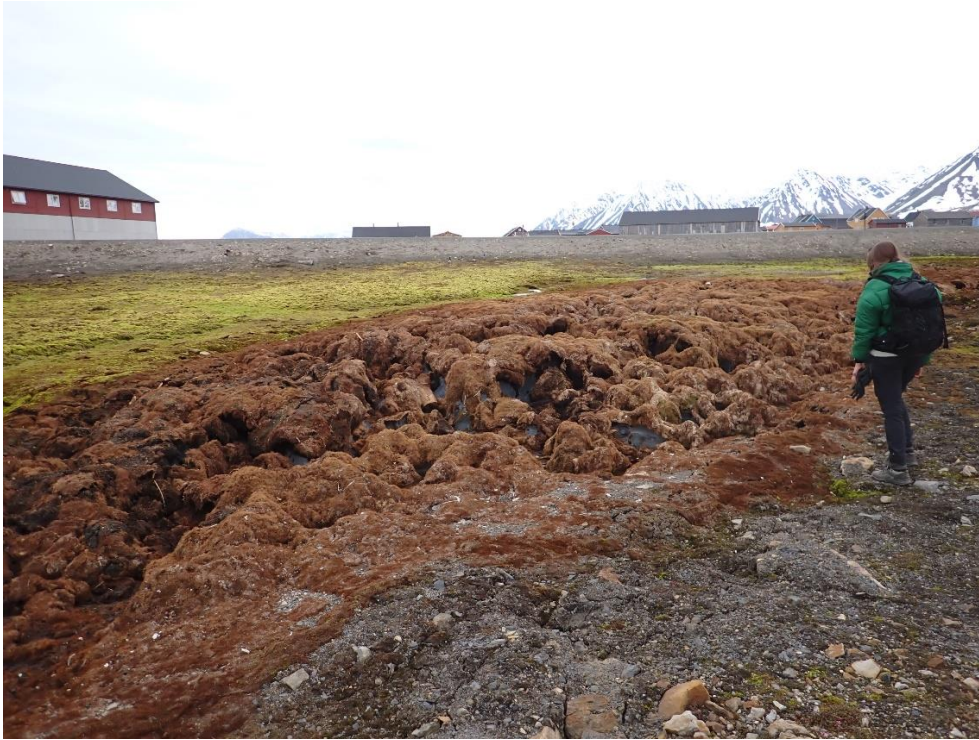
**Figure S1.k-1. Remains of a large icing, north-western part of Ny-Ålesund (26.06.2023, location k in Table S1). Photo: © Anatoly Sinitsyn/Sintef.**

<p><b>Observations of icings in Ny-Ålesund</b></p>	Figure S1.k-1 Figure S1.k-2 Figure S1.k-3	Intrapermafrost groundwater	Figure S1.4, location k  Approximate coordinates: 33X E433980	Remains of a large (at least 10 by 30 m) icing were observed in north-western part of Ny-Ålesund in late June 2023.

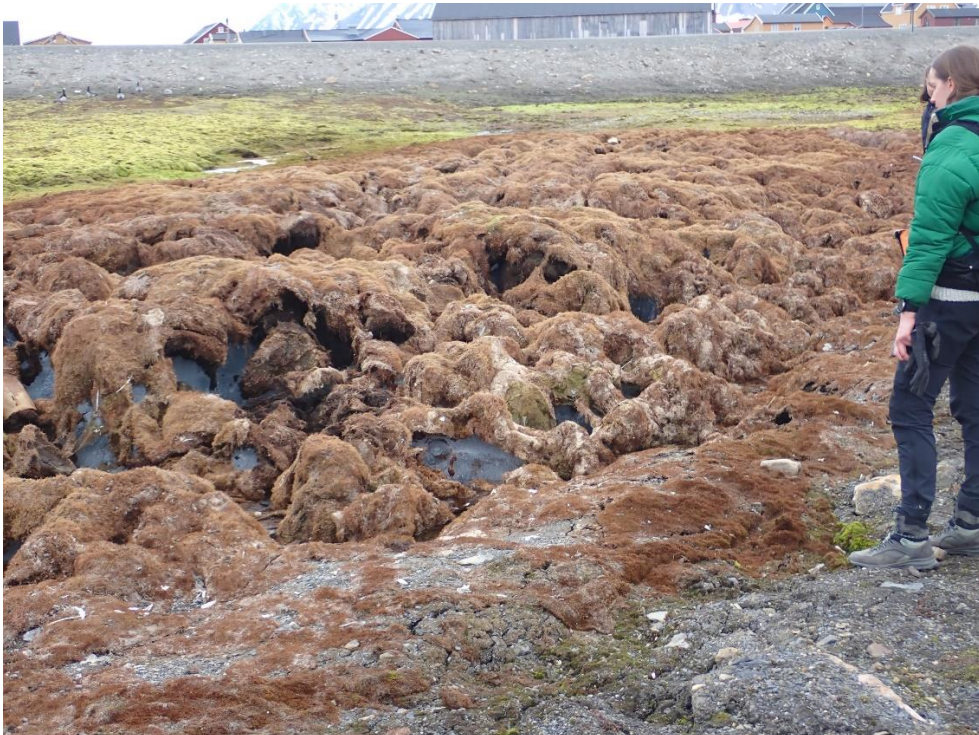
**Figure S1.k-2. Remains of a large icing, north-western part of Ny-Ålesund (26.06.2023, location k in Table 1). Photo: © Anatoly Sinitsyn/Sintef.**

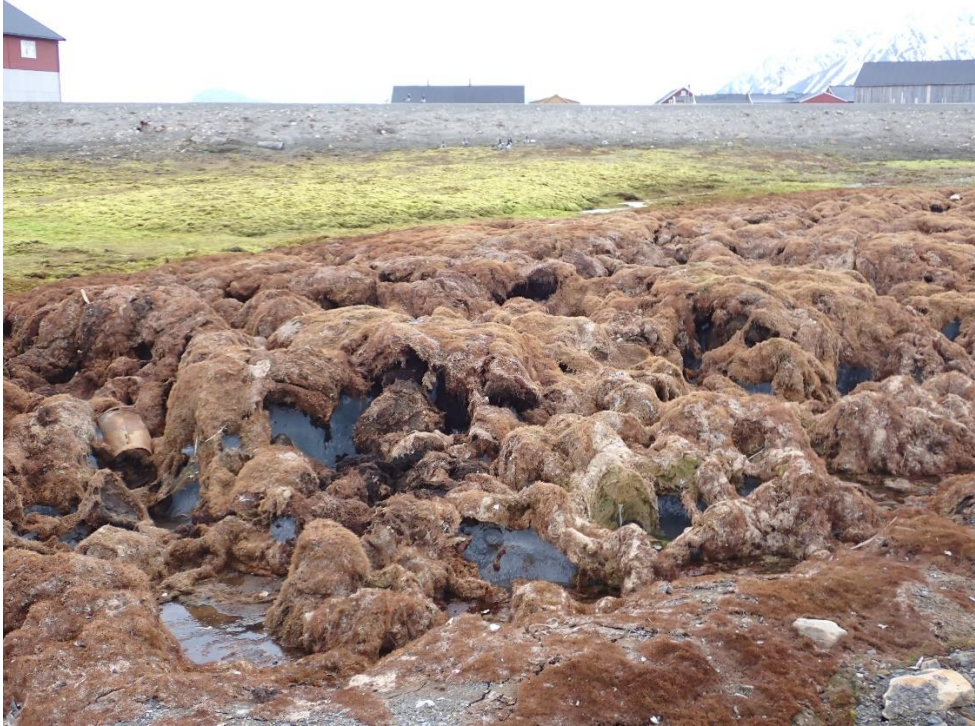
**Figure S1.k-3. Remains of a large icing, north-western part of Ny-Ålesund (26.06.2023, location k in Table S1). Photo: © Anatoly Sinitsyn/Sintef.**

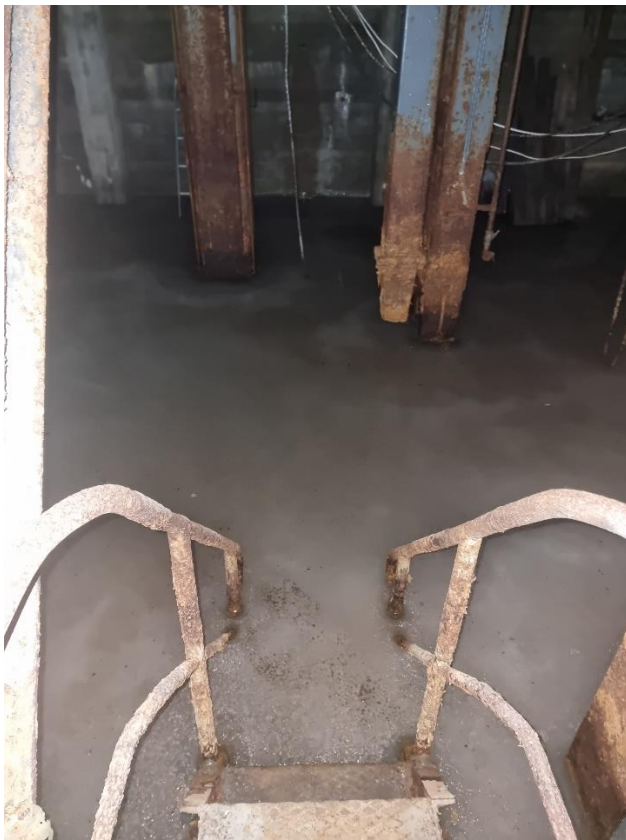
**Figure S1.l. Stairs and ground floor at Gamle kraftstasjonen (The Old Power Plant) in Ny-Ålesund, which is permanently filled with ice (12.07.2023, location l in Table S1). Photo: © Ingrid Rekkavik/Kings Bay AS.**

Figure S1.i	Suprapermafrost intrapermafrost groundwater	or	N8763490 Figure S1.4, location l	The ground floors at Gamle kraftstasjonen (The Old Power Plant) are permanently filled with ice, that points out at the presence of suprapermafrost or/and intrapermafrost groundwater (12.07.2023).
<b>Direct observations of deep thawed zones in Ny-Ålesund</b>  Drilling works in Ny-Ålesund has revealed thaw soil below the depth of active layer.	–	Intrapermafrost groundwater		Figure S1.4, location i	In Ny-Ålesund, groundwater was observed at approximately 10 m depth when replacing foundations at the eastern part of Veksthuset building (location i-1) and Vaskerilabben (location i-2) (January–February 2018); and at Kunstnerhytta (December 2021) (Sinitsyn, 2022c; Sinitsyn et al., 2022).
<b>Direct observations at the Hovtinden mountain</b>  <b>Springs were observed at the foot of Hovtinden mountain in September 2022.</b>	Figure S1.j  Video S1.j (Sinitsyn, 2023a)	Suprapermafrost intrapermafrost groundwater	or	Coordinates: 78.28416 N 13.76040 E	Springs at the Hovtinden mountain were observed in early September 2022, which point out on significantly lengthier period of drainage there compared to the springs at Huset (case a14). Groundwater from such springs contributes to inflow in the Lovénvaknet lake. One may suggest characterizing this groundwater as suprapermafrost or intrapermafrost groundwater.
