Compression and hydrothermal ageing after impact of carbon fibre reinforced epoxy laminates

ABSTRACT

This paper proposes a new methodology for the assessment of seawater ageing effects on impact-damaged composite laminates. CF/Epoxy laminates which were unimpacted, and impacted at 30 J, 60 J, and 90 J by hemispherical and conical impactors were subject to 4 months hydrothermal ageing in renewed natural seawater at 60 \pm 2 °C. The majority of water uptake by impacted laminates (0.05 wt% – 0.3 wt%) occurred in the first 24 h and is believed to be held in damage cavities by capillary mechanisms. The increase in diffusive water uptake rate by the matrix due to impact damage was only small, at less than 0.008 wt%.mm.hr^{-0.5}, compared with the total diffusive water uptake rate of 0.1 wt%.mm.hr^{-0.5}. Hydrothermal ageing reduced the residual compressive strength of pristine laminates by 25 % and impact-damaged laminates by 8 % to 16 % for impacts between 30 J and 90 J.

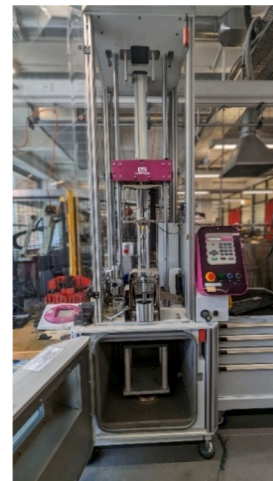
Fig. 2. (A) 16 mm diameter hemispherical impactor, (B) 12.7 mm diameter conical impactor and (C) Instron CEAST9350 drop weight impact tower.

A drop weight impact system (CEAST9350) from Instron (Fig. 2c) with a drop weight of 15.392 kg was used to conduct low velocity impacts at UNSW, Sydney, Australia. The mass was dropped from different heights to give impact velocities of 1.96 m.s⁻¹, 2.78 m.s⁻¹, and 3.41 m.s⁻¹ corresponding to impact energies of 30 J, 60 J and 90 J respectively. The energy range was selected to generate a range of damage scenarios between BVID and the most severe damage without perforation. The hemispherical and conical tips shown in Fig. 2a and Fig. 2b had tip diameters of 16 mm and 12.7 mm respectively and were used to compare the effect of sharp and blunt impactor damage on ageing and residual strength. Coupons were impacted centrally and in the same orientation as they were infused. Force-time data was recorded during impacts and double-integrated to determine the impactor displacement and energy absorption during the impacts. Peak force, peak displacement, peak energy absorption, contact duration and the energy permanently absorbed by the laminate were calculated.

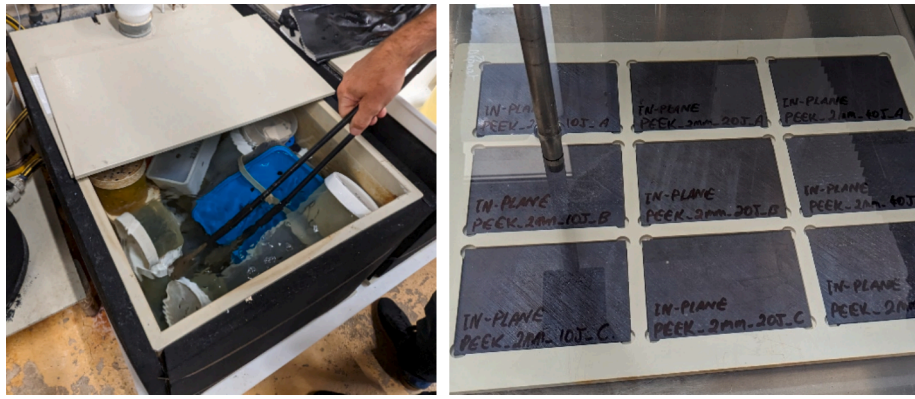
Fig. 3. (a) Hydrothermal seawater ageing tank showing specimen removal for weighing and (b) Ultrasonic C-scanning setup showing vertical probe with transducer.

Ultrasonic C-scanning was employed to compare internal projected damage areas of the impacted coupons. The scanning setup is pictured in Fig. 3b. Coupons were scanned nine at a time in the submerged polymer frame which rested on the stainless-steel backing plate. The scanner was controlled by an electronic control system which moved the 5 MHz probe in a raster scan motion across the coupons and recorded positional information. The ultrasonic data was acquired by the Sonatest Prisma™

Seawater ageing was conducted at IFREMER, Brest, France over a period of 4 months in a hydrothermal ageing tank (Fig. 3b) which was filled with natural, renewed seawater and heated to 60 °C to accelerate the ageing rate. The coupons were exposed to the water on all 6 sides to maintain consistency with similar ageing experiments by Robin {Robin, 2023 #196}. A temperature of 60 °C (±2°C) was selected as the maximum ageing temperature to avoid chemical changes associated with the glass-transition temperature of 75 °C. A selection of coupons, marked “B”, were removed from the tank periodically (approximately every seven days) to be weighed. Excess water was drained from the coupons before they were ‘patted’ dry on each side and all edges using paper towel. Each coupon was then tapped on the bench again on each edge to shake out water from the surface and again patted dry with paper towel. Weight measurements were then taken using a scale with 0.1 mg accuracy before the coupons were returned to the ageing tank.

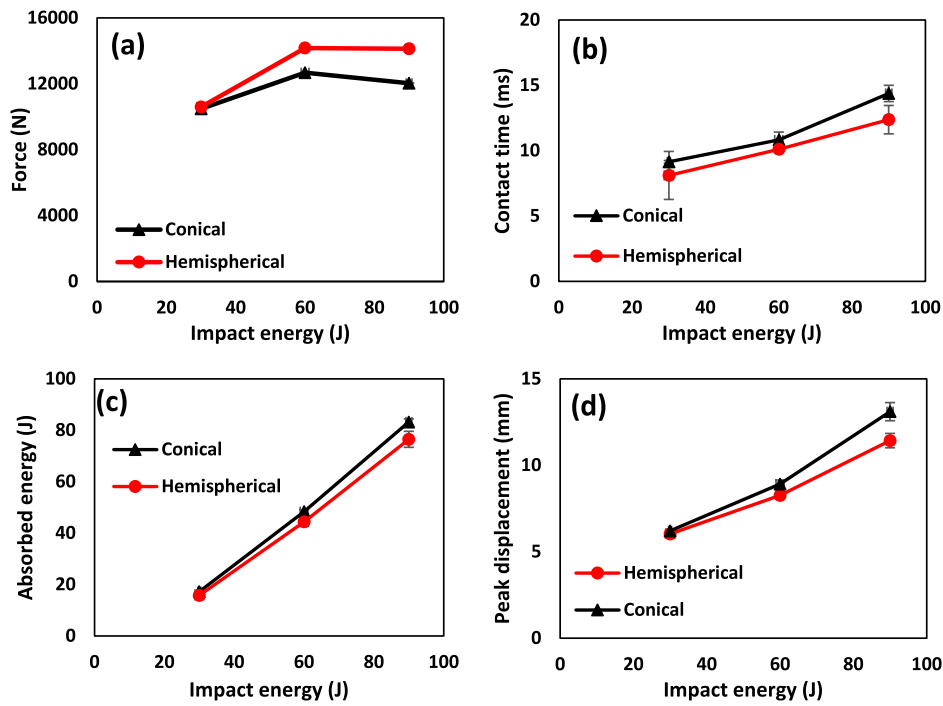
Fig. 4. Impact results for 30 J, 60 J, and 90 J impacts by hemispherical and conical impactors showing (a) peak force, (b) contact time, (c) absorbed energy, and (d) peak displacement.

Key impact response characteristics are plotted in Fig. 4 including peak impact force, contact time, absorbed energy and peak impactor displacement for each of the impacts by hemispherical and conical

data (Fig. 17, Fig. 18, Fig. 19, and Fig. 20). Absorbed energy increased almost linearly with impact energy for both impactor types (Fig. 4c). Contact time (Fig. 4b) and peak displacements (Fig. 4d) revealed similar trends. Increased energy absorption, plate deflection and impact durations are related to stiffness degradation and damage. Accordingly, projected damage areas were seen to increase from 2290 mm² at 30 J to 4770 mm² at 60 J and 6820 mm² at 90 J, increases of around 200 % and 300 % respectively (Fig. 6a).

Conical impacts did not exhibit an entirely linear increase in impact duration and plate deflection with impact energy as stiffness degradation increased at a greater rate beyond 60 J. This is reflected in the decreased peak load (Fig. 4a) for 90 J conical impacts and projected damage areas which increased to, and plateaued beyond, 60 J, as illustrated in Fig. 6a. This is likely due to the damage approaching a delamination area limit around 60 J (Fig. 5a) and a transition to through-thickness damage penetration and back-face tow debonding. Visible matrix cracking was greater than for 90 J hemispherical impacts as illustrated in Fig. 6b and c though microscopy is required to determine the true extent of internal intralaminar damage. Compared to hemispherical impactors, conical impactors also generated deeper indentations, particularly at higher impact energies. Absorbed energies for conical impacts did not depart significantly from the hemispherical impact values as the decrease in energy absorption due to reduced delamination was countered by increased intralaminar damage due to penetration.

Peak force also increased with impact energy until extensive damage occurred beyond 60 J where the load carrying ability of laminates plateaued following hemispherical impacts and decreased following conical impacts. The plateau is believed to be due to delaminations reaching the edge of the coupons as seen in Fig. 5b. The decrease between 60 J and 90 J for conical impacts is attributed to increased penetration, fibre breakage (Fig. 7c and d) and back-face tow debonding (Fig. 7a and b). Peak force appears to show the greatest sensitivity to the changes in damage mode which result from changes in impactor and incident energy. Projected damage areas revealed low sensitivity to impactor tip geometry at 30 J and 60 J. However, more severe, 90 J impacts revealed 28 % larger damage areas (Fig. 6a) due to greater load transfer enabled by the hemispherical impactor.

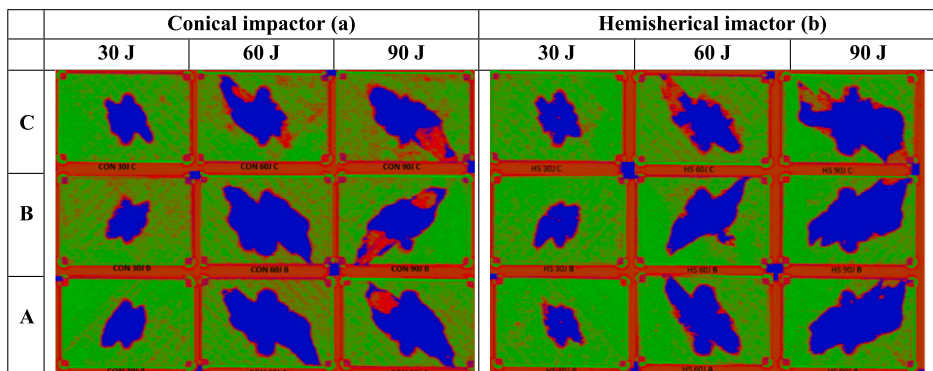
Fig. 5. Ultrasonic scan images of CF/Epoxy coupons impacted by conical impactors (a) and hemispherical impactors (b) at 30 J, 60 J and 90 J.

impacts at the three energy levels. Raw force–time data for the impacts are not provided as the present study is focussed on ageing and residual strength and not the impacts themselves. Ultrasonic C-scan images of a

sample of coupons covering the full range of impact scenarios are given in Fig. 5. The remainder of the C-scans, of an otherwise identical set of coupons subject the same impact scenarios, are given in [supplementary](#)

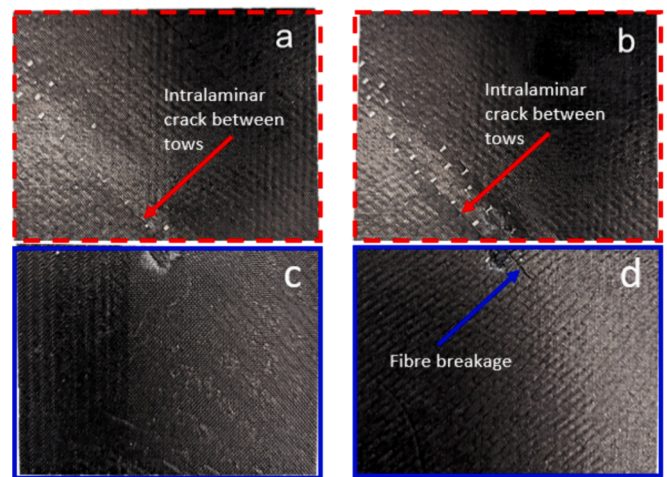
Fig. 7. Back-face impact damage due to 60 J (a) and 90 J (b) impacts by a conical impactor showing greater back-face tow debonding and intralaminar damage at 90 J, and impact-face images of laminates impacted at 60 J (c) and 90 J (d) by the conical impactor. Blue arrow indicates fibre breakage.

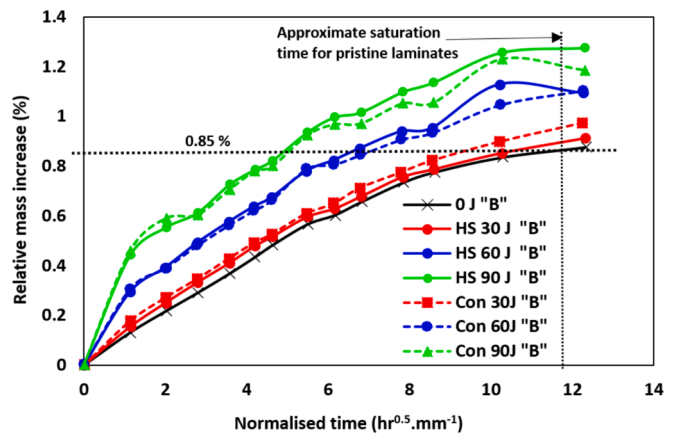
Fig. 8. Percentage mass increase via water uptake during hydrothermal ageing at 60 °C of CF/Epoxy coupons impacted by a conical (Con) impactor and a hemispherical (HS) impactor.

may be assumed that the otherwise identical, impacted coupons were also fully saturated. Saturation occurred after almost 4 months submersion at 60 °C. Mass increases (Fig. 8) beyond this time are likely the

3.2.2.1. Cavity filling versus diffusion in damaged laminates. Comparing water uptake rates in Fig. 8, it is clear that more severe impact damage led to much faster initial rates of water uptake during the first 24 h ($0.0\text{--}1.2 \text{ hr}^{0.5} \cdot \text{mm}^{-1}$) of immersion. This is likely due to water ingress into small impact damage-induced cavities such as delaminations and intralaminar matrix cracks via cracks on the coupon front and back-face. This also includes uptake via the coupon edges in coupons with impact damage extending to the edges. It is expected that these coupons will see accelerated water uptake rates due to the additional fluid entry points but the total water uptake would be similar in both cases where the total damage areas are similar. Filling of these cavities relies on capillary action which is much faster than diffusion and therefore contributes far more significantly to water uptake in the first 24 h. This assumption helps explain the large initial mass increase in a short of time observed in damaged, but not undamaged laminates. Following the initial 24 h, the water uptake rates of the damaged specimens reduce to rates similar to that in the unimpacted laminate, for approximately the next 600-hour period. This suggests that, in the first 24 h, water uptake is dominated by capillary mechanisms, and, after the first 4 h, water uptake is dominated by diffusion.

This involves separating the water uptake due to capillary mechanisms from diffusive mechanisms by assuming a linear diffusion rate from the initial submersion time as observed in unimpacted laminates in Fig. 8. The diffusion-only water uptake rate (24–600 hrs in Fig. 10) is extended toward to the Y-axis, the initial submersion time. Y-intercept values, presented in Fig. 13, estimate the cavity water uptake as a

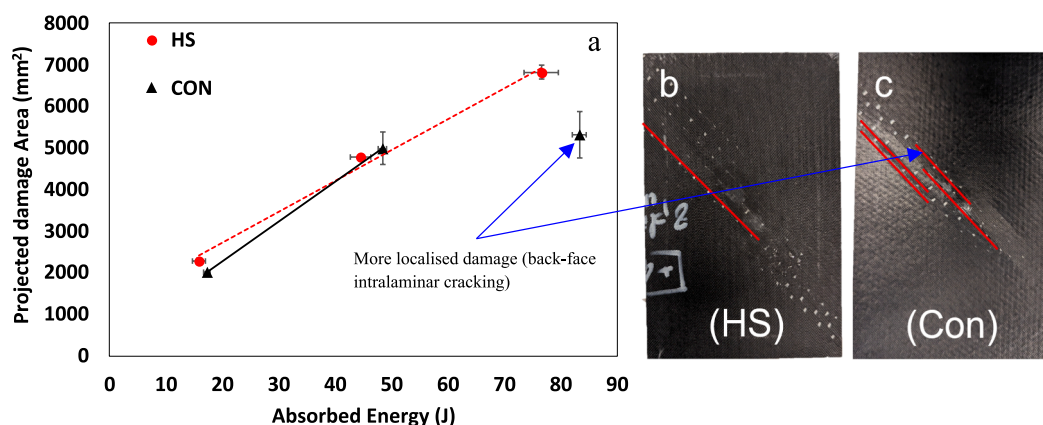
Fig. 6. (a) plot of the change in projected damage areas with impact energy and images showing back-face tow de-bonding on hemispherical (b) and conical (c) impacted coupons. Cracks between tows are delineated with red lines.

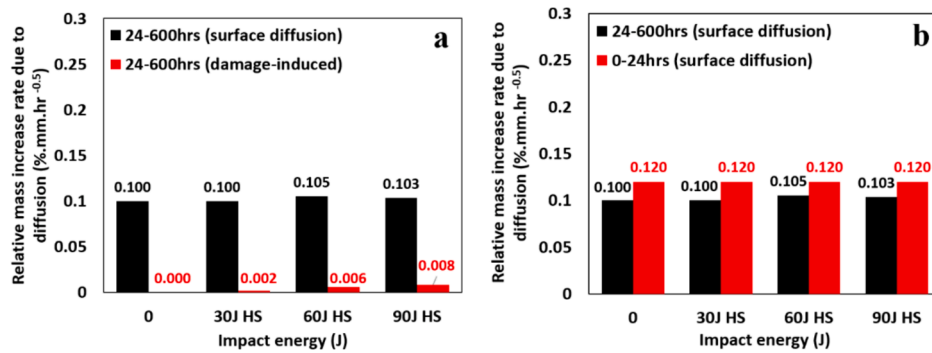
Fig. 11. The relative mass increase rates due to (a) surface (black) and damage-induced (red) diffusion in the 24–600 hr period and (b) surface diffusion alone (excluding effects of damage) for the first 24 hrs (red) and 24–600 hr period (black). Results are only shown for hemispherical impactors as conical impact results were similar.

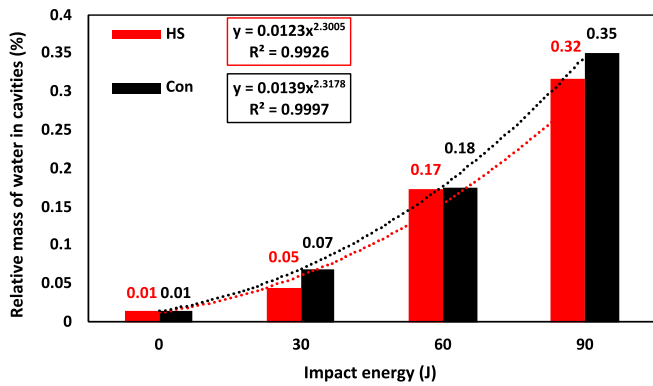
Fig. 13. Estimated relative mass gain (%) due to cavity-filling calculated from the y-intercept of trendlines parallel to the predicted diffusion-only linear region (24-600hrs) in Fig. 10.

percentage of laminate mass. A small amount of cavity water uptake shown for the unimpacted laminate may be the result of filling of air pockets which are exposed during cutting of the laminate. As expected, increased impact damage resulted in increased water uptake in cavities. The slightly greater uptake at conical impact sites may be the result of more exposed reinforcing fibres and fibre-matrix interfaces capable of capillary action. The rate at which the relative water uptake increases with impact energy is non-linear for the impact energy range tested. Curves have been fitted to hemispherical and conical impacted laminate results with reasonable correlation and could be used to predict the mass gain at the impact site for similar impacts in the given energy range. For consistency between laminates, the results are given in relative mass gain for specimens of approximately 100 g, however, a more useful formulation may be absolute mass gain, which is given in Table 3.

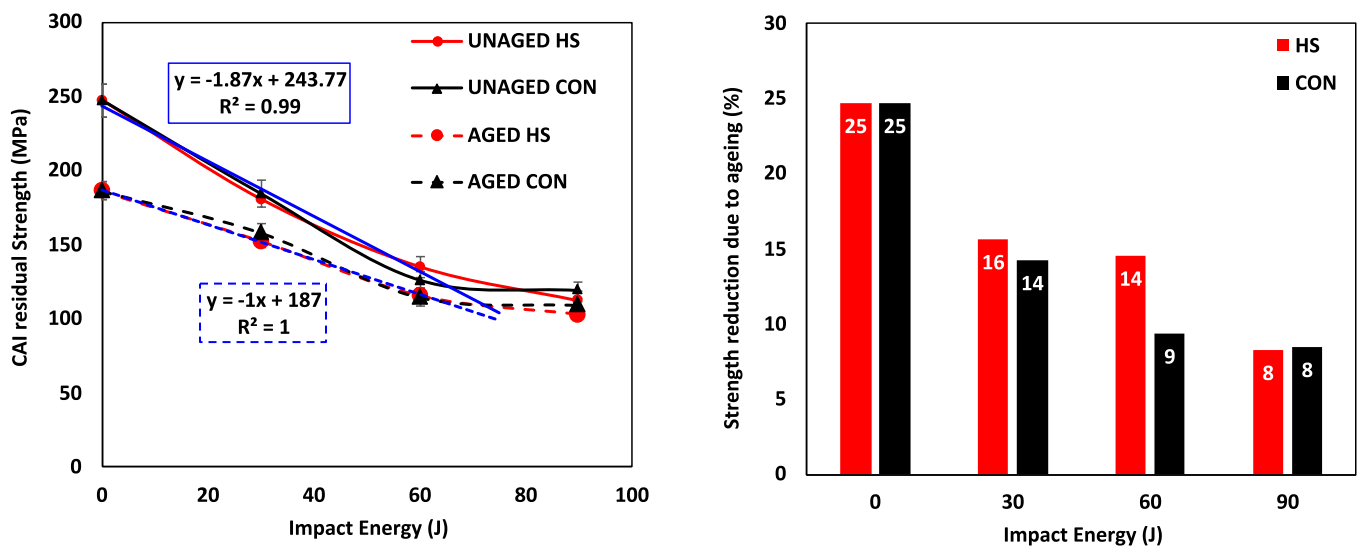
Fig. 14. (a) Change in CAI strength with impact energy for aged and unaged laminates impacted by hemispherical (HS) and conical (CON) impactors, and (b) residual strength reduction (%) due to ageing (difference between the CAI strength of aged and unaged coupons).

All of the impact-damaged coupons loaded in uniaxial compression failed via lateral cracking through the damage site in the middle of the specimen (LDM) failure while all the unimpacted coupons failed via lateral cracking near the top edge (LAT) [35]. The effects of impactor tip geometry, impact energy level and ageing on average residual

compressive strengths are illustrated in Fig. 14a. Residual strength reduced with increased impact energy but showed almost no dependency on impactor geometry. The maximum difference in residual strengths attributable to the impactor tip shape alone was a 7 % reduction from hemispherical to conical impactor damage at 60 J.

Illustrated in the column graph in Fig. 14b is a 25 % reduction in the CAI strength of unimpacted CF/Epoxy laminates when hydrothermally aged for 4 months at 60 °C. This reduced to 8 % when impacted at 90 J by either impactor tip demonstrating the predominance of the effect of severe impact damage over ageing degradation and impactor geometry on residual strength. CAI strength reduced linearly from 0 J (no impact) to 30 J and 60 J impacts in both aged and unaged laminates. The reduction rate was approximately 1.9 MPa.J⁻¹ for unaged laminates and 1.2 MPa.J⁻¹ for aged laminates (Fig. 14a). As 90 J impacts experienced a change in damage modes, the resulting residual strength was similar to that of 60 J impacts for both aged and unaged laminates.
