Small reservoirs, landscape changes and water quality in Sub-Saharan West Africa

Cecchi P., et al.

SUPPLEMENTARY MATERIALS

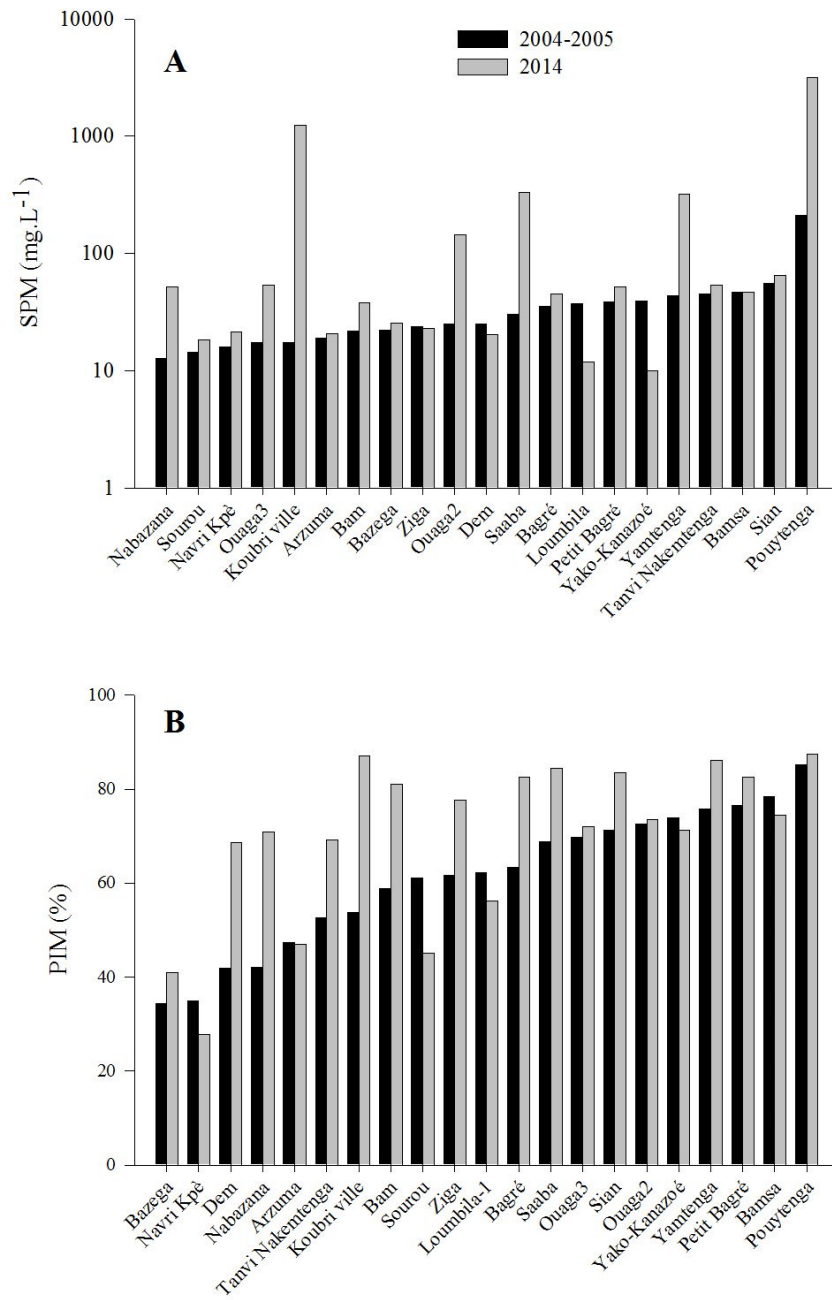
Figure S1. Bar charts of SPM values (A; mg.L⁻¹) and PIM values (B; %) in 2004/5 and in 2014, for the 21 SRs that have been sampled at the two periods.

Figure S1. Bar charts of SPM values (A; mg.L-1) and PIM values (B; %) in 2004/5 and in 2014, for the 21 SRs that have been sampled at the two periods.
