Influence of Embedded Gap and Overlap Fiber Placement Defects on Interlaminar Properties of High Performance Composites

Citation: Cartié, D.; Lan, M.; Davies, P.; Baley, C. Influence of Embedded Gap and Overlap Fiber Placement Defects on Interlaminar Properties of High Performance Composites. *Materials* **2021**, *14*, 5332. <https://doi.org/10.3390/ma14185332>

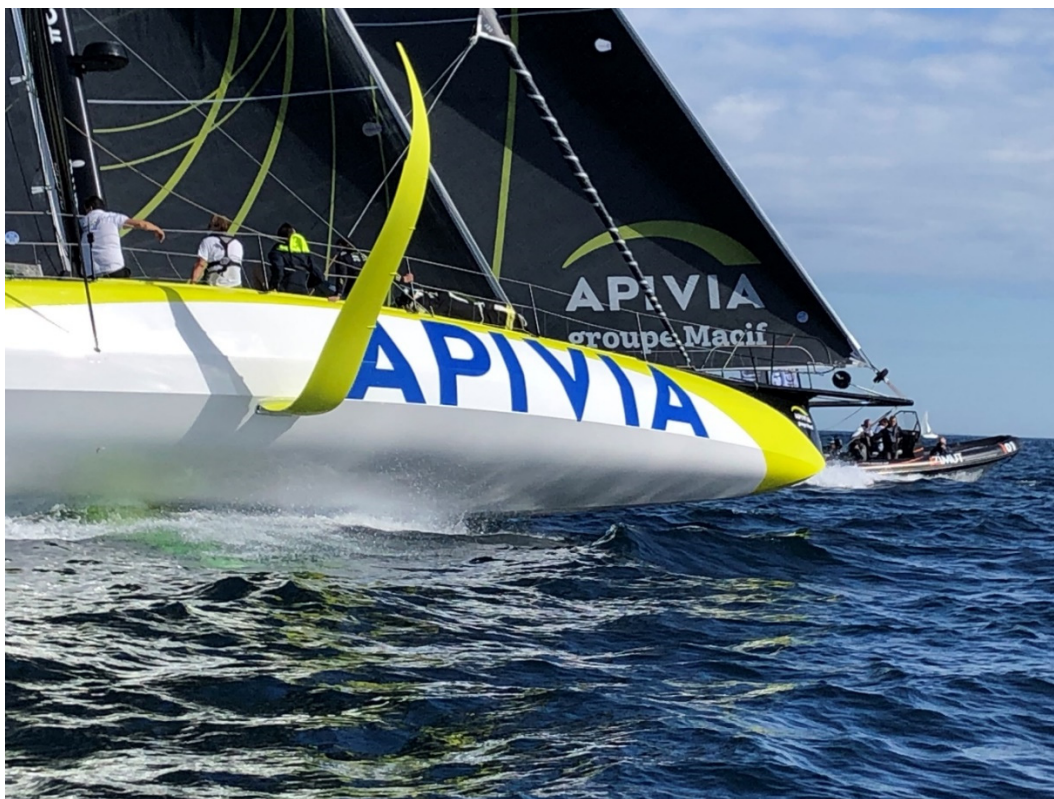
Figure 1. Photograph of IMOCA class APIVIA racing boat, the hydrofoils are manufactured using AFP technology: Photo C. Baley.

The use of automated fiber placement (AFP) is increasing, as it offers the possibility to produce very complex shapes with tight process control [1]. Initially developed for high performance aerospace applications, the capability for efficient manufacture of complex structures can also be applied to marine components such as hydrofoils [2], propellers [3], and tidal turbine blades [4]. These structures tend to be thicker than aerospace composites, so through-thickness properties are more critical. Figure 1 shows an example of a foil manufactured by AFP on an ocean racing yacht.

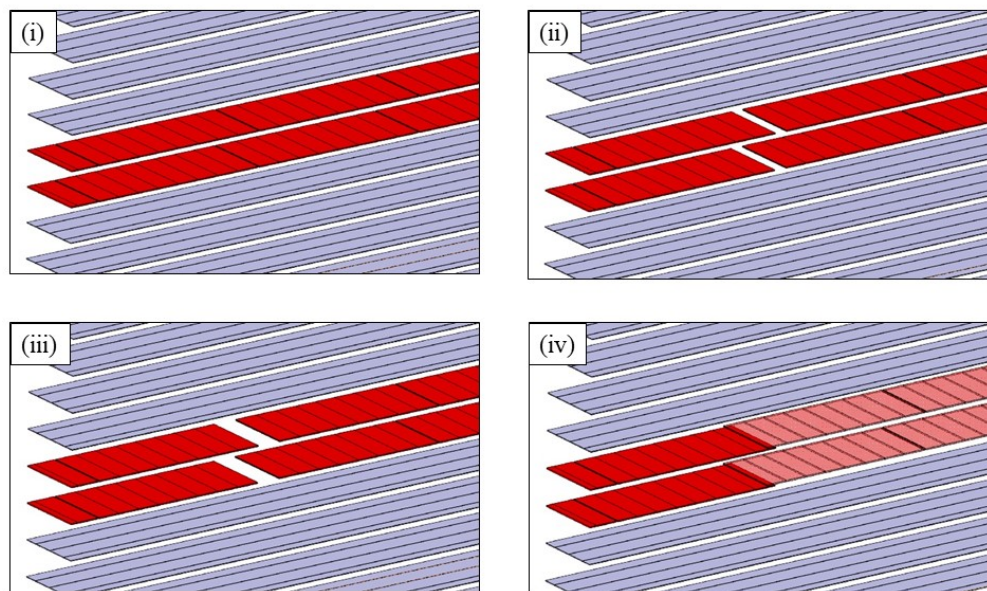
Figure 2. Specimens layups $[90^\circ/0^\circ_7/90^\circ_2/0^\circ_7/90^\circ]$ showing embedded defects in the centre plies of the laminate. Plies oriented at 0° are shown in grey and plies oriented at 90° are shown in red. (i) Gap 0.5 mm; (ii) Gap 3.175 mm, (iii) Gap 6.35 mm, (iv) Overlap 3.175 mm.

Figure 2 shows schematically the defect positions in the two central 90° plies.

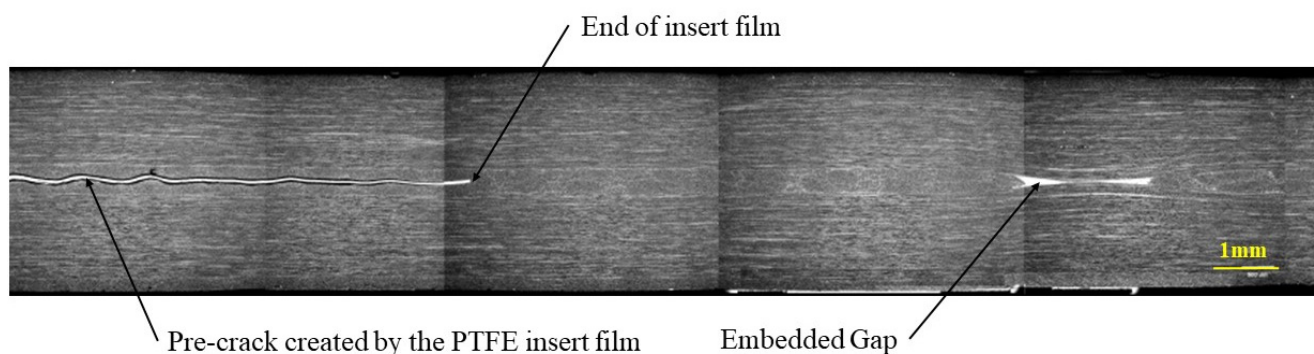
Figure 3. Microstructural SEM observation of a specimen containing embedded defect used for delamination tests—Gap 6.35 mm with caul plate.

To check for voids and to verify the position and the morphology of the embedded defects, cross sections were observed with a Jeol JSM 6460 LV scanning electron microscope. To produce flat sections, the samples were polished with diamond paste down to 1 micron before examination. Several images were taken and then assembled, to produce the figures of defect regions shown in this paper. Figure 3 shows a section through the thickness of a specimen, illustrating the film insert and a 6.35 mm gap. The pre-crack created by the PTFE film is clearly visible on the left-hand side of the micro-graph. It can be noted that the defect initially created by a 6.35 mm gap has healed during cure. The resin and the 90° fibres have flowed into the gap reducing the defect size to about 2 mm.

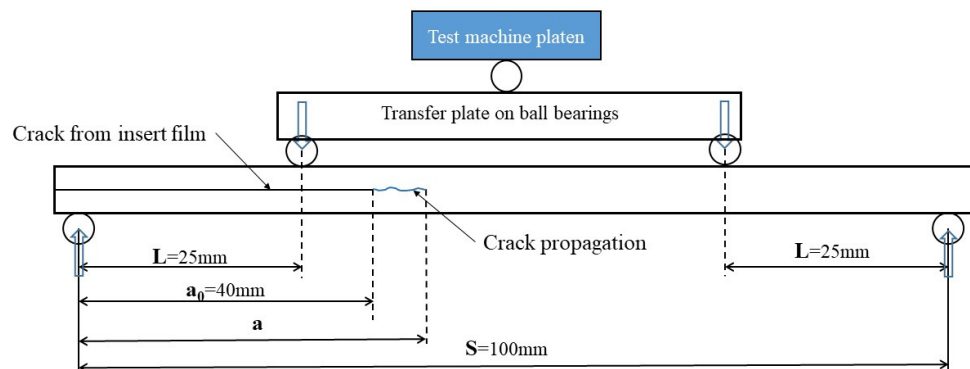
Figure 4. Mode II 4-ENF specimen configuration.

For Mode II delamination tests a 4ENF (Four Point End Notched Flexure) geometry [31] was used to propagate mid-plane cracks under the effect of a shear stress introduced in 4-point bending. This is one of a number of in-plane shear delamination tests available [32] and has the advantage of encouraging the stable crack propagation required here. Figure 4 illustrates the 4ENF specimen configuration. For this test, the distance between the upper loading points was 50 mm and the distance between the lower supports was 100 mm. A roller bearing was positioned so that the upper load points rotate about the specimen mid-length.

During the linear loading phase of the test prior to any crack propagation, the initial crack length a_0 is known (See Figure 4). The compliance $C = \delta/P$ is determined from the slope of the force vs. displacement curve during the linear loading, allowing EI to be determined for each specimen. Then G_{IIcApp} can be determined from Equation (4).

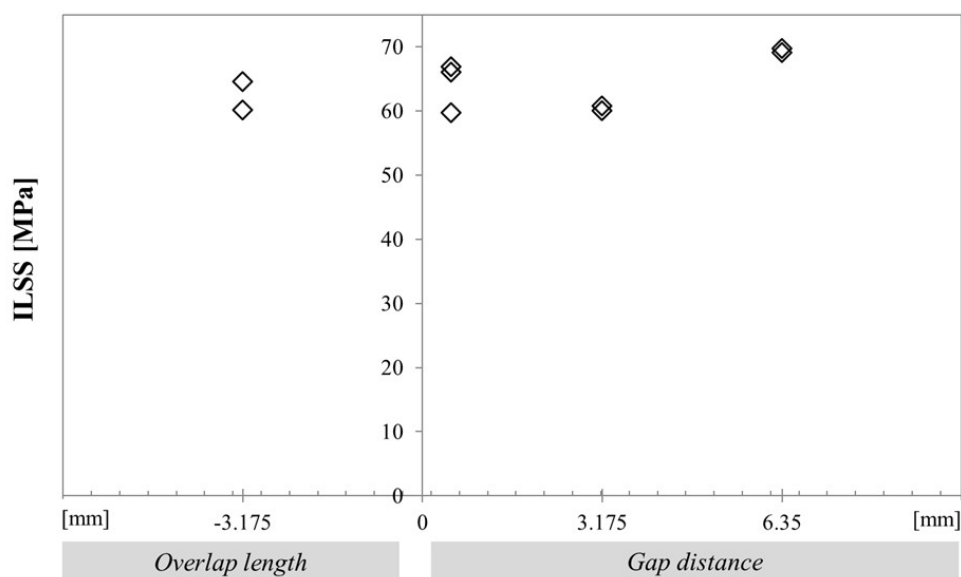
Figure 5. Apparent Interlaminar shear stress variation as a function of the type of embedded defect with caul plate, [90/0₇/90₂/0₇/90].

Figure 5 shows the results from short beam shear tests. These results indicate that the short beam shear test, among the most widely used tests to check composite quality, is not very sensitive to the presence of these singularities. This is an interesting result, but this test has some limitations as noted by Whitney and Browning [34]. They showed the complex stress state in ILSS specimens, with compression stresses tended to suppress the interlaminar shear failure mode. It was therefore decided to perform interlaminar fracture tests, as these can quantify the behaviour when a propagating delamination meets a zone containing singularities.

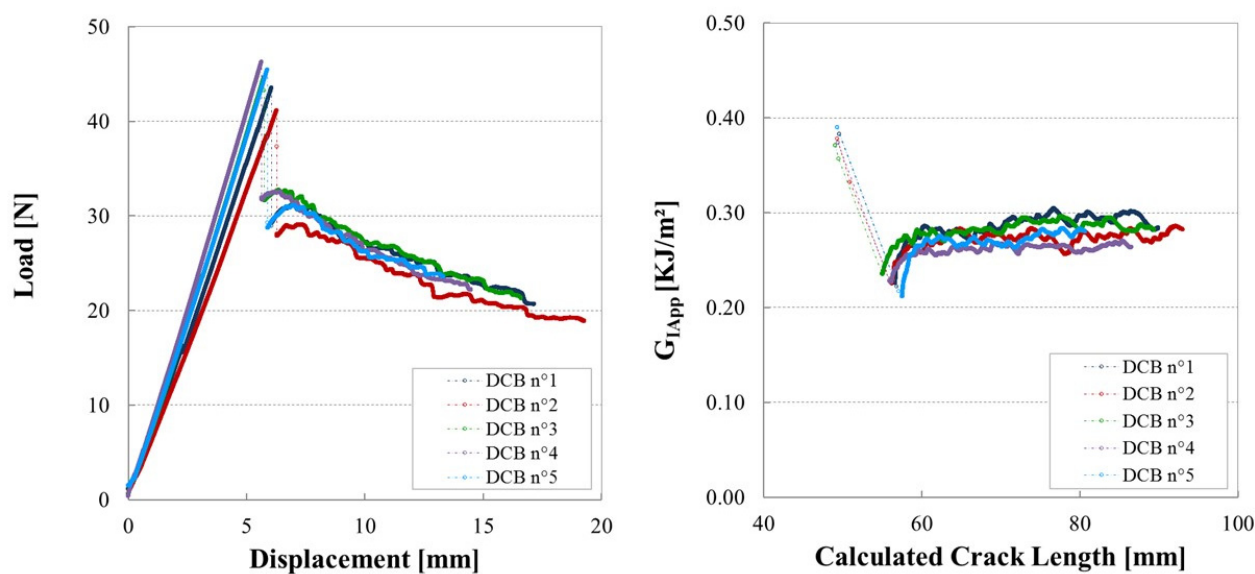
Figure 6. Mode I fracture test results for unidirectional samples without singularities. (Left) Force–displacement. (Right) Apparent G_{Ic} versus crack length.

Figure 6 shows the results from Mode I tests on samples laid up from prepreg layers of the same material as that employed for tape laying, and manufactured in the autoclave with the same cure cycle, i.e., the same composite but without any singularities.

These curves show typical behaviour of this material in DCB tests without singularities. The initiation from the starter film is unstable for all specimens, a load drop is noted on the force–displacement plot as the crack rapidly advances a few millimetres beyond the insert film, but then stable propagation is recorded throughout the test. This results in propagation values in the range 0.25–0.30 kJ/m².

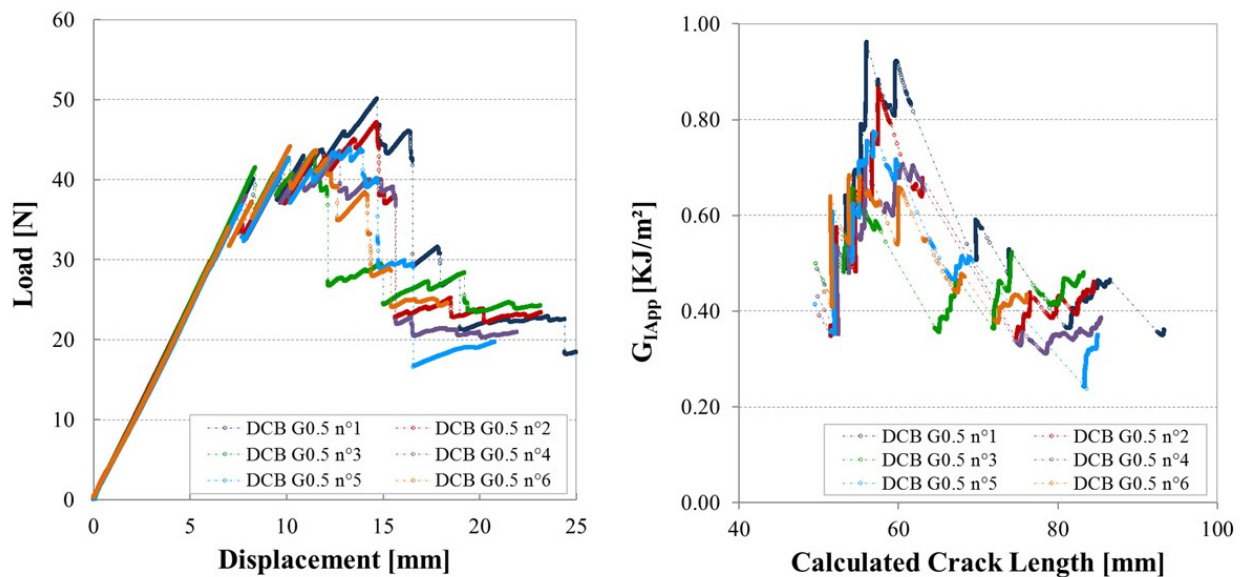
Figure 7. Load vs. displacement traces (left) and R-curves (right) for cross ply laminates ($[90/0_7/90]_s$) containing a 0.5 mm gap (considered as reference configuration without defects).

Figure 7 shows the load vs. displacement traces (left) and the calculated R-curves (right) of [90/0₇/90]s laminates containing 0.5 mm gaps. The crack propagation is typical of stick/slip behaviour. The crack jumps immediately to a 90/0 interface. With further loading, the crack jumps from one 90/0 interface to the other 90/0 interface. This phenomenon has also been observed by Brunner and Blackman for tests on specimens with 90° central layers without singularities [35]. Despite the differences in the laminate configurations, the

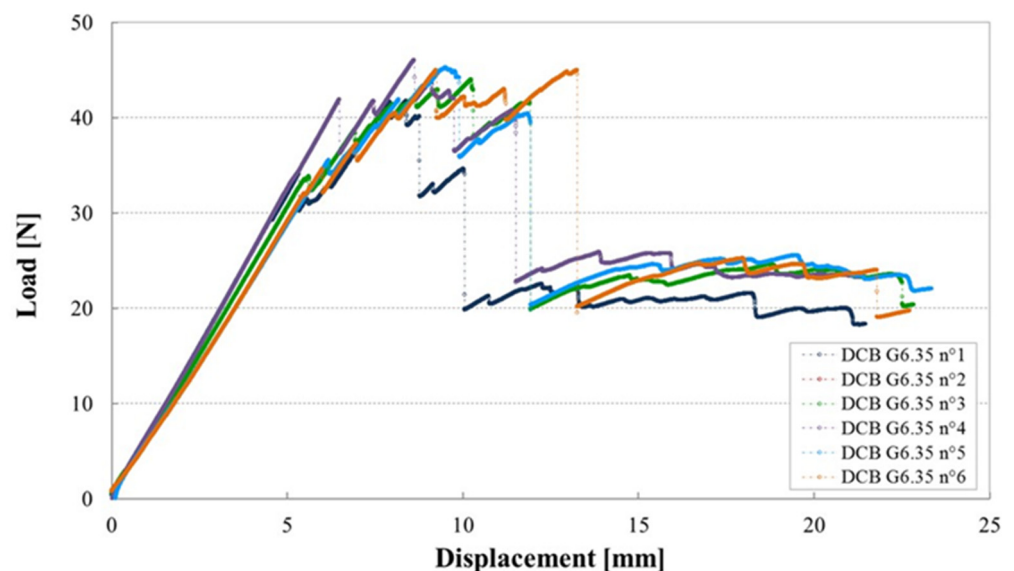
Figure 8. Load-displacement plots for the various samples containing a Gap of 6.35 mm polymerized with caul plate.

Figure 8 shows an example of the load/displacement plots from six DCB tests on specimens with the largest gap defects. There is an initial stable propagation as the damage zone in front of the insert develops, then the crack meets the singularity region and the load increases until an unstable crack jump. Further crack propagation is then stable. The plots from the six specimens all show the same form, with similar load levels once the crack has passed the singularity.

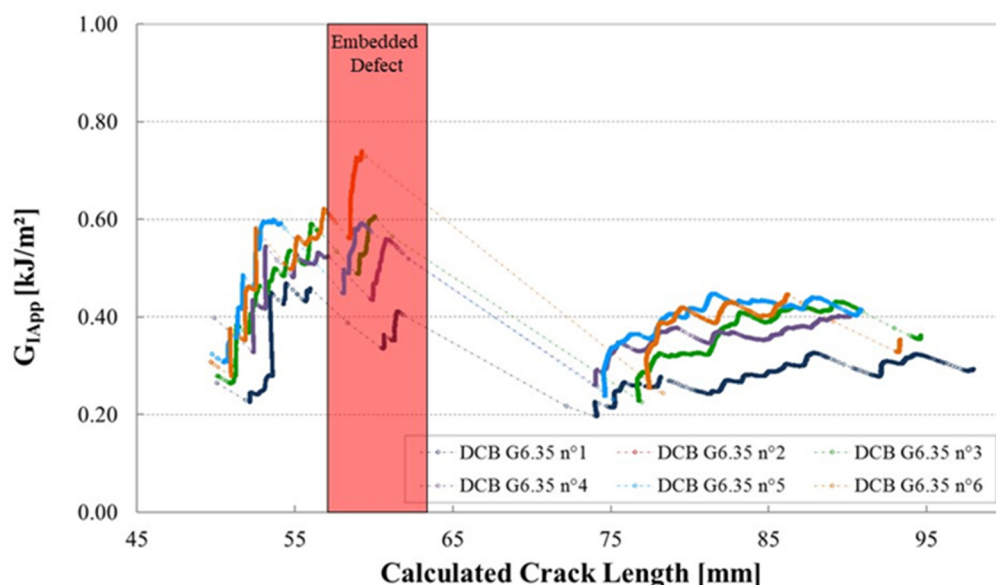
Figure 9. Mode I fracture R-curve, strain energy release rate versus the calculated crack length, for 6 DCB specimens containing a gap of 6.35 mm, manufactured with caul plate (calculated from plots in Figure 8).

The corresponding R-curves (Figure 9) show that G_{IApp} increases as the crack approaches the zone containing the manufacturing defect (red shaded area), then an unstable crack propagation of around 15 mm is noted, before the fracture energy stabilizes.

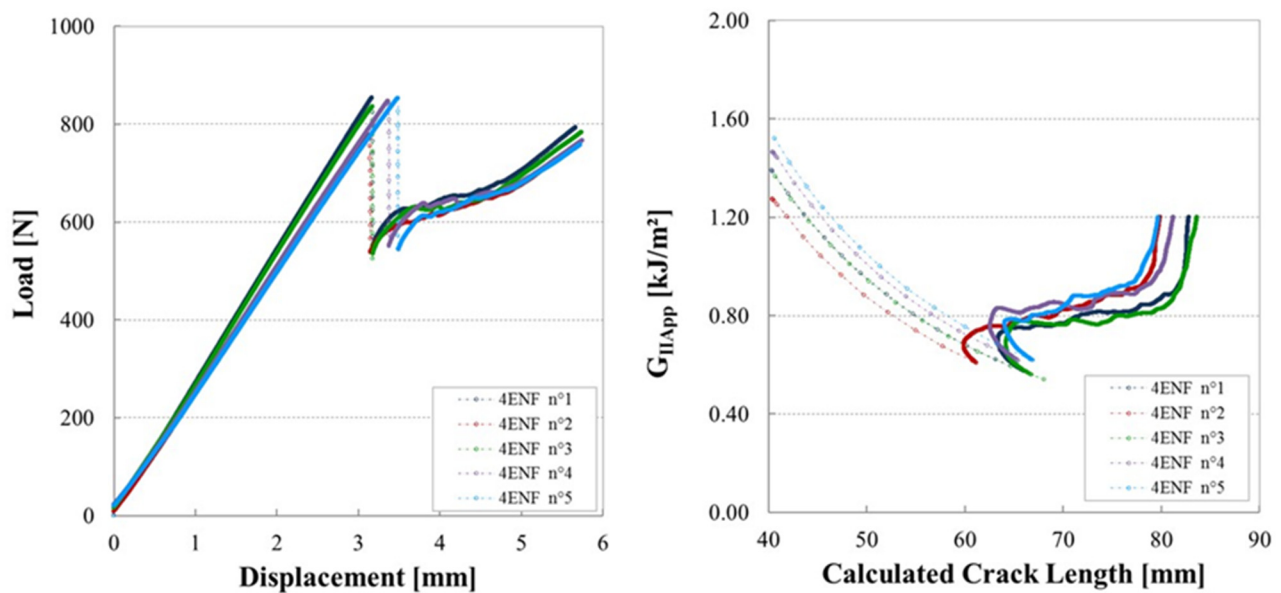
Figure 10. Load vs. displacement curves and R-curves of the Mode II unidirectional laminates.

Figure 10 shows the results from the Mode II tests on the same material in unidirectional form without singularities. As for the Mode I tests on unidirectional specimens (Figure 6), the initiation of the delamination is unstable. The subsequent crack propagation is stable reaching G_{IIapp} values of the order of 800 J/m². This level of G_{IIapp} is comparable to results found in the literature for the same material (values around 0.9 kJ/m²) [36].

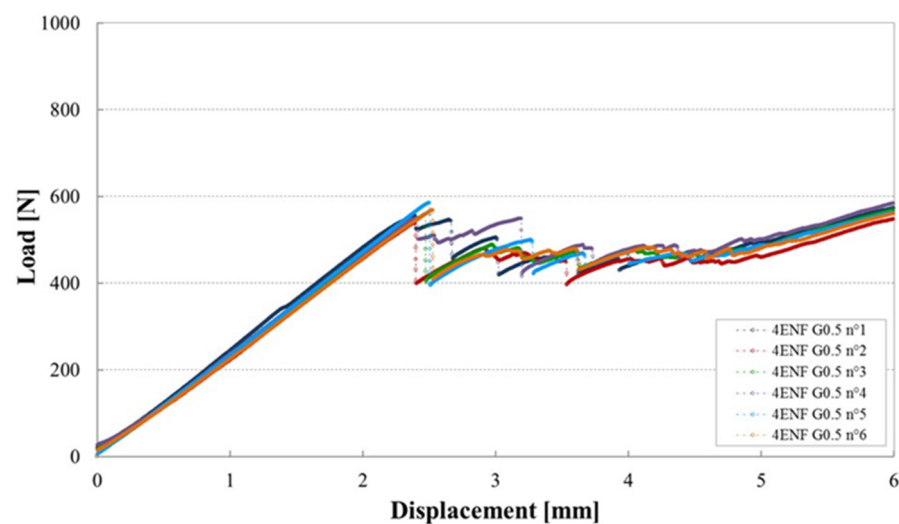
Figure 11. Load–displacement plots for tests on six 4ENF specimens containing a Gap of 0.5 mm manufactured with a caul plate.

Figure 11 shows examples of load–displacement plots for Mode II tests of the cross ply laminated containing a gap of 0.5 mm, in which no defects could be found after cure.

Here there is an initial load drop, followed by a period of stick–slip crack propagation, then a steep increase in load as the crack reached the region of the specimen affected by the loading point compression zone. The plots for the six specimens are quite similar, both in terms of behaviour and values.

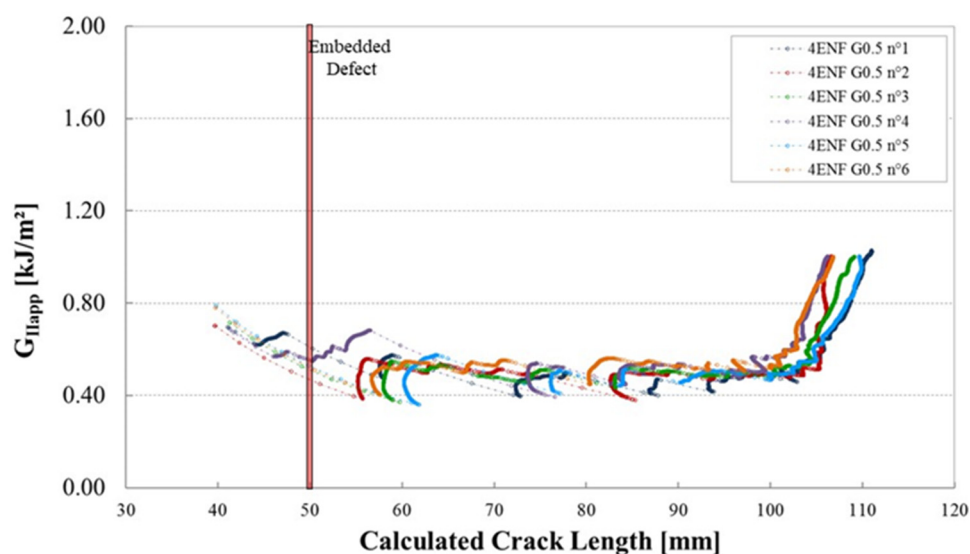
Figure 12. Mode II fracture energy as a function of the crack length for six 4ENF specimens containing a gap of 0.5 mm from a plate manufactured with caul plate (reference configuration considered without defects).

Figure 12 shows the corresponding plots of $G_{II,app}$ versus calculated crack length for these specimens. The shaded area represents the location and size of the embedded defect.

The shape of the R-curves suggests that the stiffness of the sample increases after an unstable crack propagation as observed for the samples cut out of unidirectional laminates. The observation of the edges of the test coupons indicates that the crack front has jumped to the upper 0°/90° interface, as illustrated in Figure 13. In this case, corresponding to the smallest defect, there is an initial crack jump from the insert to the defect zone. Then from the defect zone onwards the propagation values appear to be quite stable, around 0.65 kJ/m². Figures 14 and 15 show the R-curves for six Mode II specimens with the two larger gaps (3.175 mm and 6.35 mm). A clear effect of the defect zone on the crack propagation behaviour is observed, with crack arrest, there is an increase in apparent fracture energy followed by an increasingly unstable jump as the defect zone is

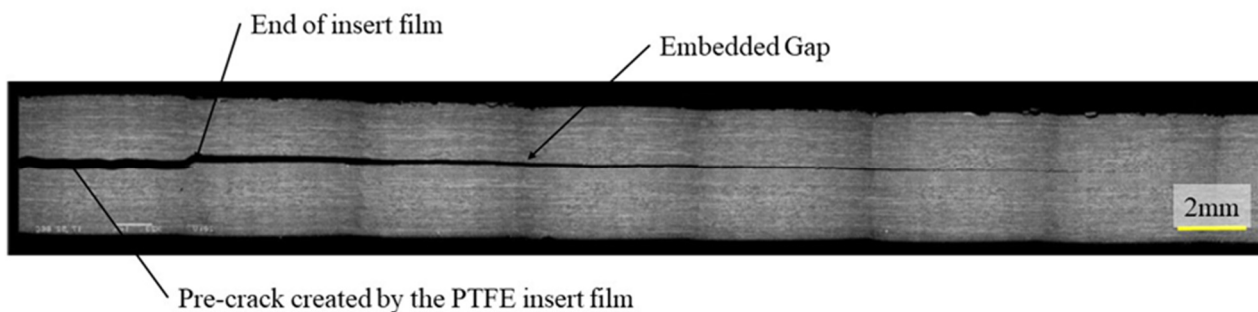
Figure 13. Example of a Mode II crack propagation path on a specimen with a 0.5 mm gap with caul plate.

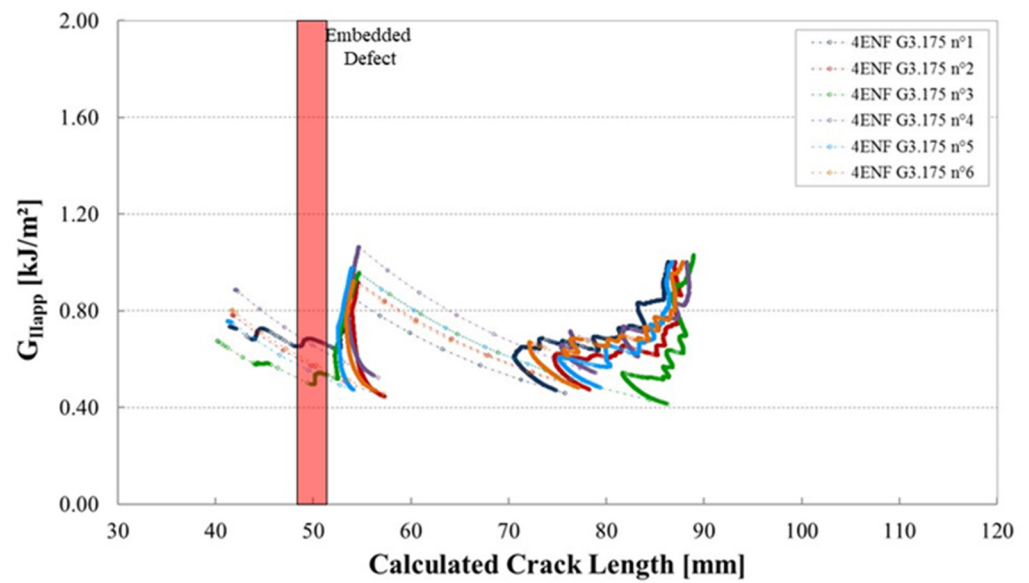
Figure 14. Mode II fracture energy as a function of the crack length for six 4ENF specimens containing a gap of 3.175 mm, plates manufactured with caul plate.

increased. For the 6.35 mm gap the crack jumps to below the loading point, there is no longer any stable propagation. The results for the 3.175 mm gap show an intermediate behaviour. Figure 16 shows the R-curves of a laminate containing a 3.175 mm overlap defect (Figure 2iv). The crack propagation in these samples differs from that of specimens containing gap type defects by the fact that the crack advances rapidly through the defect area to a calculated crack length of approximately 65 mm with a corresponding G_{IIapp} of approximately 0.4 kJ/m². Once the crack front has passed the defect area, the crack propagates in a more stable manner at a G_{IIapp} of the order of 0.6 kJ/m², similar to the values for specimens without defects, until it reaches the loading roller. The behaviour is similar to that of the specimens without defects but with more unstable crack propagation through the defect area. This can be explained by the fact that in the case of overlap defects, the local fibre content is increased. The lack of resin results in lower resistance to the crack propagation.

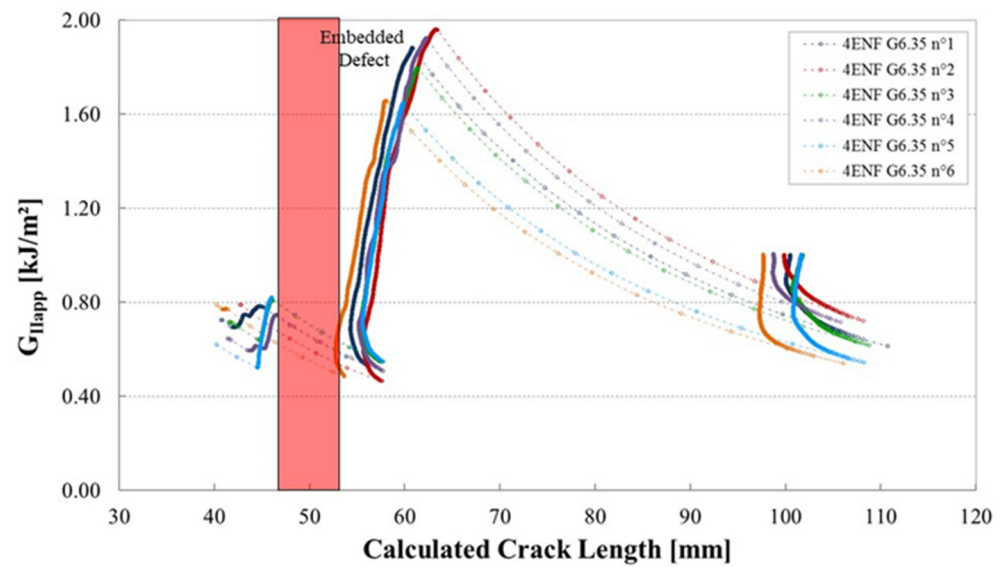
Figure 15. Mode II fracture energy as a function of the crack length for six 4 ENF specimens containing a gap of 6.35 mm from plates manufactured with caul plate.

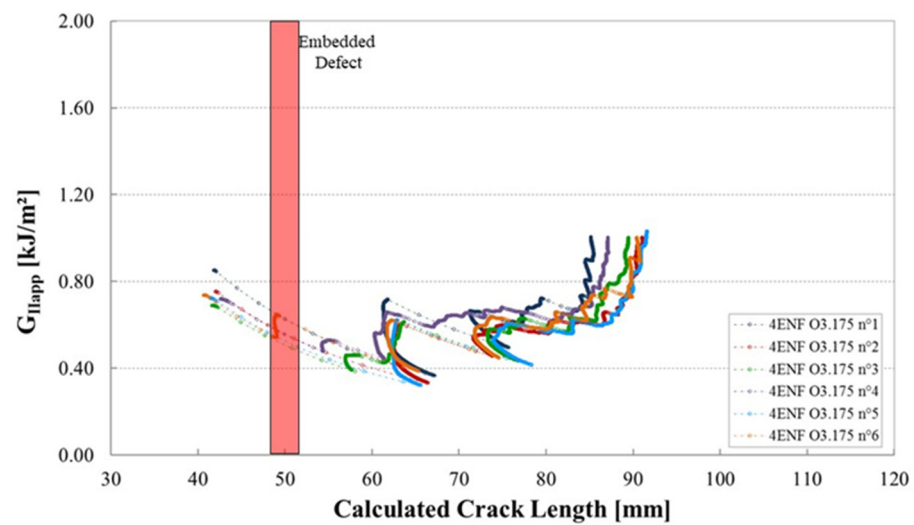
Figure 16. Mode II fracture energy as a function of the crack length for six 4ENF specimens containing an overlap of 3.175 mm from plates manufactured with caul plate.

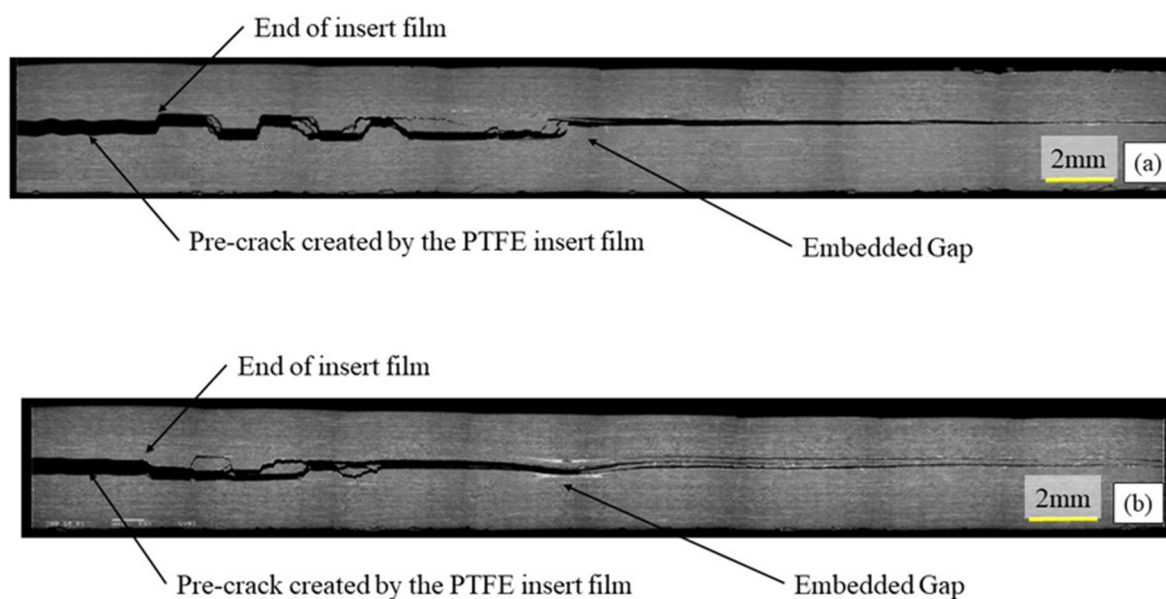
Figure 17. Examples of Mode I crack propagation paths for tests on (a) gap 0.5 mm, with caul plate, (b) gap 6.35 mm, with caul plate.

A comparison of the Mode I results with those for the unidirectional material indicates higher peak values in the initiation region. The apparent crack resistance tends to increase as the damage zone in front of the crack tip interacts with the singularities. Various authors have shown that a plastic or process zone precedes the main crack tip during Mode I propagation [39,40]. As a result of the development of this zone, and its interaction with through-thickness defects, damage including resin cracking and debonding, can occur above and below the crack plane, initiating secondary cracks. Even during the first millimetres of propagation, there is a tendency for the crack to jump between the $0/90^\circ$ interfaces (see Figure 17). This has been seen in previous work on crack propagation at $0/90^\circ$ interfaces [41]. These appear to encourage crack bifurcation, deviating cracks to the $0/90^\circ$ interface, and this raises the apparent fracture energy, Figure 17b. Once the crack has passed the singularity it propagates more easily, and stable propagation fracture energy values return to those measured at the start of the test, around $0.3\text{--}0.4\text{ kJ/m}^2$. These values are similar to those published elsewhere for this $0/90^\circ$ material [41]. The type and dimensions of the singularity and the presence of a caul plate, all affect the peak fracture energy (Table 1).

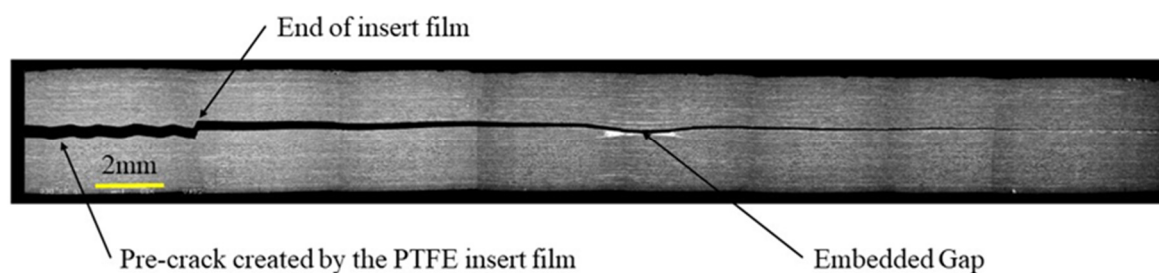
Figure 18. Micrograph Mode II specimen, 6.35 mm gap with caul plate.

Concerning the Mode II results, these clearly indicate that the presence of the larger gaps has a significant effect on the crack propagation behaviour. There is a large arresting effect increasing with increasing defect size (within the range of defect tested in this study) followed by unstable crack growth. The specimens with overlaps are much less affected by the defect. Examination of micrographs suggests that the crack arrest may be due to large resin pockets resisting Mode II crack propagation, though local curvature in the plies visible in Figure 18 which will also hinder crack advance. The scatter in Mode II values is quite low; the crack tends to stay at the same $0/90^\circ$ interface during propagation.

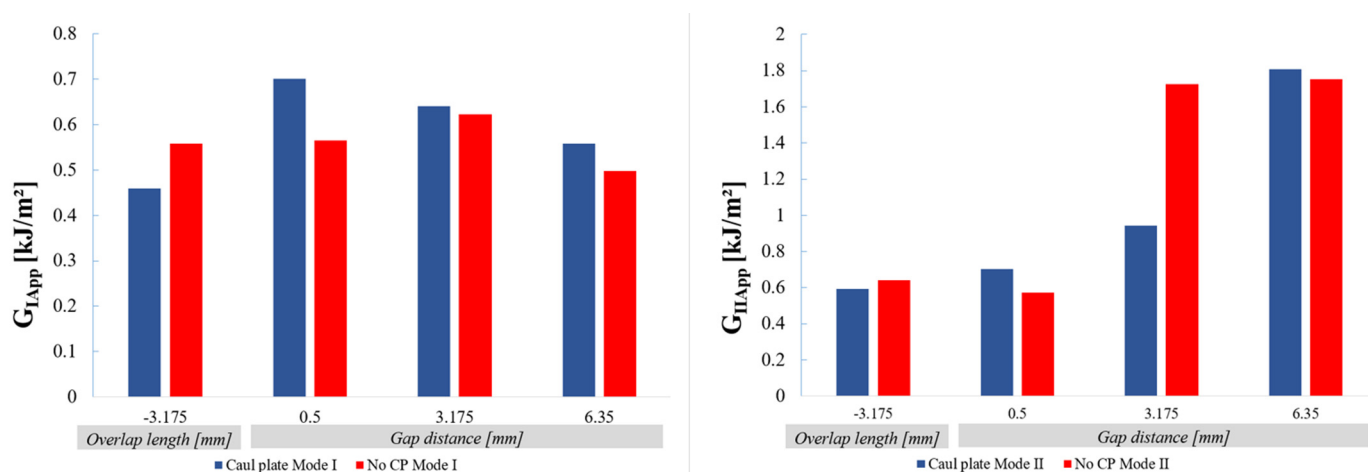
Figure 19. Influence of the caul plate on Mode I (left) and Mode II (right) fracture energies.

Finally, concerning the influence of the caul plate, the data are provided in Tables 1 and 2, but Figure 19 shows plots of mean values to illustrate the effects more clearly.

Under Mode I loading the caul plate tends to increase the fracture energy slightly, perhaps due to a more constrained interlaminar microstructure resulting in less planar interfaces.

Under Mode II loading the difference is small for small defects but for larger gaps (3.175 mm) the crack resistance with a caul plate is lower than without. For the largest 6.25 mm gaps the results are similar with and without the caul plate. This suggests there may be a critical ratio between the dimensions of the zone affected by the defect and the homogenizing effect of the caul plate, which controls the damage zone and energy required to propagate the crack. More work is needed to quantify this effect.
